COLUMBIA ACCIDENT INVESTIGATION BOARD (CAIB)/
NATIONAL AERONAUTICS AND SPACE ADMINISTRATION (NASA)
ACCIDENT INVESTIGATION TEAM (NAIT)

WORKING SCENARIO

FINAL VERSION: JULY 8, 2003

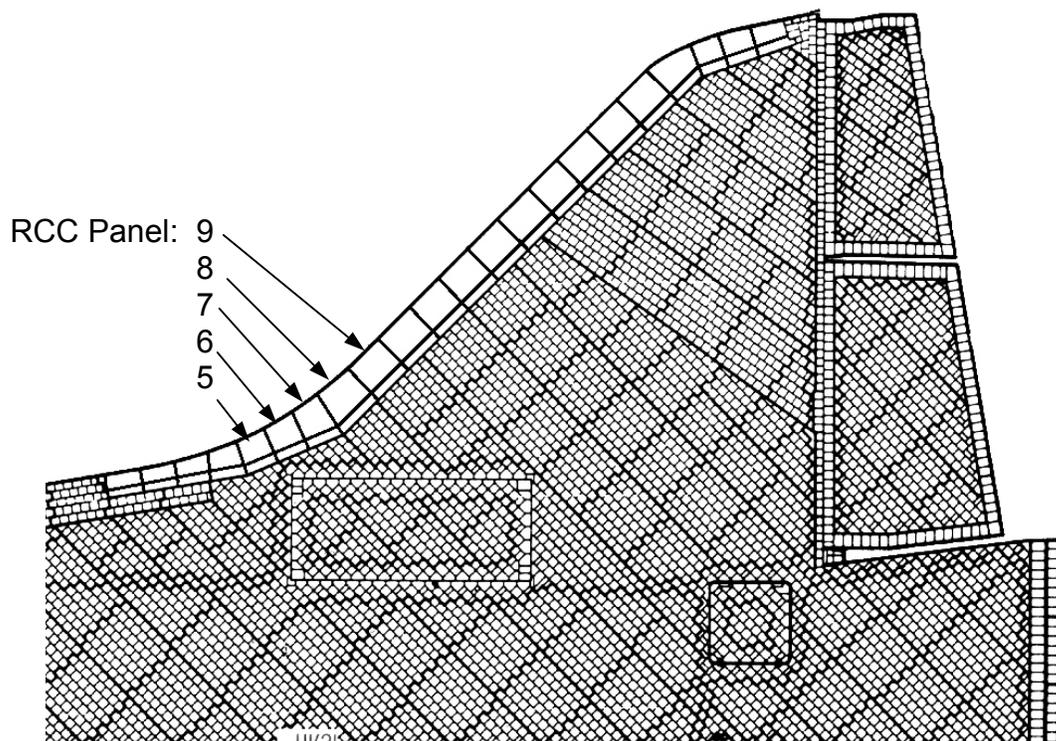
Figure 3-4. Area of most likely wing damage

Several approaches were taken to assess the area of left wing damage. The efforts included launch video and photograph analysis, review of launch MADS data, debris transport analysis, forensic analysis of debris found in Texas, wire bundle burn through analysis, and aero/thermal modeling of the entry. The data indicate that the area of the highest probability of damage to the left wing was between RCC panels 5 and 9, with the most likely damage occurring on the lower side of RCC panel 8 or an adjacent Tee seal. The damage was most likely equivalent in size to a 6 to 10 inch diameter hole or area broken from the RCC panel or an adjacent Tee seal. Figure 3-4 shows the area of highest probability of wing damage and Table 3-1 shows the methods used to determine the damage.

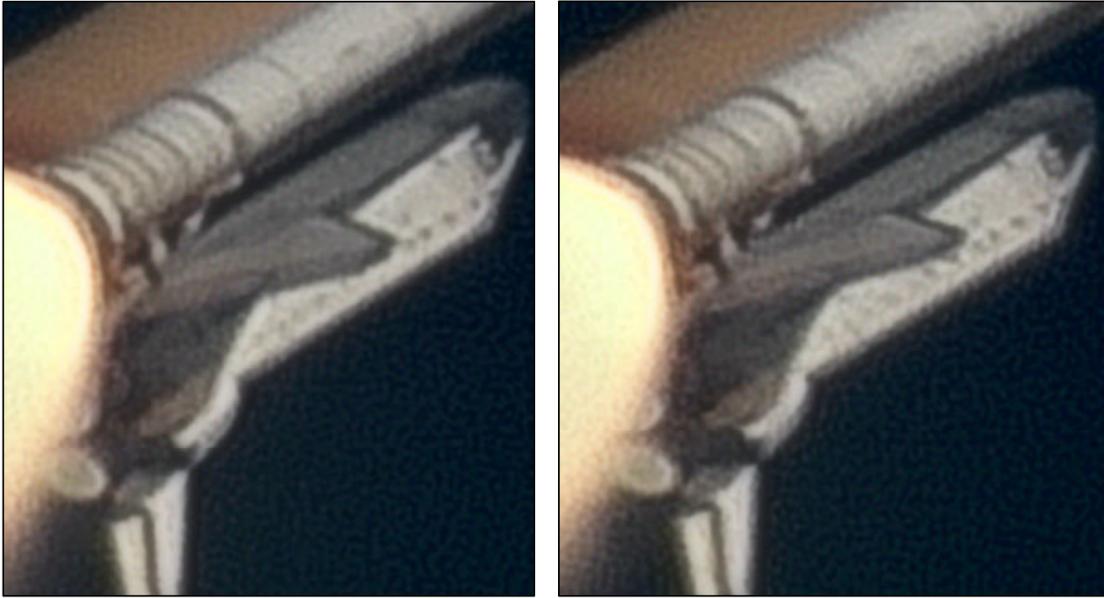
Figure 3-11. Pre-impact vs. post-impact shows no observable damage within the resolution limits

Enhancements of the ascent video indicated there was no discernable damage to the orbiter wing leading edge or lower tile surface. Figure 3-11 is a sample of these video enhancements. The figure compares 30 pre-impact integrated video fields with 21 post-impact integrated video fields. Based on these enhancements, photo experts have been unable to determine or quantify any damage to any portion of the orbiter vehicle as a result of the impact.

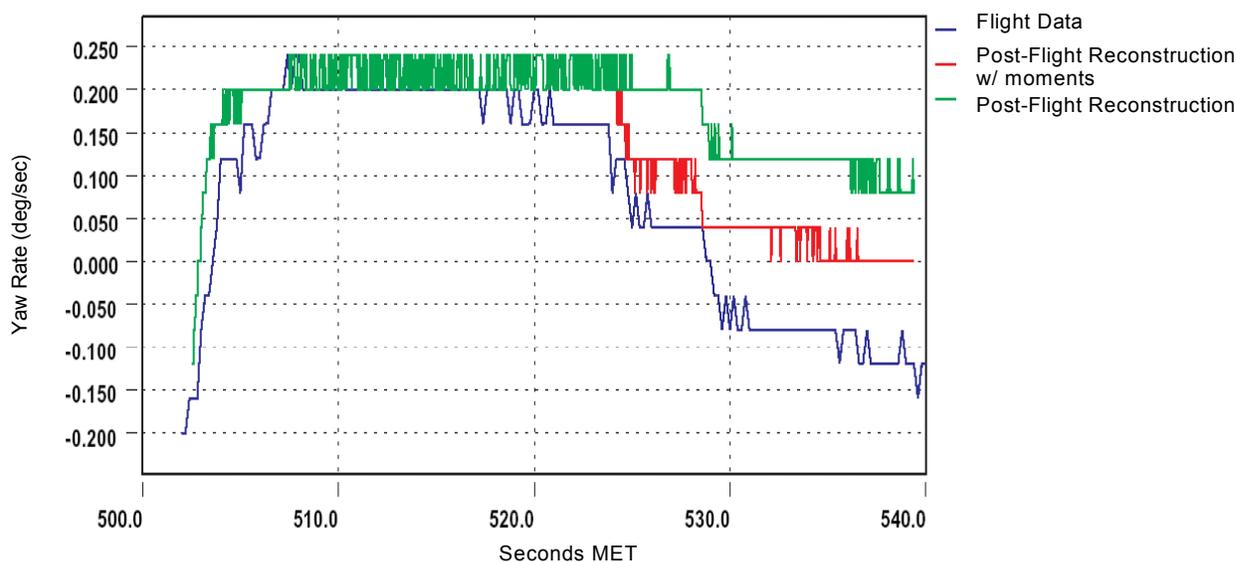
Figure 3-36. ET separation yaw rate

A higher than typical negative yaw rate was observed at ET separation during STS-107. The yaw rate, shown in Figure 3-36, was approximately -0.12 deg/sec and near the edge of the flight experience envelope. The negative yaw rate is noteworthy because it does not correspond to the flight control system's thruster activity, known vent forces, or any other explained mission activity. Furthermore, the rate appears at the time of physical separation between the orbiter and external tank, which indicates that it is related to the structural release between the two objects. Although the negative yaw rate was unusual, it was well within the design and certification envelope for ET separation. This rate was also well within the flight limits (± 0.7 deg/sec) for ET separation to occur.

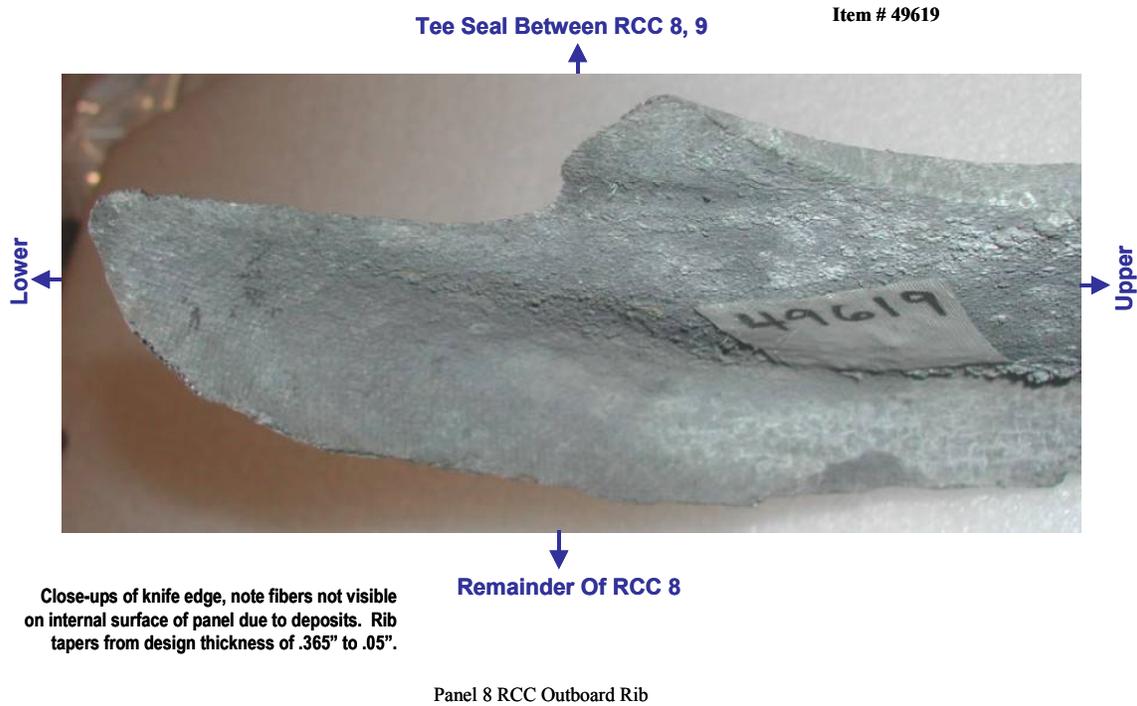
Figure 5-4. Example of rib erosion

these inner surfaces indicate flow from the panel 8 direction toward panel 9. This is also consistent with the knife-edge erosion shown in Figure 5-4 below. The proposed flow direction leading to the erosion and slag deposition on the lower carrier panel 9 tiles can be seen in this view as well. The detailed flow, erosion, and deposition are best viewed in Figure 5-5. The last significant feature in Figure 5-6 is the heavy slumping that is observed on the upper carrier panel 8 tile (50336T) in the upper right portion of the drawing.

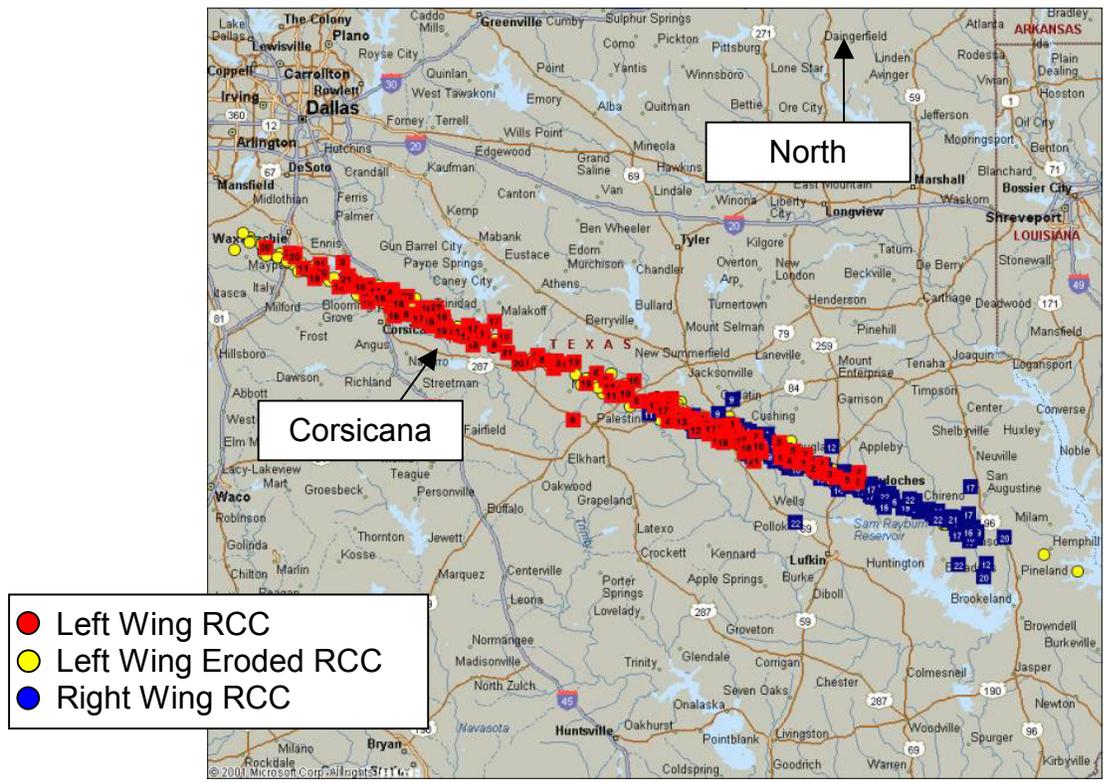
Figure 5-8. RCC panel debris location

In addition to the slag deposition and flow analysis, there are two other significant pieces of data that point to a breach in the RCC 8/9 area as the initial damage. The first item is the location of the leading edge RCC in the debris footprint. Figure 5-8 shows the recovered RCC for both the left and right wing and its location in the debris footprint. The eroded RCC pieces from panels 8 and 9 are found in the westernmost part of this debris footprint near Waxahachie, Texas, along with other pieces of RCC panel 8. Left wing RCC panel 9 and other aft panels appear to have been lost relatively early in the break-up sequence since their footprint spans the western to center part of the footprint. This is indicative of a left wing breach in the panel 8/9 area. The forward portion of the RCC panels on both the left and right wings (panels 1 through 7) are found from the center to eastern part of the debris footprint possibly indicating that these were lost in a secondary aerodynamic break-up.

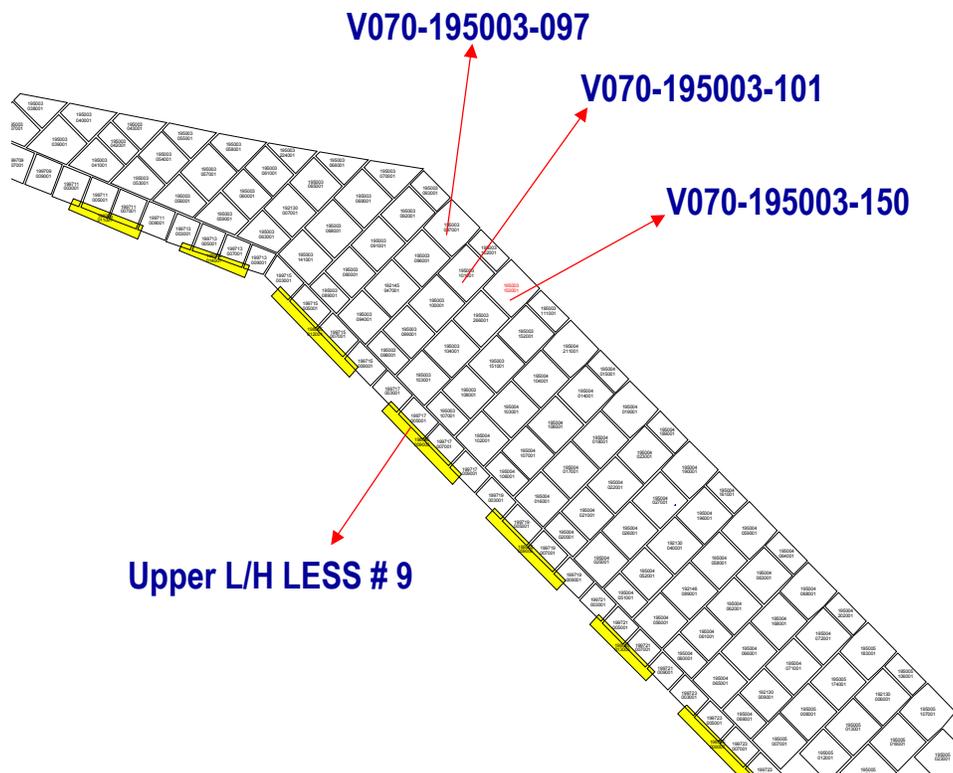
Figure 5-9. Three possible orbiter locations of the Littlefield tile on left wing

The tile departed the orbiter more than one minute prior to final break-up due to prolonged internal heating of the upper wing skin in the area shown in Figure 5-9. The tile shows indications of backside heating and an RTV debond. It was not a failure in the densification layer, which would have been caused by mechanical loading. This piece of recovered debris is not very significant on its own merit; however, it is consistent with the previously discussed forensics data (rib erosion, carrier panel 9 tile slumping, etc.) and other events that will be discussed later in Section 5.4.

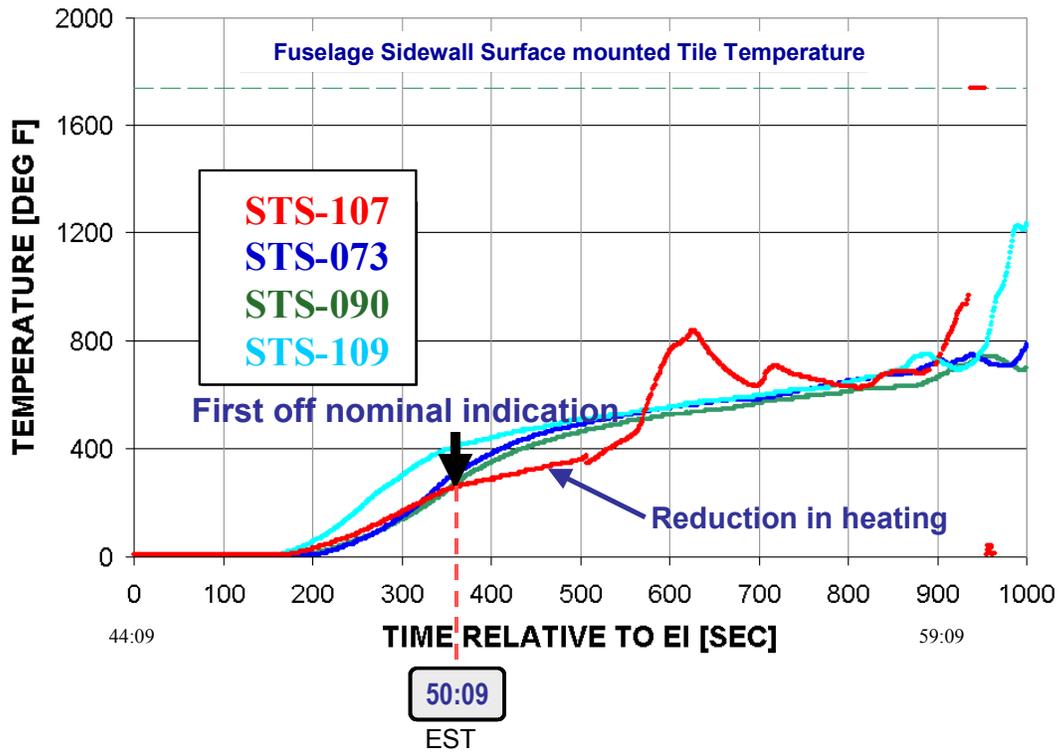
Figure 5-20. Off-nominal temperature indication on the left sidewall

In the same timeframe, at 8:50:09 EST (EI + 360 sec.), a left payload bay fuselage MADS surface temperature measurement (Figure 5-19) showed an off-nominal temperature trend. This trend is a reduced rise rate when compared to other previous Columbia missions, as shown in Figure 5-20. The previously discussed theory of venting and or disturbed flow due to panel 8 damage, causing a shift in the vortices on the upper surface of the wing, is also believed to be the cause of this off-nominal behavior. The flow field and venting on the upper surface rate are constantly increasing since the mass flow rate into the RCC breach is increasing as the orbiter descends lower into the atmosphere.

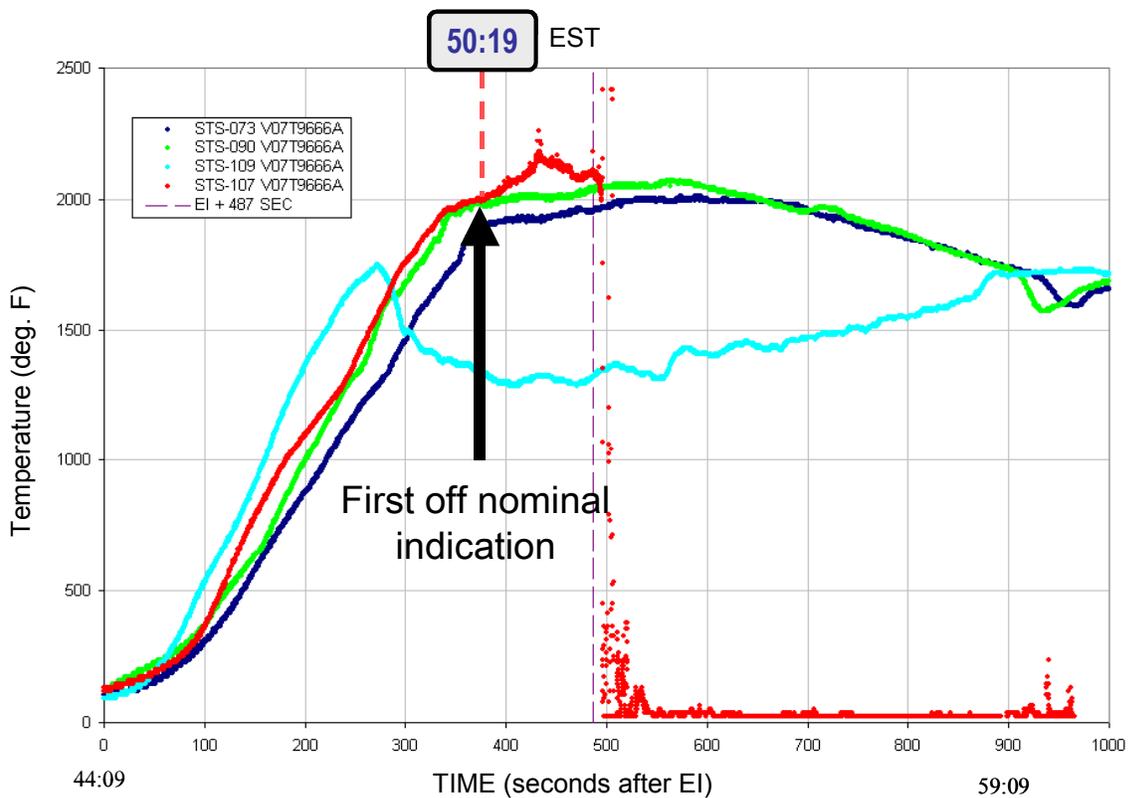
Figure 5-21. Temperature rise on tile surfaces aft of RCC panel 9

At 8:50:19 EST (EI + 370 sec.), a lower surface thermocouple showed signs of off nominal, increased heating. The best explanation for the increased heating in this area is severely disturbed, turbulent flow caused by the leading edge damage on the bottom of RCC panel 8 and flow from the lower corner of this panel as discussed in Section 5.3. Langley Research Center wind tunnel testing has confirmed that wing leading edge damage (notch or protuberance) near panel 8 will cause increased heating to the lower wing surface. As previously discussed, the eroded lower carrier panel tiles on panel 9 indicate this strong flow from panel 8. This is consistent with flow patterns observed on many recovered lower surface wing acreage tiles along the flow lines aft of the RCC panel 8 area. Figure 5-21 shows this temperature response as compared to other Columbia missions. The location of the sensor can be seen in Figure 5-22.

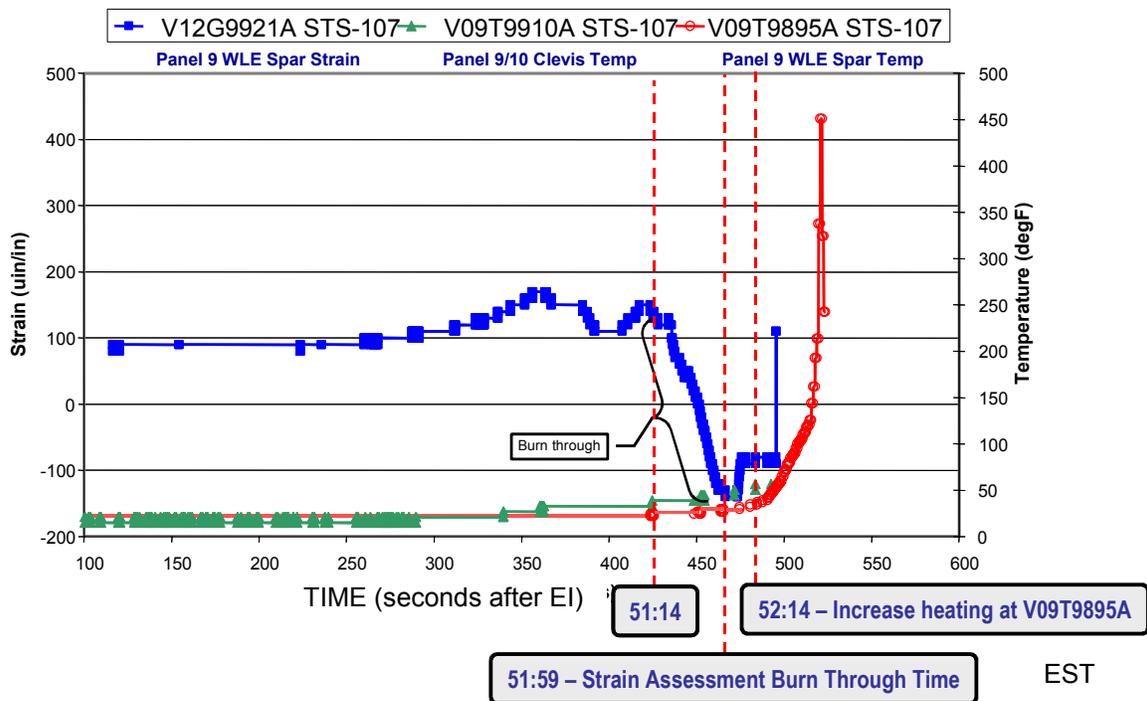
Figure 5-23. RCC panel 9 MADS strain and temperature measurements, STS-107

By 8:51:14 EST (EI + 425 sec.), the wing leading edge spar temperature began an early, off-nominal rise, shown in Figure 5-23. At the same time, the clevis temperature in the RCC panel 9/10 region continued to increase. The initial spar temperature rise was relatively slow and was caused by conduction since this measurement is on the backside of the spar in the wing cavity. Eventually, the rise rate increased dramatically as first the Inconel and Cerachrome insulation and later the aluminum honeycomb were destroyed. The exact time of the spar breach is unknown; however, it is estimated to have occurred between 8:51:14 to 8:51:59 EST (EI + 425 to 470 sec.) based on the observed wing leading edge linear decrease in strain during this timeframe. A more detailed discussion of the method used to bracket the time of the wing spar breach is contained in the following section.

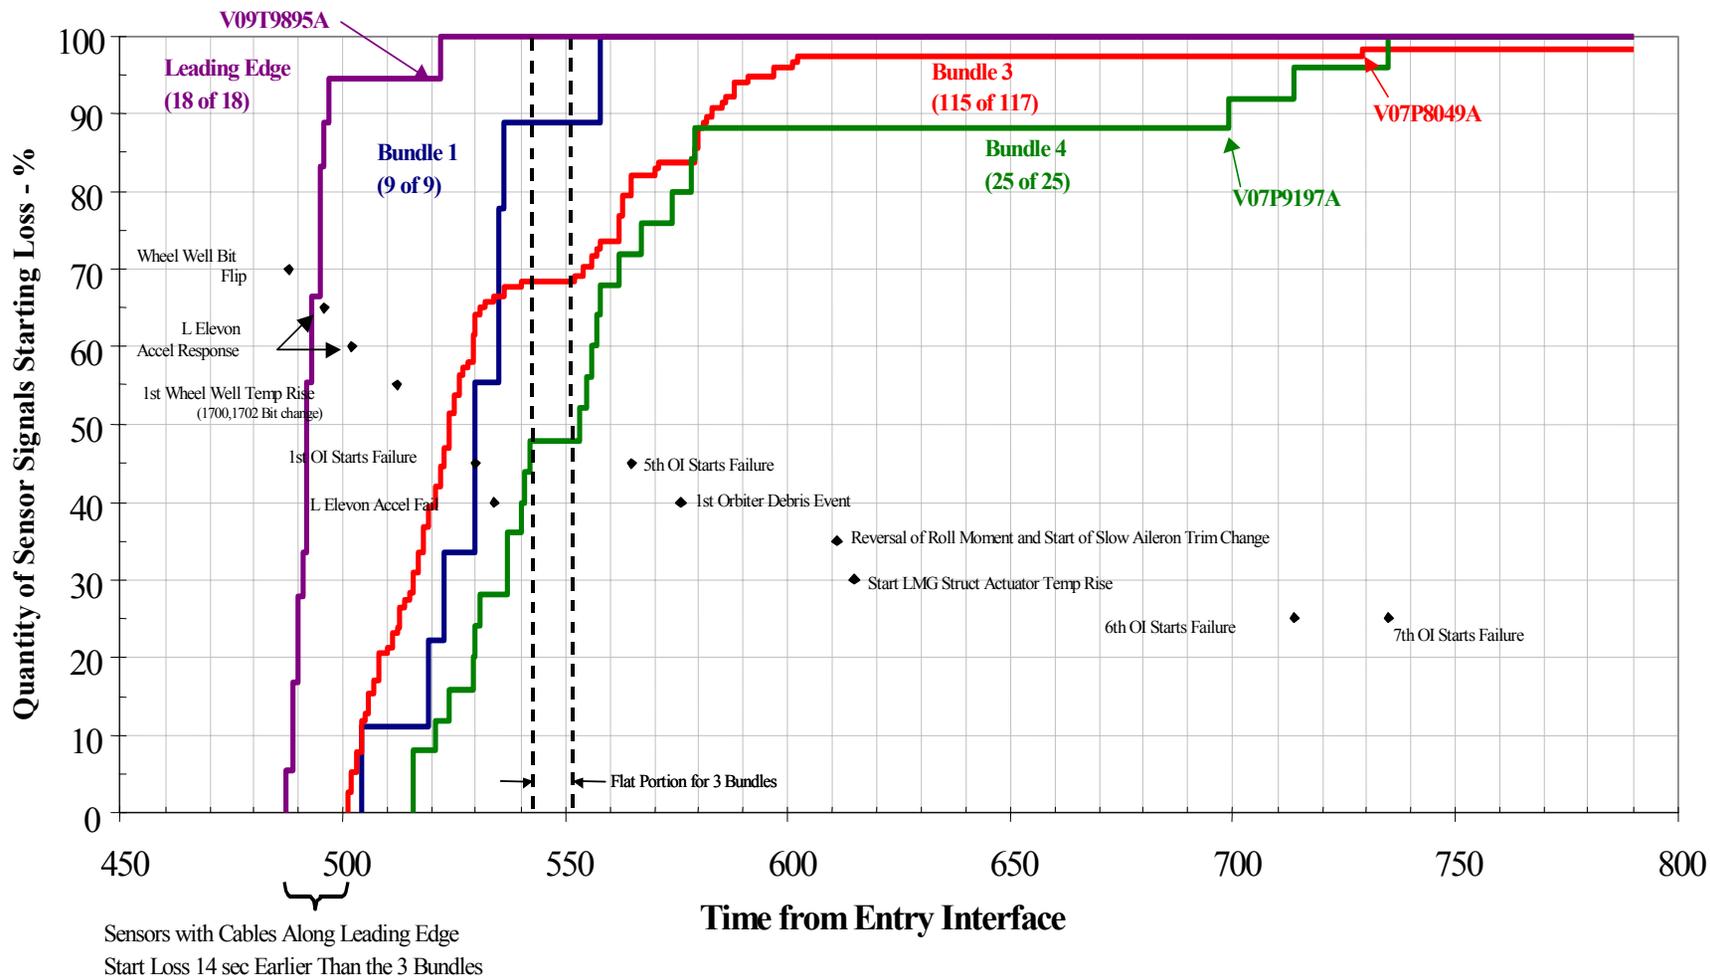
Figure 5-34. MADS data failure due to wire burning

Arc-jet testing was performed in a facility at JSC to demonstrate how quickly a hole in a 0.1 inch thick aluminum plate would grow in an attempt to determine the feasibility of a rapid spar burn through followed by rapid wire measurement failures. The test configuration had an initial 1-inch diameter hole, and a stagnation heat rate of 12.13 BTU per square foot per second (equivalent to the flight environment at about 8:50 EST, EI ~ 351 sec). During the test, the aluminum plate hole grew from 1 inch in diameter to 5 inches in diameter in approximately 13 seconds. This was consistent with thermal math models developed to analytically predict hole growth. A wire bundle placed 15 inches from the heat source showed very rapid erosion after the hole grew to 5 inches in diameter. The measurement losses in this bundle were very consistent with those observed for wire bundle number 3 (see Figure 5-34). The hole would have grown to a larger diameter; however, the test set-up provided a heat sink that eliminated further hole growth. Overall, the test indicated that a hole in the aluminum honeycomb would grow rapidly, allowing a substantial plume to destroy the wire bundles on the wheel well wall.
