## HYPERGOLIC PROPELLANTS: THE HANDLING HAZARDS AND LESSONS LEARNED FROM USE

B. Nufer

NASA Kennedy Space Center, Engineering Directorate, Fluids Division, Hypergolic and Hydraulic  
Systems Branch

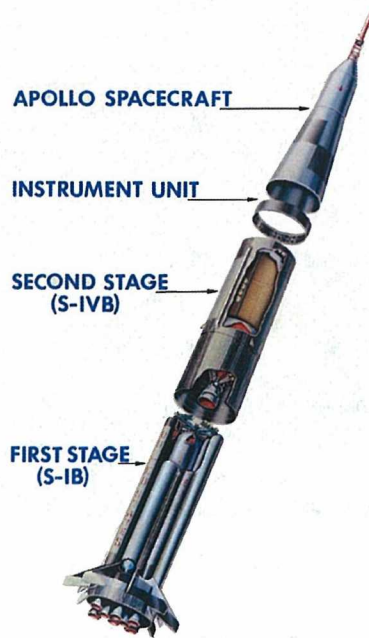
Figure 4: Saturn 1B Launch Vehicle

The  $N_2O_4$  spill occurred when a vacuum was applied to the Command Module Reaction Control System (RCS) propellant tank prior to the second dry-run servicing test. It was later determined that a quick disconnect (QD) servicing valve had become blocked during the initial dry-run test (proximate cause). When the vacuum pump was brought online for the second dry run, oxidizer was pulled into the pump's oil sump and then subsequently released out of the oil sump tank vent port. Technicians used the standard procedure at the time, which was to dilute the propellant using water. This, unfortunately, resulted in the formation of nitric acid. Approximately 400 gallons of water were used to dilute the  $N_2O_4$  which ultimately ran down the side of the launch vehicle and into the instrument unit ring, as seen in Figure 4 in the Saturn 1B cutaway view.

The damage to the vehicle was extensive and the delay was several weeks. The cleanup on the ground level of LC-34 took several days. A de-stack was completed to remove the instrument unit ring for repair. Most of the wiring in the instrument unit was removed and cleaned. Four cables were replaced and five connectors were rebuilt. Three of the outside antennas were also replaced along with the Saturn IB fin #4 and liquid oxygen bay three door. The forward skirt was removed from the Saturn IV B segment to allow for access inside the launch vehicle. The primary concern for the vehicle was long term corrosion. The vehicle design organization eventually became comfortable with proceeding to launch following several tests. This incident led to the following process and design changes:

- Following use, every QD was disassembled, cleaned, and all soft good were replaced
  - An inadequate maintenance plan was considered the root cause of this incident

- All subsequent GSE tests were performed using a referee fluid such as Freon or alcohol

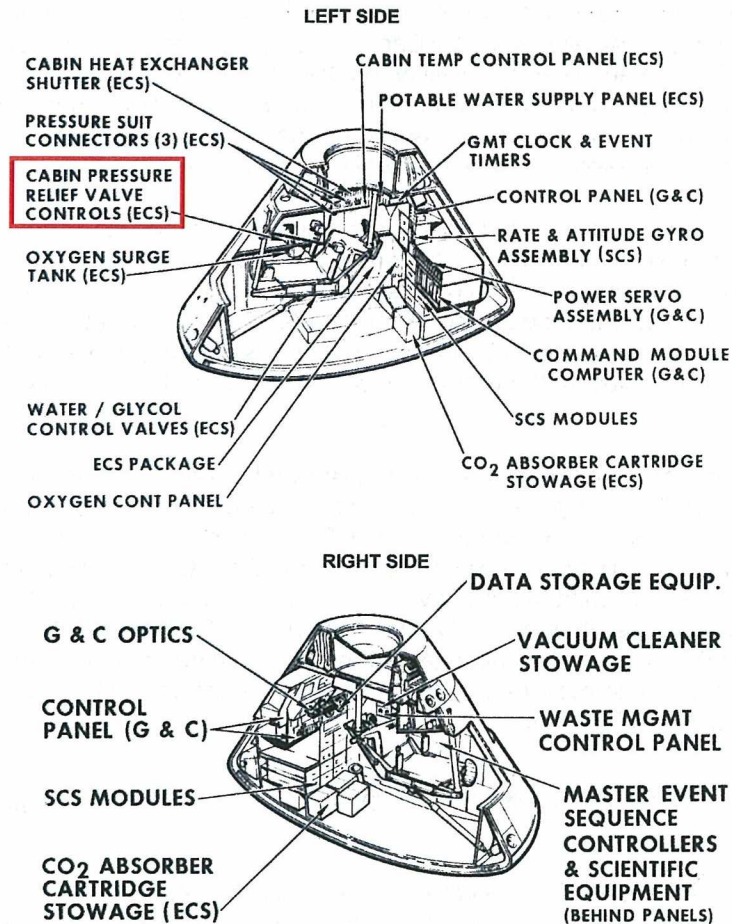
Figure 6: Apollo Command Module Interior Cutaway

The exposure greatly altered the astronauts' abilities to complete assigned tasks in a timely manner; therefore, they experienced a very rough landing along with the poor luck of having the capsule splash-down in the "Stable 2" configuration, which meant it was inverted in the water and thus closed off from the outside air with the relief valves closed. Following splash-down, the crew was forced to don their oxygen masks, but in the interim before Stafford could retrieve and distribute the masks, Brand (who was sitting closest to the relief valve, see Figure 6) lost consciousness.

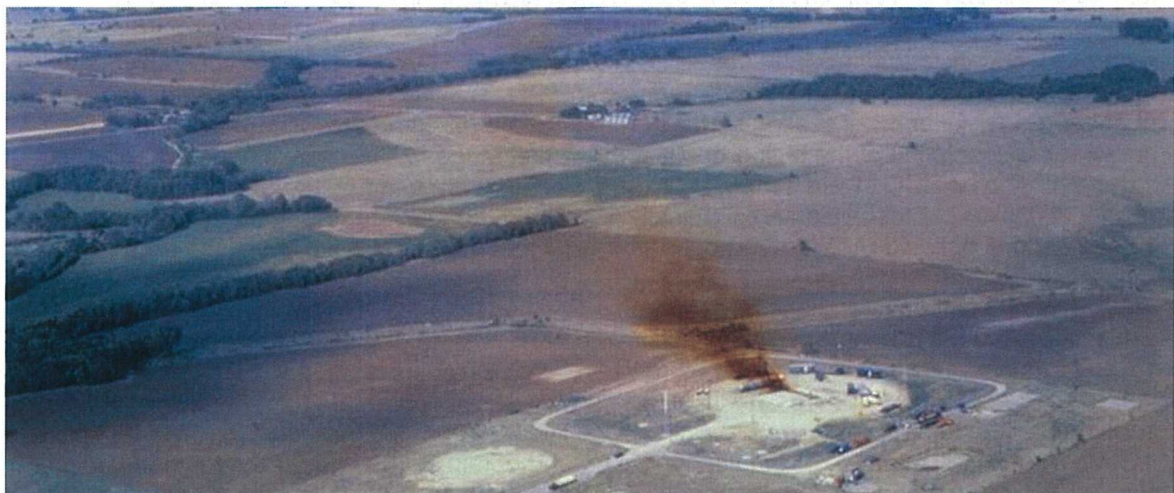
Figure 8: Aerial View of  $N_2O_4$  Vapor Cloud Coming from Missile Silo 533-7

On August 24, 1978, at McConnell AFB southeast of Wichita, Kansas, the worst reported unintentional N<sub>2</sub>O<sub>4</sub> spill in U.S. history took place. Approximately 13,450 gallons of liquid N<sub>2</sub>O<sub>4</sub> spilled into the underground missile silo. Two members of the 381<sup>st</sup> Strategic Missile Wing were killed and 25 more were injured from N<sub>2</sub>O<sub>4</sub> liquid and vapor exposure. The silo also suffered extensive damage. The Titan II first and second stages were an A-50/N<sub>2</sub>O<sub>4</sub> bi-propellant propulsion system. The loading operations were completed using a holding tanker located above ground. Recall that N<sub>2</sub>O<sub>4</sub> (NO<sub>2</sub>) vapors are heavier than air and they boil at approximately 70 °F at ambient pressure.

Once the N<sub>2</sub>O<sub>4</sub> loading of the rocket's first and second stages had been completed, all that remained was disconnecting the QDs from the rocket air half couplings (AHC). The technicians wearing Rocket Fuel Handler Coverall Outfits (RFHCOs) were unaware that a Teflon o-ring seal had dislodged from an upstream location, moved through the filter assembly (of which there were no filter elements installed), through the QD, and wedged itself in between the poppet of the AHC and its primary sealing surface on the Titan II (proximate cause) of the spill. This prevented the isolation of the bulk propellant in the first stage oxidizer tanks once the QD was removed. The RFHCOs were similar to SCAPE suits that are used by the Space Shuttle Program. When the technician mechanically separated the QD from the AHC, approximately 13,450 gallons of liquid N<sub>2</sub>O<sub>4</sub> poured out of the AHC and into the missile silo.

It was later discovered that the suit of the supervisor had failed, introducing him to dangerous levels of N<sub>2</sub>O<sub>4</sub> (NO<sub>2</sub>) vapors, which was ultimately fatal to him within minutes of being

- Proper configuration control of GSE components, in this case the filter, is highly important in the handling of toxic chemicals, especially hypergols (root cause of the incident)
- Emergency procedures and safing must always be reviewed, practiced, and ingrained in the minds of personnel working with toxic chemicals
- Procedural oversight may have been beneficial
- Proper isolation of bulk propellant should be inherently designed into any rocket propulsion system and used accordingly during loading operations
- Personal protective equipment (PPE) should be inspected prior to every use

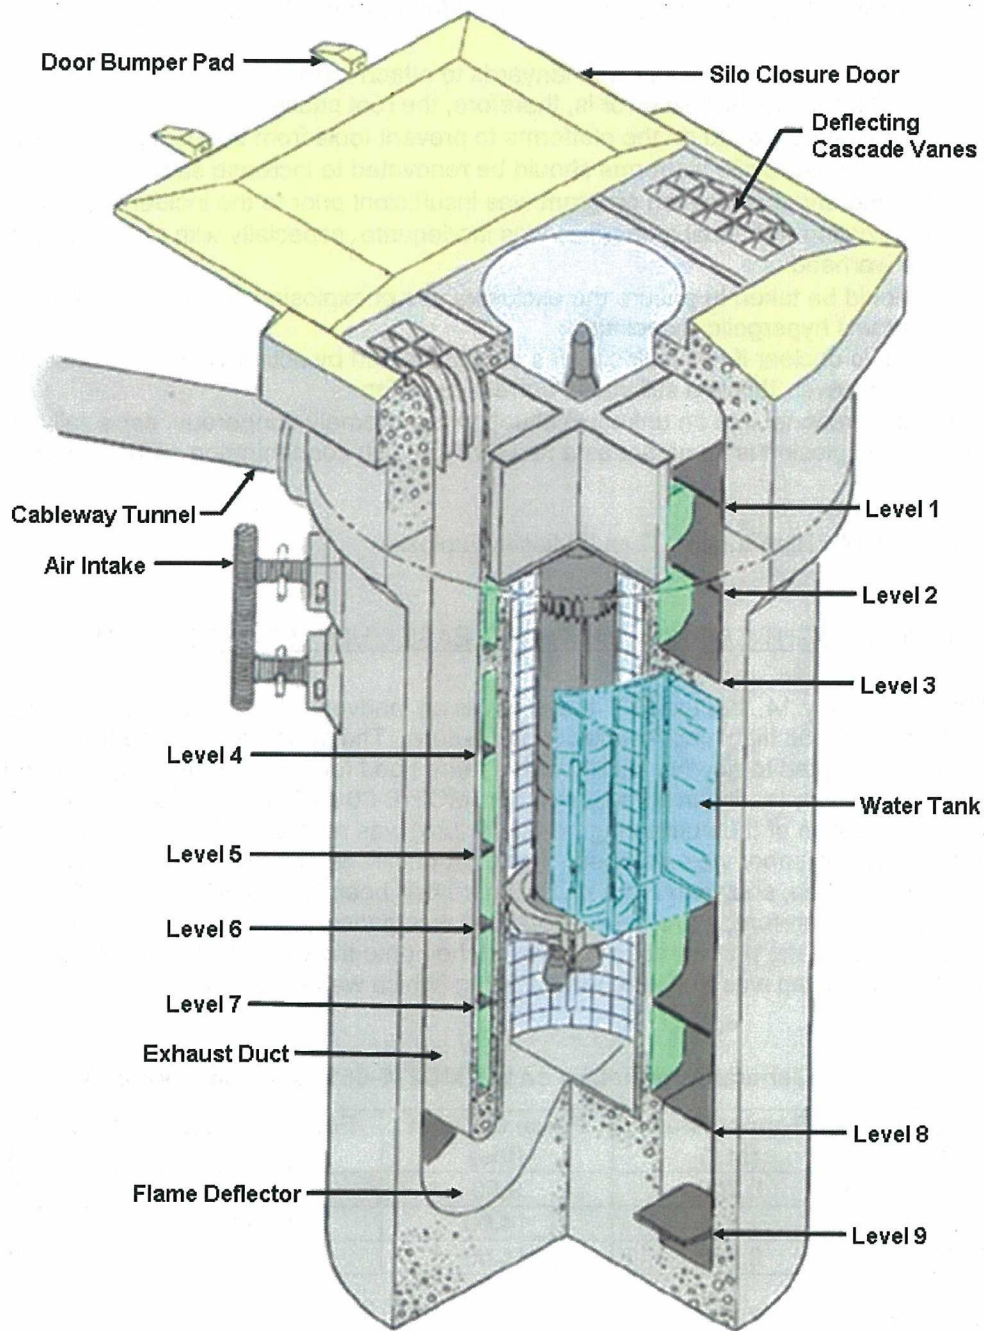
**Figure 10: Titan II Missile Silo**

It was reported that the explosion blew the 740-ton reinforced concrete and steel silo door (see Figure 10 for a depiction of the Titan II missile silo) 200 feet into the air and 600 feet from the silo. The rocket's second stage, with the W53 thermonuclear warhead attached, was launched out of the silo following the explosion of the first stage. The second stage then supposedly blew up in midair, (it contained about 1,730 gallons of A-50 and 3,120 gallons of  $N_2O_4$ ) sending the undetonated warhead several hundred feet from the silo. The W53 warhead had a mass of 8,136 lb and a yield of 9,000 kilotons (the Hiroshima bomb "Little Boy" was estimated at about 15 kilotons). Luckily the warhead's safety features operated as they were designed. There was no reported loss of radioactive material.

- All workers should wear a belt with lanyards to attach tools
  - Operational human error is, therefore, the root cause
- Cloths should be placed on the platforms to prevent tools from bouncing off the metal

- The Titan II missile silo platforms should be renovated to increase safety
- The training and qualification program was insufficient prior to the incident (a root cause)

- Communication with local authorities was inadequate, especially with reference to the nuclear warhead
- Care should be taken to ensure the exclusive use of explosion proof hardware in a facility that contains hypergolic propellants

- It is unclear if this incident was indeed caused by activating the exhaust fans; however, this is a still viable corrective action
- Sending personnel into an unknown situation is extremely dangerous, especially one in which an explosion is imminent as a result of the high concentration of fuel vapors

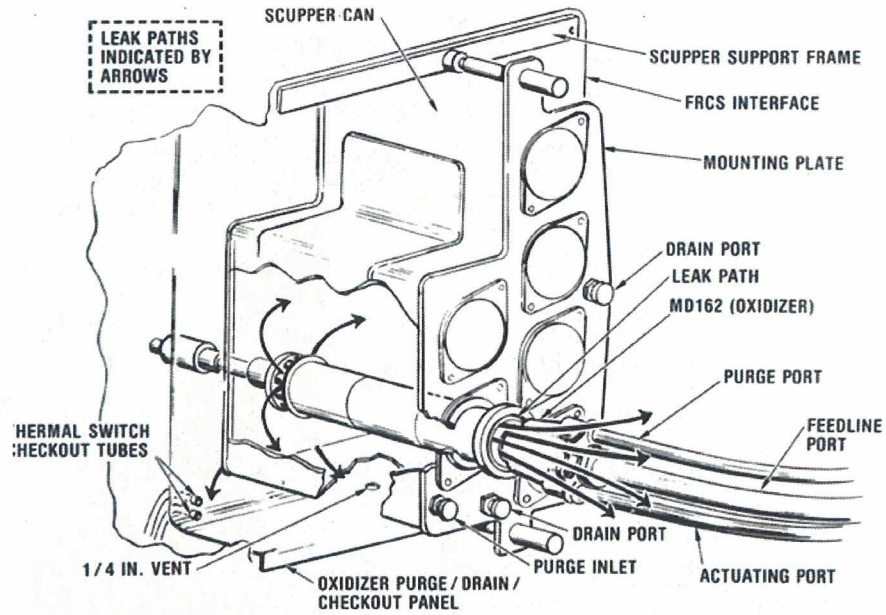
Figure 12: Drawing of AP28-12 Door and Failed MD162 GHC

At 1:13 AM on September 22, 1981 an N<sub>2</sub>O<sub>4</sub> spill occurred at Pad 39A. The proximate cause of the spill was a failed ground half coupling (GHC), MD162, at the AP28-12 door (shown in Figure 12) on FRC2 of OV-102 (Columbia). Failure of the GHC was a result of iron nitrate build-up between the probe and the dynamic head of the GHC along with the tight tolerances of the GHC. See Figure 13 for a description of the AHC and GHC and also the failure location. Between 15 to 20 gallons of oxidizer was released into the attached scupper, which subsequently overflowed onto the vehicle. Damage to thermal tile adhesive resulted in the removal of 370 tiles (shown in orange in Figure 14). The photograph in Figure 15 shows the thermal tiles and the underlying vehicle structure along with the scupper and QD flexhoses going into the AP28-00 door (second FRCS oxidizer servicing door just beneath the AP28-12 door when the vehicle is in the vertical orientation).

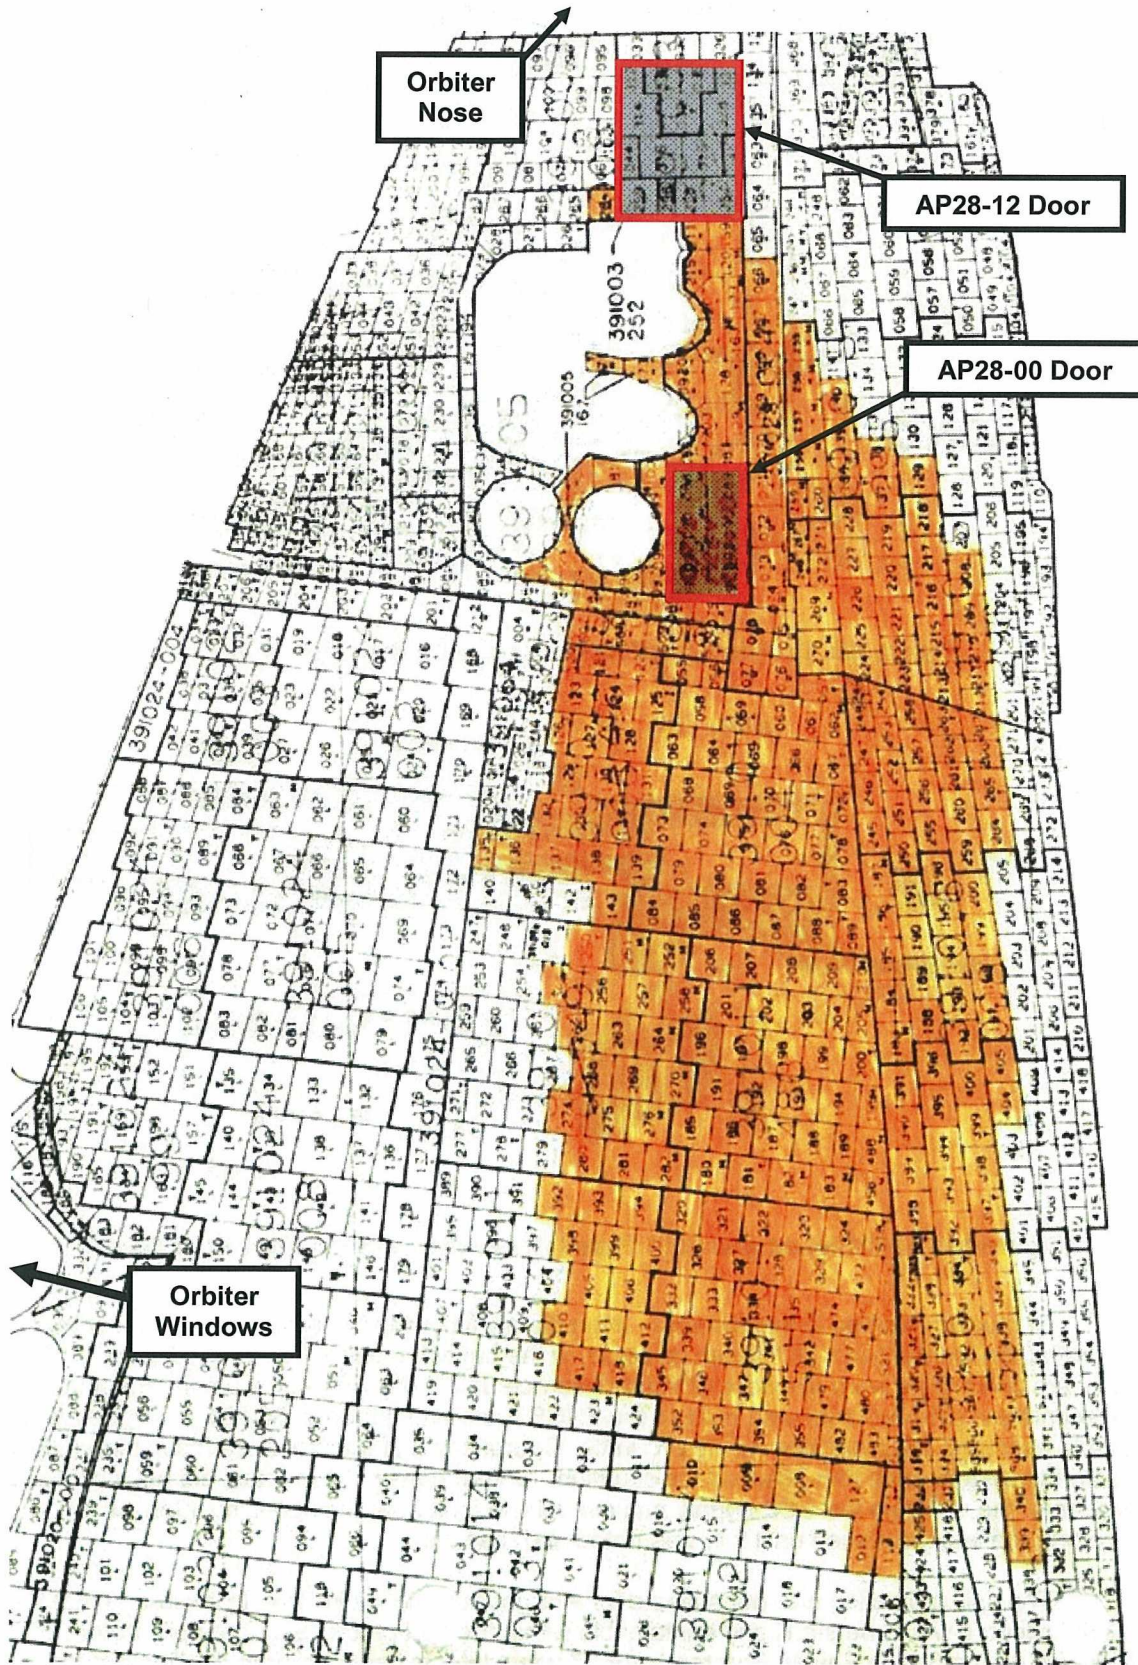
Figure 14: Removed Tile from OV-102 Following STS-2 N<sub>2</sub>O<sub>4</sub> Spill

The spill protection was not suitable for a large leak. It was incorrectly assumed that if a spill did occur; it would be small and containable within the spill protection. The spill protection still in use on the Space Shuttle Program over 27 years later is very similar to the "temporary" redesigned spill protection following the STS-2  $N_2O_4$  spill.

The launch was delayed by about one month while repairs were made to the vehicle, which remained at the launch pad. Many of the thermal tiles were baked in an oven and reinstalled onto the orbiter, which is a standard procedure to remove the  $N_2O_4$  or  $NO_2$  from thermal tiles when they become impregnated with oxidizer vapors. Several damaged thermal blankets located inside the forward module were replaced at the pad by accessing them through two doors adjacent to the orbiter windows.

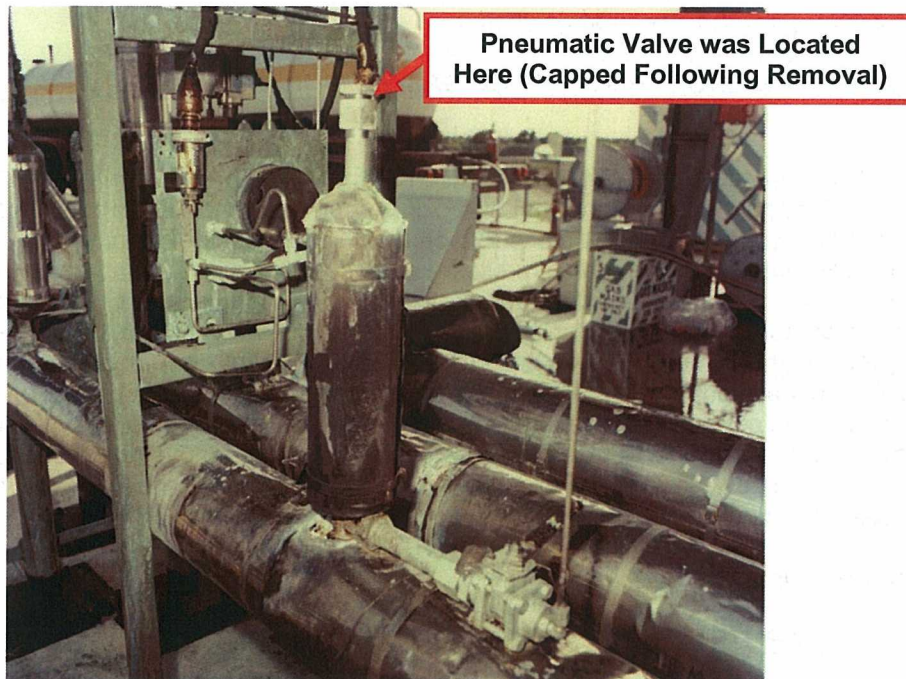
**Figure 16: Photograph of Fuel Farm Following Fire**

- The procedure was not written or reviewed by an experienced engineer prior to the task
- The engineer on console was making changes to the procedure real-time while monitoring another task in parallel
  - Improper adherence to the procedure and the procedure approval process are also root causes of this incident
- There was only one engineer on console supporting the hazardous operation
  - The engineer had to leave the communications channel to talk to the test conductor and in doing this missed some reports from the personnel at the fuel farm
- There was not a charged water line nearby when the fire occurred

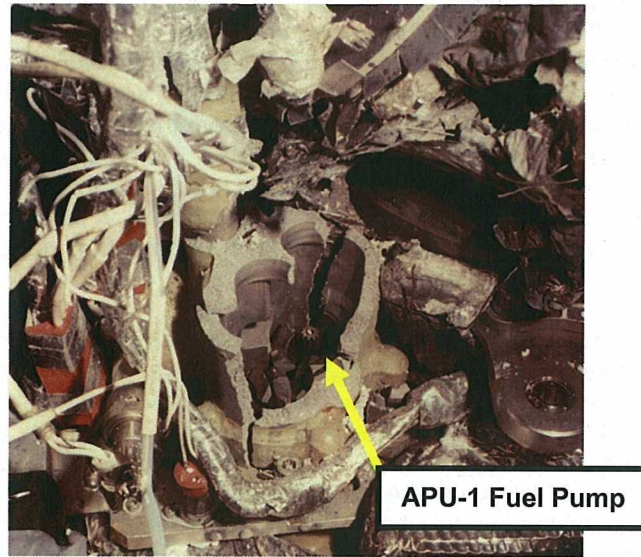
**Figure 18: APU 1 Fuel Pump Explosion Following STS-9**

*The APU failures most probably resulted from a crack in the injector stem caused by corrosion of the sensitized inside diameter surface. The corrodant is probably carbazic acid or some similar substance which can be derived from air, moisture, CO<sub>2</sub>, hydrazine and/or ammonia. The corrosion is time dependent and the crack progressed under sustained stress levels from the inner diameter surface toward the outer diameter surface until mechanical or thermal fatigue conditions could [complete] the crack rupture.”*

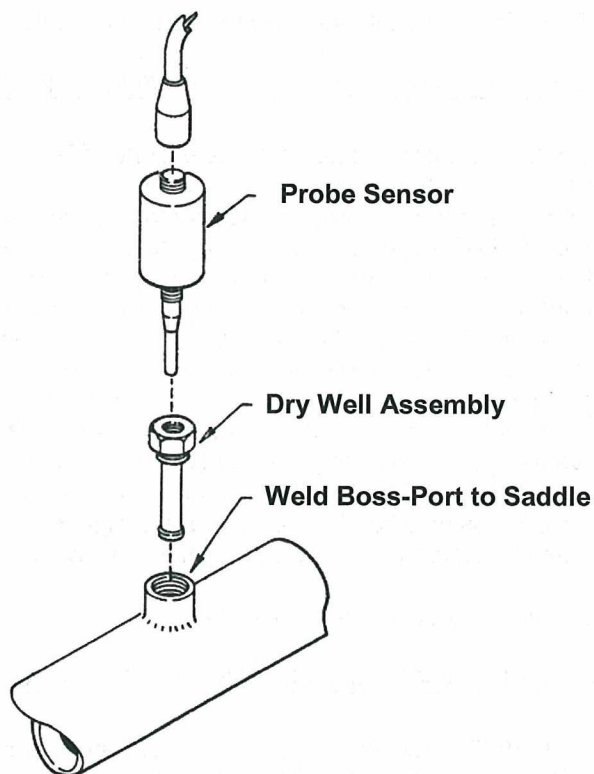
**Figure 22: Transducer and Dry Well Assembly**

*“The LSOC hypergolic mechanical technician actually performing the task of transducer removal used incorrect shop practice and loosened the wrong nut. Instead of using a one-inch wrench to retain the dry well in place while loosening the transducer lock nut that threads into the dry well, he used the wrench to loosen the dry well. He then used his hand to unscrew the transducer thinking he was extracting the transducer from the dry well while he was actually unscrewing the transducer dry well assembly from the three-inch MMH line. A mixture of fluid and vapor MMH immediately erupted from the line sending a column 10 to 12 feet in the air.”*

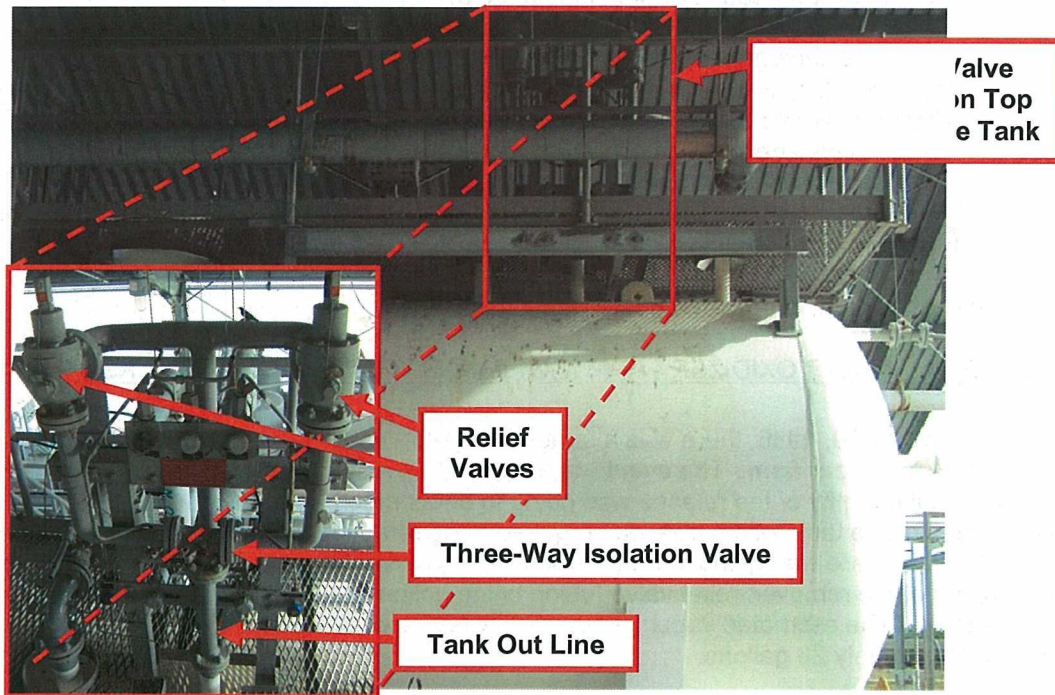
**Figure 23: Dual Relief Valve Modification Location**

An improper GSE design and operational human error were the root causes of this incident. About ten months prior to this relief valve removal and replacement operation, a formal request had been submitted by engineering to install a dual relief valve system onto the storage tank with a three-way isolation valve to prevent a vapor release during component removal. This request was denied. Following the large vapor release, the modification was implemented at both launch pads, greatly reducing the possibility of any future hazard. This dual relief valve modification allowed for isolation during the relief valve annual maintenance. The modification was also implemented on the fuel storage tanks at both launch pads. Figure 23 is a photograph of the relief valve locations on the top of the  $N_2O_4$  storage tank with a close-up photograph of the relief valve three-way isolation valve modification.

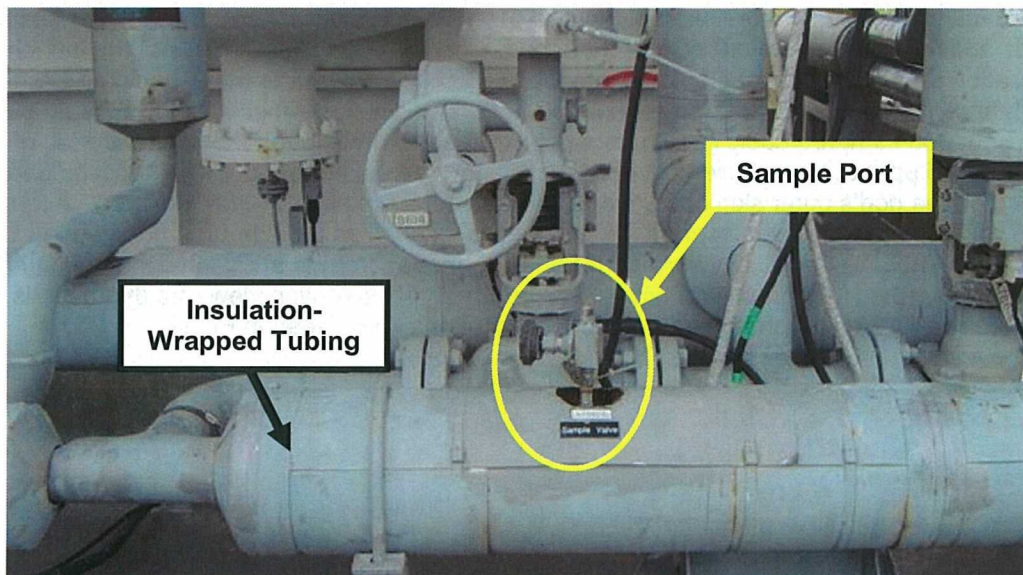
**Figure 24: Photograph of Sample Port**

On May 25, 1988, at the Pad 39B oxidizer farm, technicians were completing an N<sub>2</sub>O<sub>4</sub> sampling operation. During the operation, the technicians detected a small leak at the interface between the sampling valve and the tubing (see Figure 24). The sampling operation was delayed until the leak could be fixed. The repair was finally scheduled to be worked about a month later during the afternoon of June 23, 1988. The removal of some local insulation was required to fix the leak along with re-torquing the fitting that connected the sample valve to the tubing. This was all completed that afternoon.

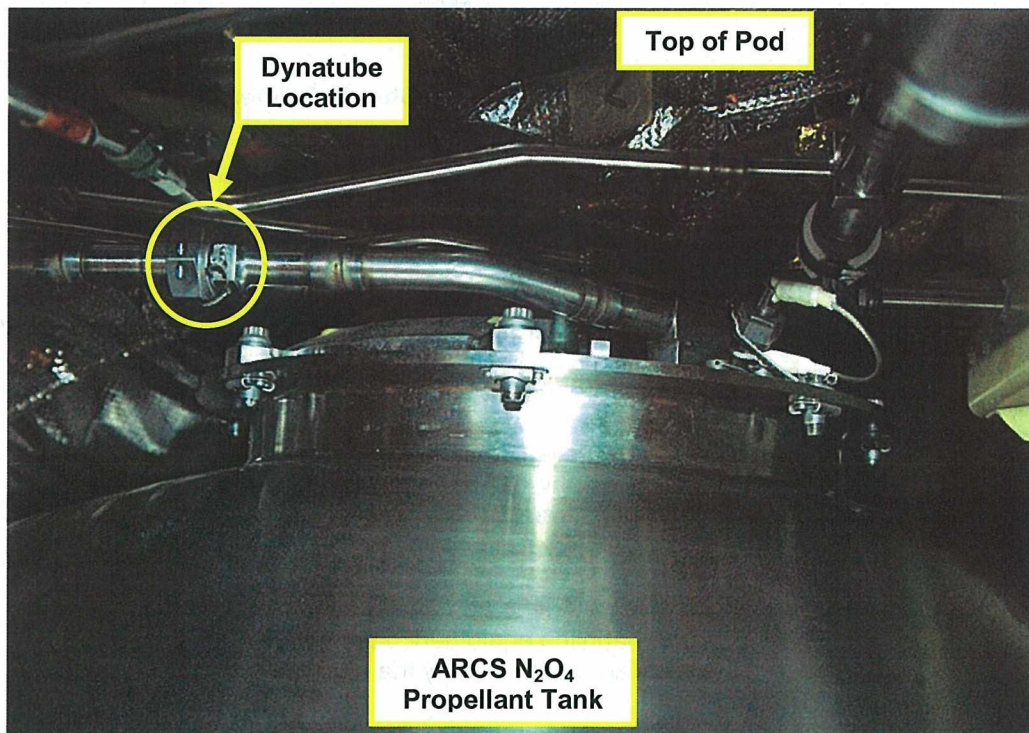
Figure 27: Dynatube Location on ARCS N<sub>2</sub>O<sub>4</sub> Tank

First, the exact location of the leak within the pod had to be found (a cutaway view of the Space Shuttle OMS pod can be seen in Figure 25). This was difficult because the internals of the aft pods and forward module are not meant to be accessed while the vehicle is at the launch pad. The location of the leak had been isolated to the LRCS  $N_2O_4$  system or the associated tubing through monitoring of the instrumentation in the LCC. The leak was measured to be 0.26 psi per hour (about 800 standard cubic centimeters per hour) and a TVC found the concentration of  $NO_2$  vapor to be 15 ppm at the vehicle vent door. This later decreased to 3 ppm. An access door was removed on the pod's outer skin and several internal thermal blankets were removed. A long section of PVC pipe was then inserted into the pod to function as a guide for a borescope. Using a borescope, the leak was finally isolated (after a six hour search) to a ½-inch dynatube fitting on the MD224 leg (the  $N_2O_4$  propellant tank ullage vent). A cross-section view of a dynatube is shown in Figure 26 and a photograph of the leak location can be seen in Figure 27.

- This would delay the launch about two months
- Fly with the leak and fix it following landing

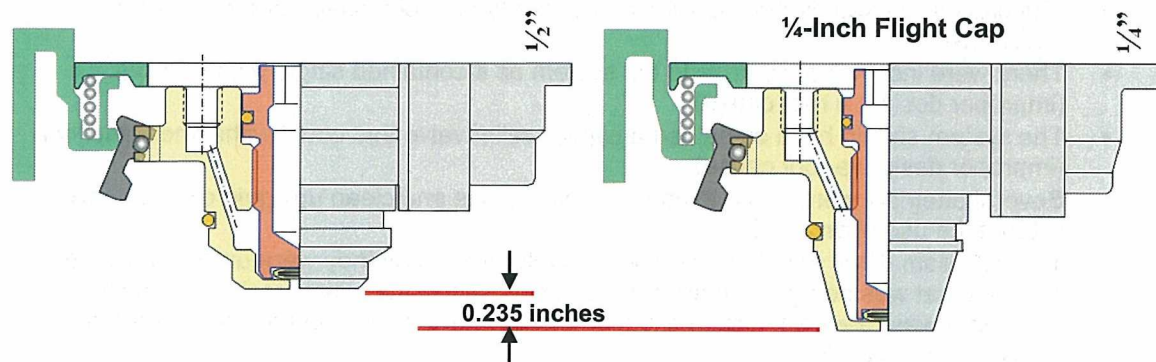
**Figure 30: ¼-inch and ½-inch Hypergolic Flight Cap Cutaway View**

- The appearance of a ¼-inch AHC cap is such that it could be mistaken for a ½-inch AHC cap to an untrained technician
  - The technician was undergoing on the job training under the direct supervision of an experienced technician, but the distinction between a ¼-inch cap and a ½-inch cap was not explained to him
- Age and wear made part number identification on the AHC cap difficult
- Work instructions should be written to include positive identification of interface equipment
- AHC cap mating should not be considered a benign activity; therefore, PPE should be used to protect the employees from credible releases of propellants
- Future designs should consider keying of AHC caps to preclude incorrect size/commodity installation

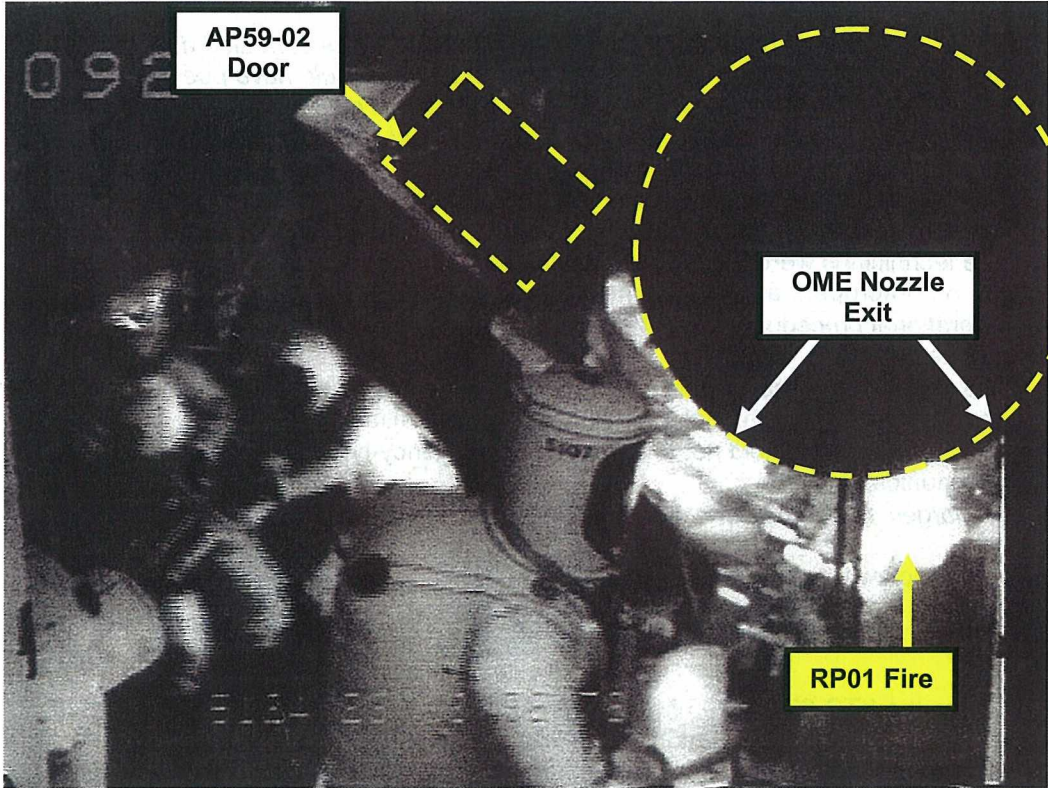
Figure 34: Still Photograph from Video of RP01 Fire

The technicians managed to put the fire out with a parts rinse bucket nearby, which they had to refill several times with water in the safety shower. Apparently, there was not a charged water line in the vicinity. Once the fire had been reduced in size from a large flame to a small flame at the open end of the dynatube, a technician cupped the end of the dynatube with his SCAPE suit glove and placed the aspirator in the flame, which immediately put out the fire.

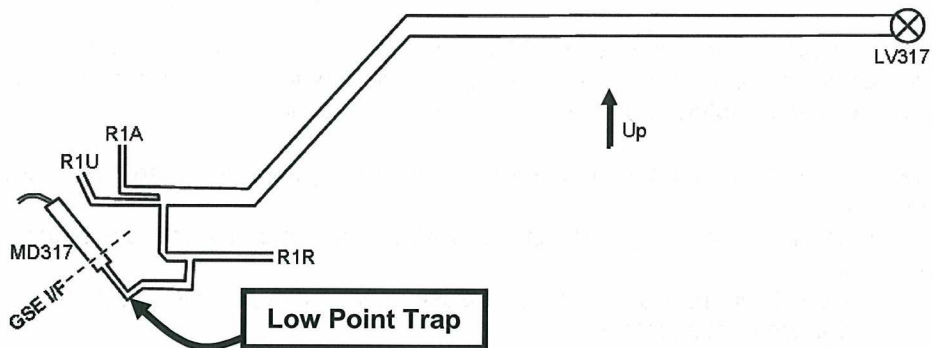
**Figure 36: Approximate Manifold 1 Layout Schematic**

Another possible scenario (not included in the formal mishap report) for the pressure increase was put forth stating the pulse purges were unable to remove all the liquid MMH as a result of a low point trap present in the manifold near the MD317 (manifold 1 drain/purge QD) AHC interface. Figure 36 shows the basic layout and low point in fuel manifold 1 in the right pod stinger area. It is believed that during the purge, gas was unable to enter the line through the MD317 QD to displace the liquid MMH out of the manifold. This was a result of a small bubble that had formed in the low point as a result of helium coming out of the liquid MMH/helium solution. The helium slowly coming out of solution may have been the source of the pressure rise in the manifold rather than a leaking manifold isolation valve. Once the fire started, it heated the area thus increasing the pressure and pushing additional fuel out of the fuel feedline that was trapped. In both scenarios (leaking manifold isolation valve or helium coming out of solution), liquid MMH was present in the manifold line just prior to and during the fire and the manifold pressure increase went unnoticed.

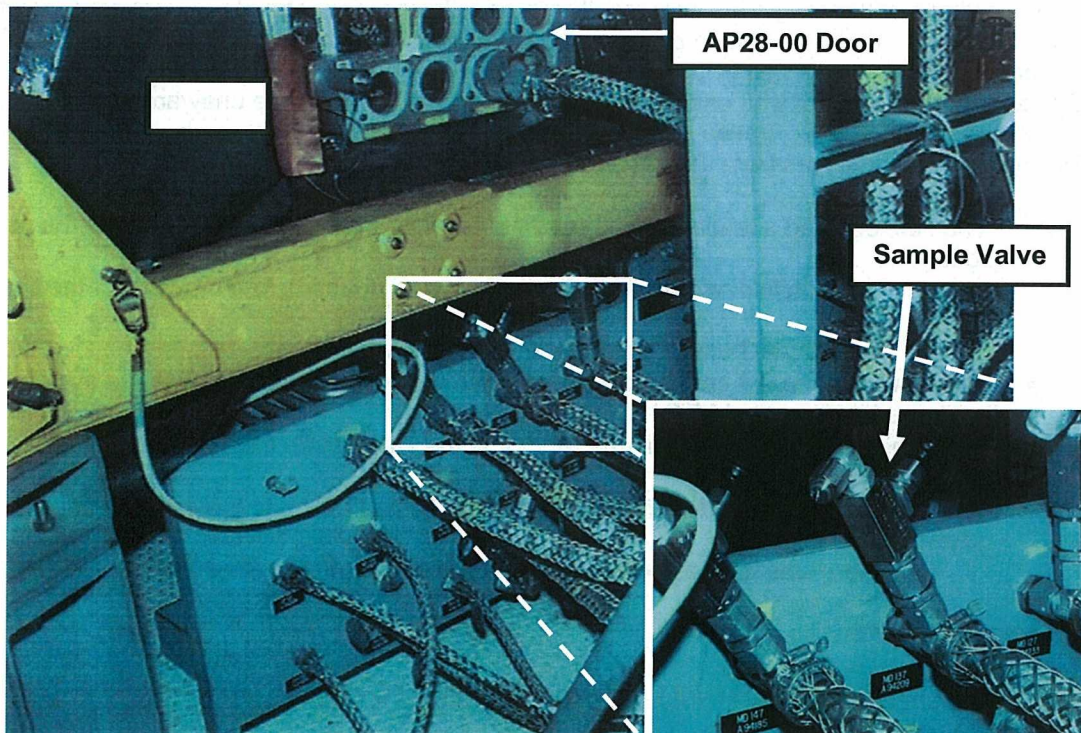
**Figure 37: MD137 Flexhose Sample Valve**

One technician powered up the aspirator and then began to remove the sampling valve outlet cap from the MD137 flexhose (see Figure 37 for a close-up view of the sampling valve). A TVC of the area was then performed with a resulting reading of 0.0 ppm. The technician laid the aspirator hose on the side of the rack, which was not a suitable position to capture any liquid or vapor that may be released from the valve outlet as the procedure stated.

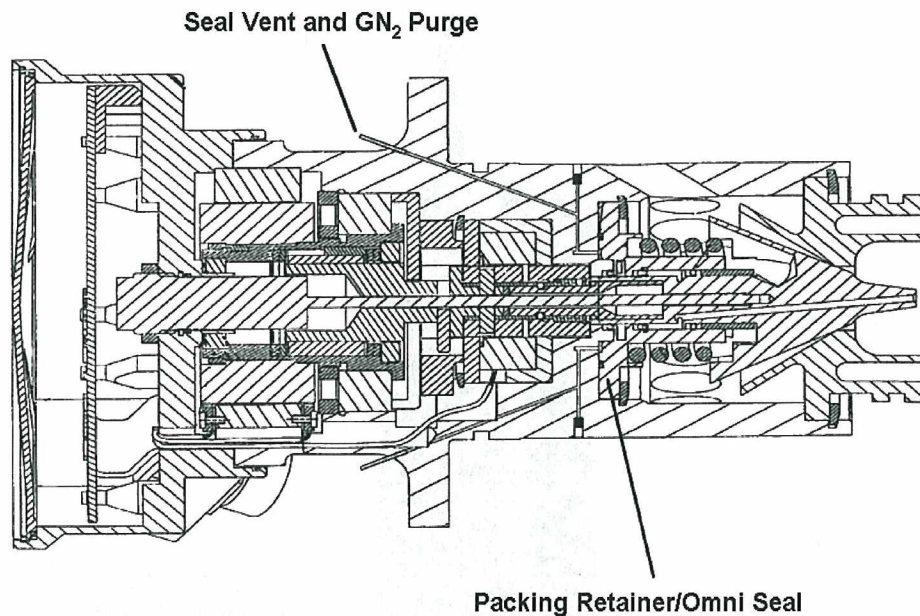
**Figure 39: Titan IV A TVC FCV Cutaway View**

The degradation of the omniseal resulted in liquid  $N_2O_4$  flowing into the FCV's electronics compartment and out the purge port. There were no leaks found within the TVC propellant tank or the associated system plumbing.

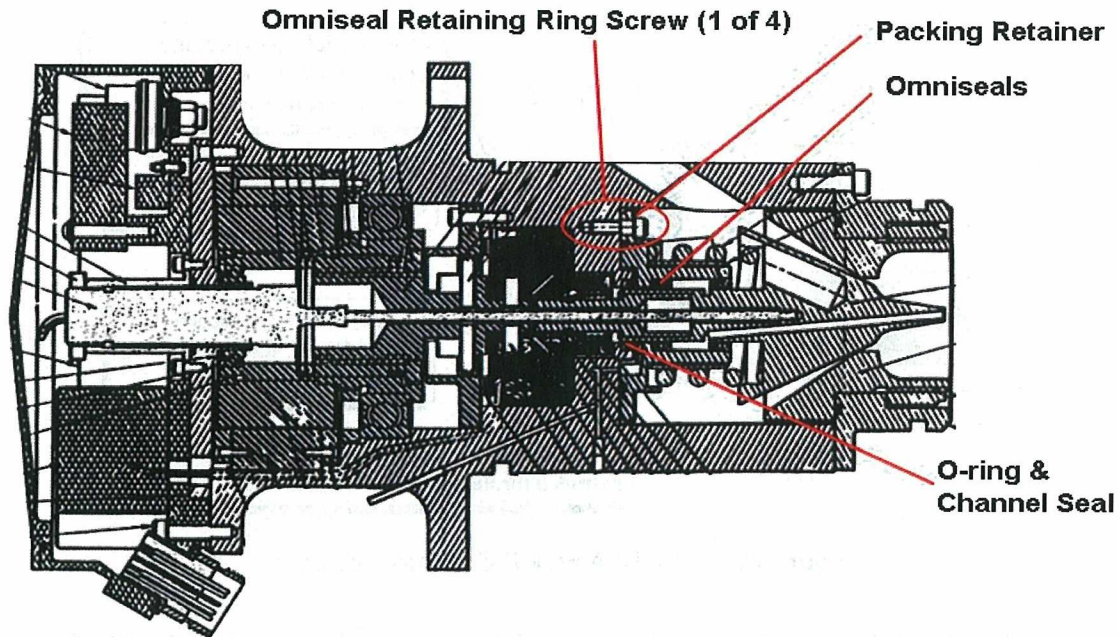
Figure 40: Titan IV A TVC EMV Cutaway View

enough gap between the component surfaces that the liquid Bio T-200A cleaning solvent was able to accumulate on the omniseal spring.

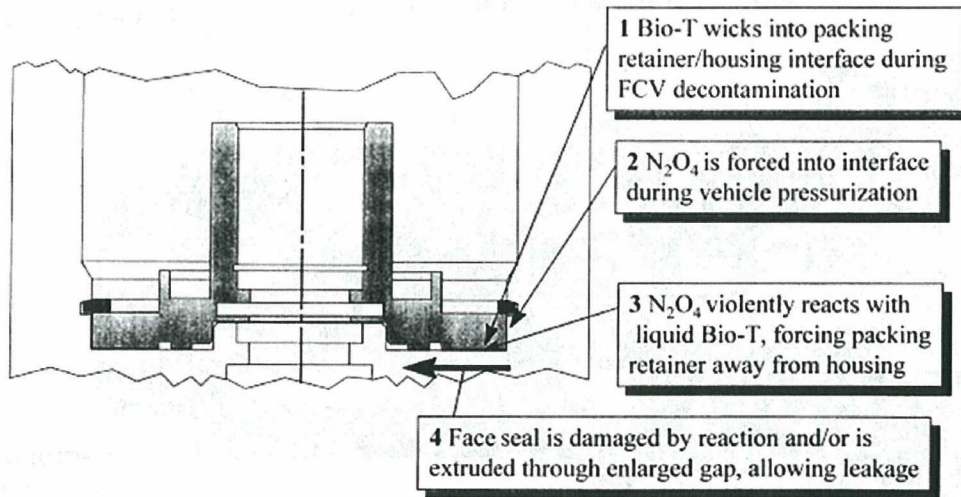
**Figure 41: Titan IV A FCV Failure Description**

- The force of the increased system pressure overcame the remaining, compromised integrity of the seal components and thus flowed past the seals to atmosphere.

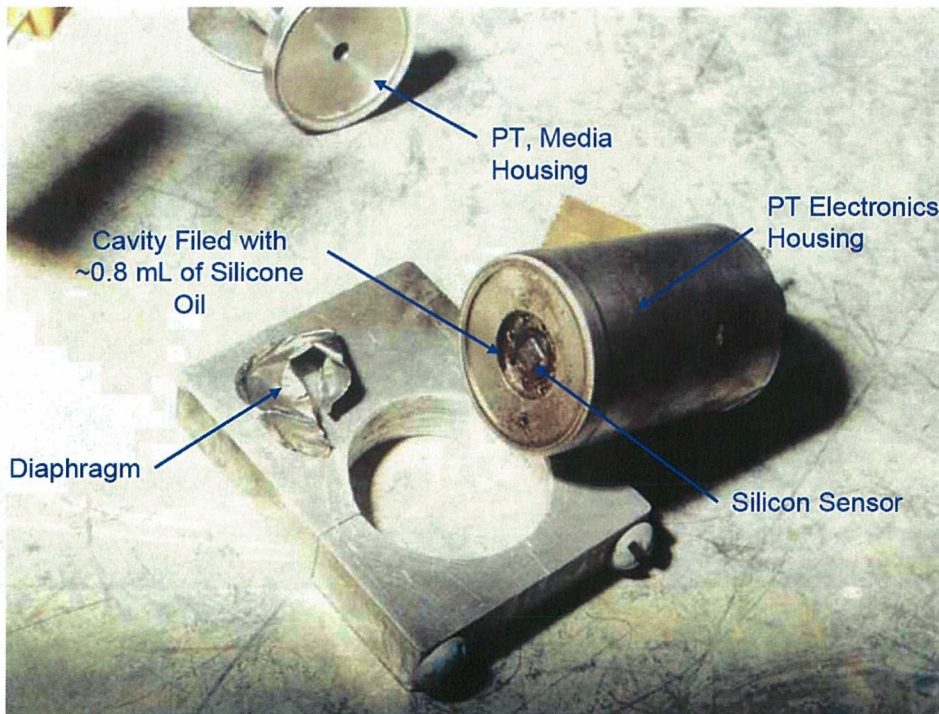
**Figure 46: Failed Pressure Transducer**

Initial inspections of the pressure transducer indicated that the transducer failed as a result of one of the following: over-pressurization, inadequate design, or cyclic fatigue at a highly stressed location. Since the pressure transducer failed, data from it at around the time of the failure may be suspect; therefore, the investigation included a detailed inspection of the nearby system tubing to determine if there was an over-pressurization event. Close inspection of the pressure transducer itself would indicate if the transducer failed from cyclic fatigue or was subject to a ductile failure from a single overload event.

The presence of the silicone oil was not mentioned in the pressure transducer specification from the manufacturer. This is the case for many pressure transducers of this specific design. Close scrutiny of specifications during hypergol component procurement is extremely important. This incident was difficult to prevent since the WSTF personnel did not know that there was silicone oil in the pressure transducer, but an improper GSE design (component procurement) is designated as the root cause. The wind corridor was also assessed and, as a result of this incident, it was altered to reduce the risk to the surrounding buildings from an oxidizer vapor release.

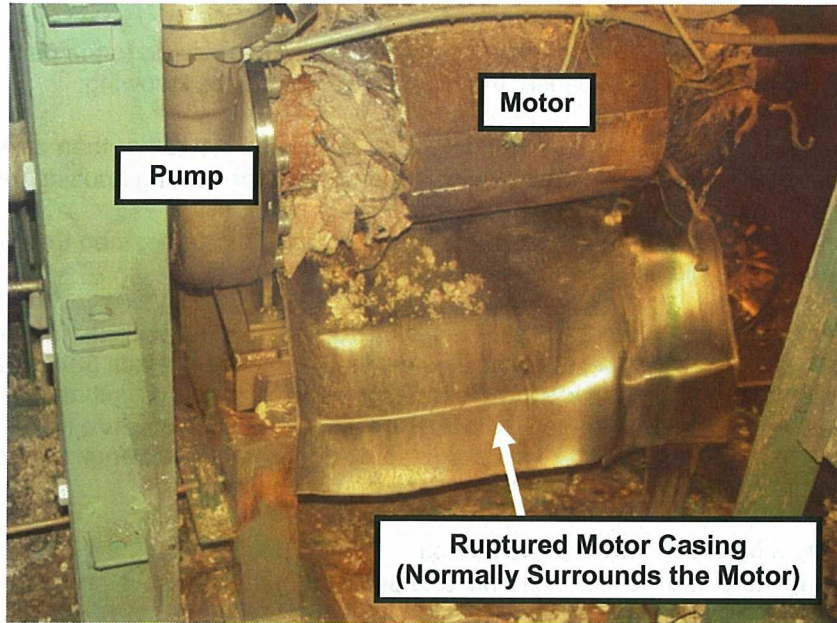
**Figure 48: Pump and Motor After Explosion**

Following the pump explosion, the loading team quickly removed power from the pump, closed the flow control valves at the oxidizer farm, and immediately evacuated the pad. The large NO<sub>2</sub> cloud that was created following the explosion was found to pose no danger to the local communities; however, a 5,000- or 12,000-foot clear (depending on the wind speed and direction) was put in place around the oxidizer farm.
