Selected Lessons Learned in Space Shuttle Orbiter Propulsion and Power Subsystems

Francisco J. Hernandez¹, Hugo Martinez², Abigail Ryan³, Shayne Westover⁴, and Frank Davies⁵

NASA/Johnson Space Center, Houston, TX 77058

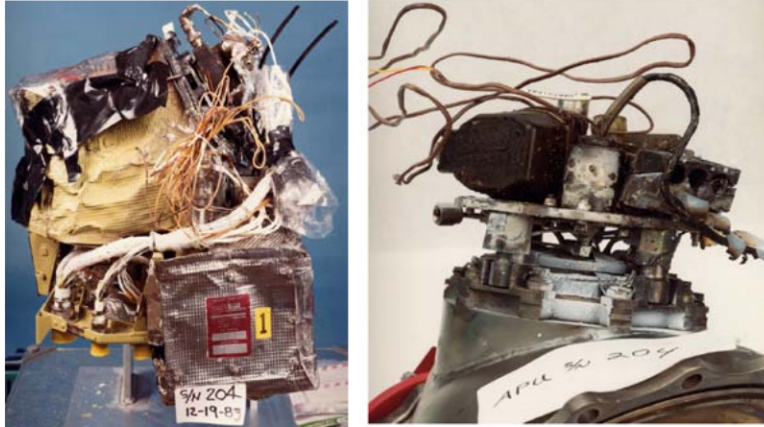
Another problem that occurred during the early flights happened during STS-9 landing phase where two APUs suffered an explosion due to an injector tube crack which took everyone by surprise (Fig. 3). This required extensive research into the cause of the origin which was found to be stress corrosion cracking of the injector stem; primarily due to the environment to which the APU is exposed from the hydrazine decomposition products. All the qualification testing preceding STS-9 had not taken into account the long “down time” or exposure time between operation cycles. In order to make the most efficient use of time during qualification testing, the APU was operated for a specified number of hours to qualify it for the same amount of operational time, not taking into account any down time between flights. This was found to be a significant factor for this failure. Hence, as a lesson from this failure, the IAPU qualification program was designed so that a segment of the testing included the long down time between missions at KSC (approximately 3-4 months); while simulating the highly humid and salt corrosive Florida environment.

Figure 3: Damaged APU from STS-9 detonation, showing approximate location of cracked injector stem and hydrazine leak

STS-9 APU 1 and 2 fires during entry and APU detonations post landing caused by stress corrosion cracking in GG injector stems.	<ul style="list-style-type: none"> • Reduce installation and removal stresses on critical materials; monitor if necessary. • Reduce residual carbon and stresses from manufacturing process. • Minimize leakage between firings by improved seals. • For reusable systems, implement periodic inspections (e.g., borescope) and maintenance plan based on critical parameters and expand as data/experience is gathered. • Locate instrumentation in the vicinity of high criticality leak sources to better enable fault detection, isolation and recovery.

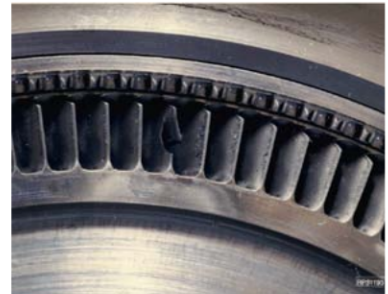
The discovery of fatigue cracks (roots and tips) in the original APU turbine disk blades led to the re-design of this component. Eight cases of blade cracking occurred on development units, qualification units as well as production flow units. Figure 4 shows a close-up of a fractured blade found during a routine overhaul inspection of APU#3 in 1987, removed from OV-104. When blades fail, loose pieces can cause extensive blade damage, high vibration, leading to shaft failure and possible uncontained wheel rupture. In all cases wheel crack damage was limited to blades and shroud, with all incidents being contained/safe, although some resulted in significantly increased vibration levels and noise. The investigation concluded that the cracks were due to high cycle fatigue, with some evidence of environmental interaction and blade rub. A redesigned 75-hour APU turbine made from Rene 41, a Nickel-based high temperature and strength alloy, was implemented as part of the IAPU in 1992. Some lessons from this investigation as they apply to turbine wheel design, manufacturing and maintenance were: to incorporate a full-width shroud that supports the complete blade profile, perform periodic NDE (e.g., mapping via dye penetrant inspections), reduce the number of grinding operations (without a stress relieve) after the final heat treatment to prevent imparting residual stresses, use a controlled heating method (no use of torch), and specifying the weld inspection criteria after the finish is completed.

Figure 4: Close-up of fractured APU turbine blade

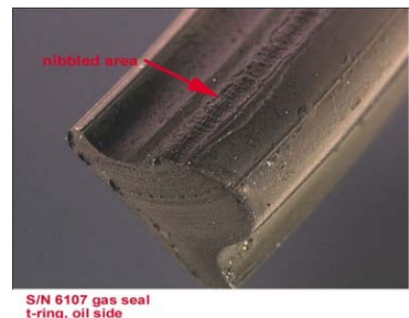
Hydraulic bootstrap pressure decay has occurred multiple times due to life and system contamination issues with the piston accumulators. The purpose of the bootstrap accumulator is to pressurize the hydraulic reservoir to maintain sufficient inlet pressure to the main pump for startup. On STS-50, an accumulator leaked on orbit due to nibbling of T-seal caused by extrusion of backup ring, resulting from long term exposure to pressure (Fig. 6). It resulted in continuous circulation pump

Figure 6: Hydraulic piston accumulator seal damage

operation on-orbit. The majority of piston accumulators inspected have shown minor backup ring extrusion. As a result of this, a 4-year flight limit was imposed on all piston accumulators. A welded bellows accumulator-type design replaced the piston type design in 1999. No gas leakage has ever occurred from Orbiter (or SRB) bellows accumulator units. The bellows accumulator requires no servicing for the life of the accumulator. The obvious lesson here is the preferred use of welded bellows hydraulic accumulators to prevent leakage and loss of function.

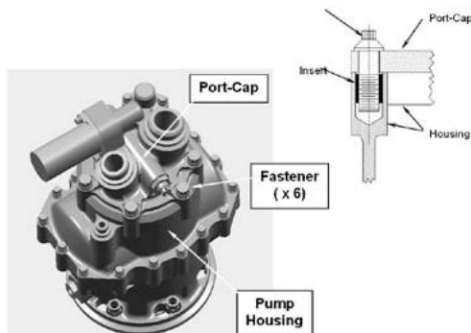
Just prior to STS-109 launch, a routine inspection at the hydraulic main pump vendor found the pump's port cap bolts to be dry-film-lubricated (DFL) rather than passivated, as it is required. This resulted in overstress of the bolt inserts due to the lower friction, and reduced structural margin, resulting in damage to the housings. Several pumps inspected and x-rayed had sheared aluminum housing threads and significant insert movement (Fig. 7-8). This could result in hydraulic pump port cap separation and hydraulic fluid leak resulting in loss of a hydraulic system. STS-109 launch rationale was given with the DFL bolts based on testing that indicated reduced, but sufficient margin remained to prevent leakage. A redesign of the port cap with passivated studs and self locking nuts resolved the concern. One lesson from this problem is to establish and verify adequate mandatory inspection points (MIP) in order to catch assembly errors. Another lesson is to carefully assess the use of helical coil inserts and the installation torque requirements, particularly in soft materials. This investigation highlighted the importance to design critical joints to be low maintenance with the capability to detect joint failure, easy to inspect, avoid moisture intrusion/corrosion, with high pullout strength and consistent preload (nut factor).

Figure 7: Hydraulic main pump port cap

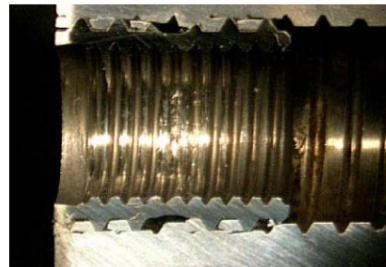
Figure 8: Hydraulic main pump port cap showing displaced helicoil insert and sheared aluminum housing threads

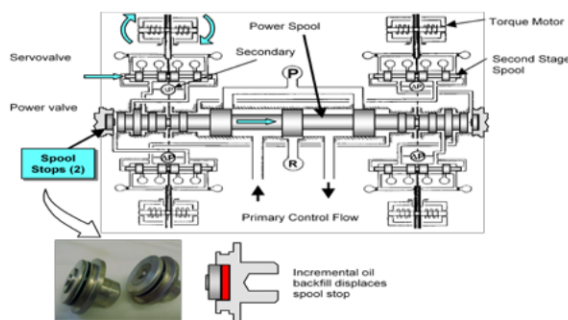
Contrary to commercial aircrafts, the Space Shuttle Orbiter did not initially establish a periodic maintenance interval for the flight control actuators. As most of the other Shuttle systems, the flight control actuators were certified to 10 yrs and 100 missions. Refurbishment of the elevon and TVC actuators occurred on a case-by-case basis, from the Program onset through the year 2001. These were driven by unscheduled removals for specific component repairs. Depending on the typically limited disassembly, the actuators were repaired, rebuilt and underwent a partial acceptance test prior to being delivered back as flight spares. Given the very few of these actuators that were disassembled during this period (i.e., <5 units) as well as the limited scope, very limited insight was obtained on the degradation of the internal component, including soft goods. In the case of the elevons and TVC actuators, the refurbishment effort was established as a result of a RSB Power Drive Unit (PDU) power valve failure during a Frequency Response Test (FRT) ground checkout, just prior to STS-101 in 2000. An extensive investigation into the

Figure 9: Hydraulic actuator power valve showing displacement of 2-piece spool stop restricting movement.

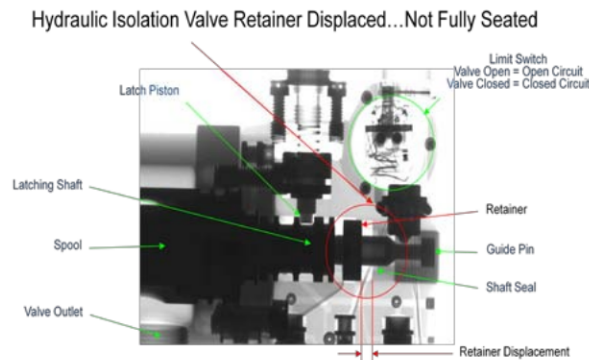
Another example of a displaced/unseated insert on a hydraulic component occurred in early 2006. A failure occurred during the Acceptance Test Procedure (ATP) elevated temperature test where the internal retainer became loose and displaced; it should be fully seated in housing with positive interference or shrink fit (Fig. 10). This particular isolation valve had flown 9 missions on OV-103 prior to this finding. Dimensional inspection found the retainer seat and two other areas of housing bore to be oversized. Oversized housing condition resulted in negative interference with the retainer at elevated temperature. This defect appeared to be the result of manufacturing error in machining process. All similar valves installed on all Orbiters, were x-ray inspected (7 per vehicle), and no retainer displacement was detected in any other valve. However, due to concerns with subsequent failure of valves, a periodic in-situ vehicle x-ray inspection was instituted, which proved to be successful. Lessons from this event are: for interference fits assure positive interference is maintained at all temperatures, design hydraulic valves without retainers or with positive retention, successfully using x-ray inspection for in-situ valve assessments in order to avoid costly removals and schedule impacts.

Figure 10: Hydraulic isolation valve showing displaced/unseated retainer (shown in closed position).

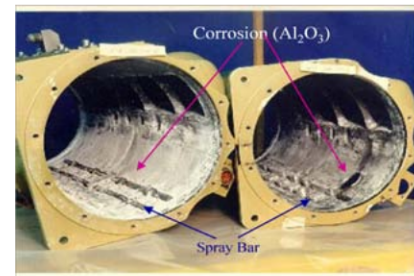
Since the beginning, the WSB aluminum heat exchanger containers have always had corrosion problems (Fig. 13). Nine WSB containers were removed during the Orbiter flight history due to severe corrosion and external leakage, primarily at the inlet/outlet stainless steel connections. The average useful life was 12.5 years, based on actual corrosion time of aluminum containers in the fleet. Post landing sampling/analysis of container water revealed presence of aluminum oxide (Al₂O₃) corrosion byproducts. Using an aluminum water tank in an open system makes the tank prone to aluminum-oxide corrosion and bi-metallic galvanic effects. A galvanic corrosion couple is formed from the dissimilar metals (aluminum and stainless steel) in the presence of conductive water. Adoption of higher water quality control in 1990 and PGME/Water in 2001 slowed the corrosion process but did not eliminate it completely. A preferred solution would be to change the container material to a non-galvanic material such as titanium.

Figure 13: WSB heat exchanger containers showing evidence of galvanic corrosion

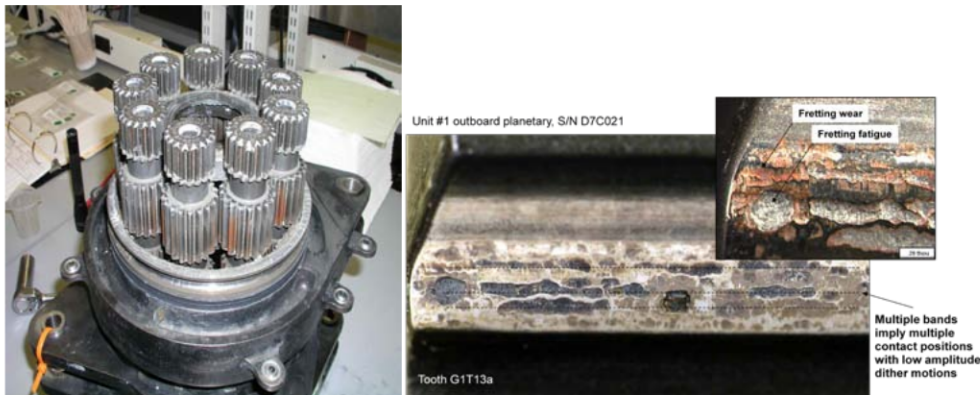
As part of a fleet leader inspection effort, the fleet lead RSB actuator was removed from OV-103 in 2003. To everyone’s surprise, considerable internal damage was found in the form of planetary gear and ring gear wear and fretting corrosion in addition to grease degradation (Fig. 15). The internal grease was yellow-colored and had decreased lubricity, with some physical oil separation and chemical breakdown. Some local gear teeth areas had reddish-brown grease, chemically-degraded from the fretting corrosion process. These findings had a considerable cost and schedule impact to the Program in that all fleet RSB actuators had to be inspected and most of them replaced, with all RSB actuators on OV-104 requiring the imposition of a limited life given that no available spares existed. These findings also led to Program-wide increased emphasis on corrosion and aging vehicle concerns. A lesson here is for future space applications to utilize greases with extreme pressure (EP) additives necessary for efficient boundary lubrication, better out-gassing qualities, corrosion-inhibitors and improved properties against physical separation and chemical breakdown.

Figure 15: RSB actuator disassembly, showing the planetary gear set corrosion damage.

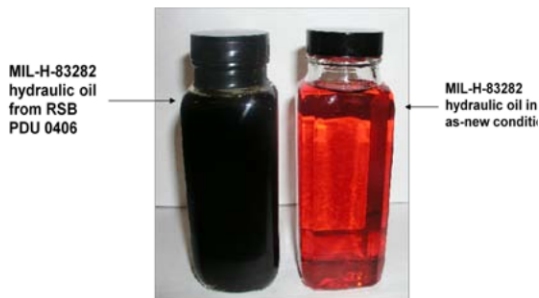
In addition, scheduled teardowns of RSB PDU at the vendor in 2003 and 2006 revealed many unexpected findings when the gearbox cavities were opened: significant gear scuffing, dark lubricating oil (MIL-PRF-83282), low oil level and significant particle contamination in the oil (Fig. 16). Silt and grease (Braycote 601) deposits were

Figure 16: RSB gearbox oil comparison; new vs. old oil after 25 missions

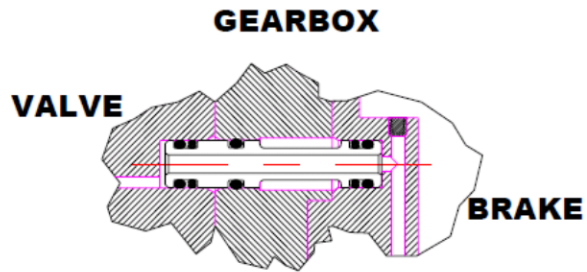
Inspection of four Body Flap PDUs in 2005 revealed that their sealed gearboxes were overfilled with oil (~1600 cm³), which could lead to a structural failure and loss of the system. The inspections were initiated as part of a fleet leader effort. Investigation found the cause to be internal leakage through the o-rings within the interfacing transfer tube (Fig. 17). There is no insight into this internal leakage post-assembly. It turns out that unless

Figure 17: Body Flap PDU transfer tube

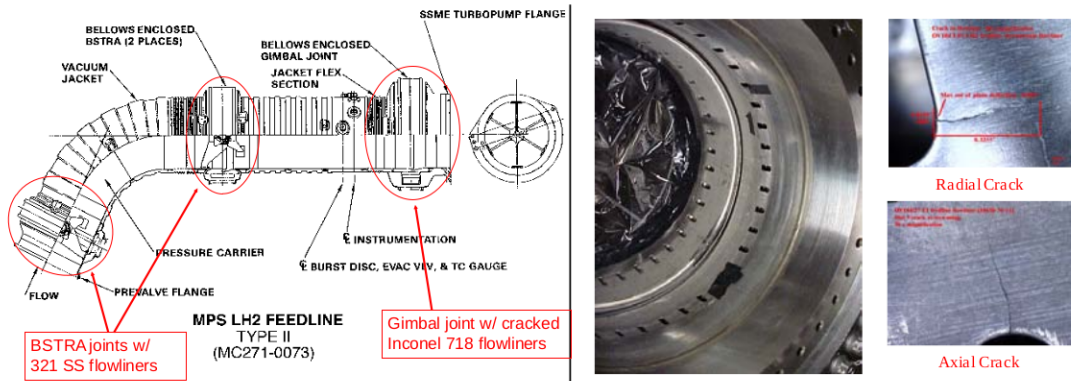
The MPS flowliners smooth the flow over the gimbal joint bellows and extend bellows fatigue life by eliminating flow induced vibration (FIV) in the feedlines. In 2002, cracks were discovered in the 12 inch feedline flowliner slots (Fig. 19). Since these liners are located in the gimbaling joint immediately upstream of the SSME low pressure pump inlets, particle liberation into the SSME would be catastrophic. The cracks caused by previously uncharacterized vibro-acoustic coupling of the flowliner and slots with high order surging and rotating cavitation generated by the SSME low pressure fuel turbopumps. These cracks were repaired by welding them closed while still on the vehicle, and the flowliner slots were then precision-polished to remove any residual micro-cracks from the original slot punching process. In future applications, it is important to fully characterize the environment, especially across element interfaces where relatively little may be known. Avoid the use of stamped flowliner slots, favoring machining if required at all, especially where debris liberation is critical.

Figure 19: MPS LH2 Feedline showing flowliner cracks

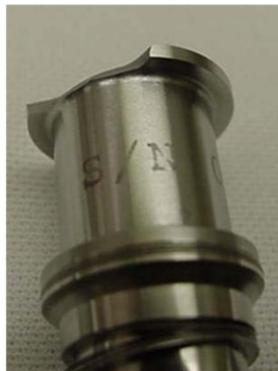
During STS-126 powered flight, the engine#2 Flow Control Valve (FCV) poppet broke across a portion of its flange (Fig. 20). This condition was detected via a change in inlet and outlet pressures though no command to change position had been sent. Since the poppet flange sees no impact loads, the cause was eventually deduced to be acoustic resonance caused by the high speed hydrogen gas exiting the valve. Special inspection methods were developed progressively as more was learned about the crack formation and propagation. Every flight valve tear downs and inspections were required to provide part of the continued flight rationale. It was learned that even structure with very high natural frequencies can be excited with acoustic inputs. Also learned was the fact that inspection methods need validation by complementary techniques, especially when cracks are very tight due to material properties and/or driving environment.

Figure 20: STS-126 broken FCV poppet

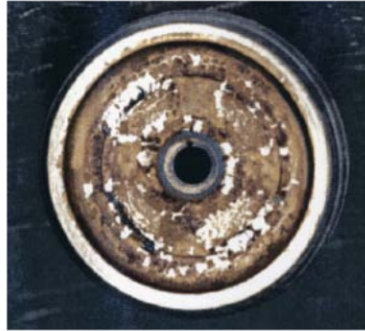
- Moisture Intrusion - increased corrosion and nitrate formation
- Sustained Low level leakage - nitrate formation at leak site
- Oxidizer Quality - nitrate formation potential

Figure 22: Iron nitrate on RCS POV pilot seat assembly

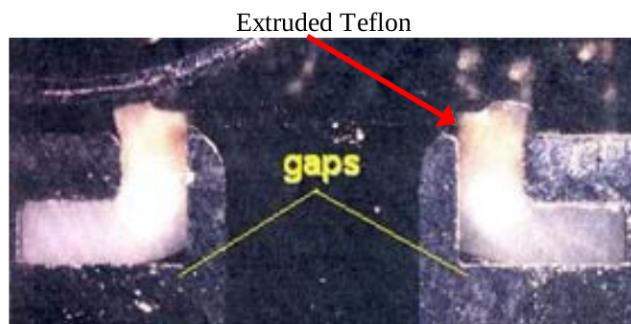
The TPET concluded that the fuel valve extrusion phenomenon was the result of a fuel-oxidizer reaction within the Teflon seal itself. Oxidizer vapor has been shown to readily permeate into PTFE (Teflon). Evidence of FORP within the PTFE pilot seals suggests that fuel may be forced into the semi-porous PTFE seal with regulated pressure and then reacts with the permeated oxidizer vapor. The reaction of the fuel and oxidizer would produce heat and evolve gas as a portion of the reaction by-products. It is therefore possible that evolved gas increases the internal void space of the PTFE by mechanical force, thus, causing expansion and a decrease in the density of the polymer. The extruding seal is not “walking out” of its retainer cavity, but instead the volume of the seal is increasing due to the larger internal voids. As a result, the seal extruded upward into the pilot stage flow path since that is the only unconstrained direction, as seen in Figure 23.

Figure 23: STS-68 POV extruded Teflon seal and voids

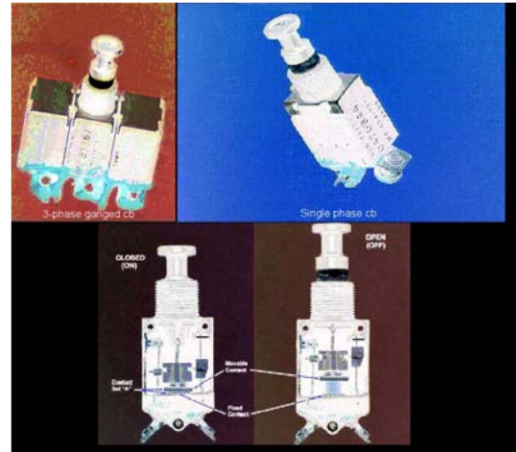
On STS-31, during the power up for Flight Control System (FCS) checkout, the Air Data Transducer Assembly (ADTA) #3 circuit breaker was closed but showed no signs of power. The circuit breaker was cycled five times. Three of these times, the LRU showed power, but following final closure, the power was off. The circuit breaker was cycled an addition five times, and ADTA#3 regained power and functioned nominally the remainder of the flight. There have been many (>10) occurrences of similar circuit breaker malfunctions (fail to conduct upon closure) during flight and on the ground. Multiple failure analyses have concluded that the failure mode is non-conductive debris interrupting continuity between the fixed and moveable contacts. This debris is generally small particles of the Circuit Breaker body's molding resin, and is generated when the circuit breakers are cycled (Fig. 31). The circuit breaker construction does produce a small amount of contact wiping action which can clear contamination. A workaround to ground occurrences (implemented in the OMRSD) is to cycle the circuit breaker until it operates. Unfortunately this also generates more internal debris. The failure rate has been tracked and is increasing but never reached unmanageable levels.

Figure 31: CBs used as power switches and redundant controls. Not a good practice.

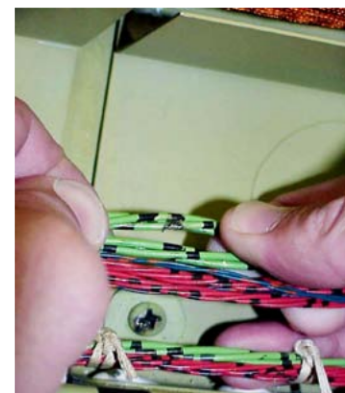
On STS-93, a short circuit occurred in the AC system during ascent that caused the loss of the primary controller on the center main engine and the secondary controller on the left main engine. Post-mission inspection found a damaged wire in one of the payload bay wire trays. The failure analysis revealed that the conductor was exposed because of mechanical impact; something striking the wire harness against a screw that had raised burrs on the head (Fig. 32). As a result of this failure, extensive vehicle wiring inspections were performed. As a result of the inspections, many other incidents were found of damaged wires and improperly protected wire harness.

Figure 32: STS-93 wire short

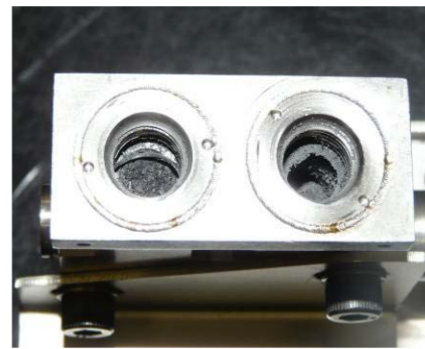
Pyrovalve gas sampler failures have occurred during several Shuttle flights. These pyrovalves are part of the Orbiter Aft Fuselage Gas Sampler System (OAFGSS) which consists of two standalone racks located in the Orbiter aft compartment. Each rack contain three Vacuum Bottle Assemblies (VBA) and all electrical components required to fire the pyrovalves in flight. Post-flight analysis of the gas provides an estimate of Integrated Main Propulsion System (MPS) leakage by measuring aft fuselage hazardous gas concentrations during ascent. Typical failures result in the normally opened valve failing to close and trap hydrogen gas. Given the low criticality of the hardware, plus the fact are six gas samplers flown during each Shuttle flight, there was never any mission impacts due to valve failures to seat properly after firing/actuation. Failure analyses show that debris and manufacturing dimensional variations in the valves were the main contributors to the failures. (Fig. 34).

Figure 34: Pyrovalve (post-fire) showing result of failure.

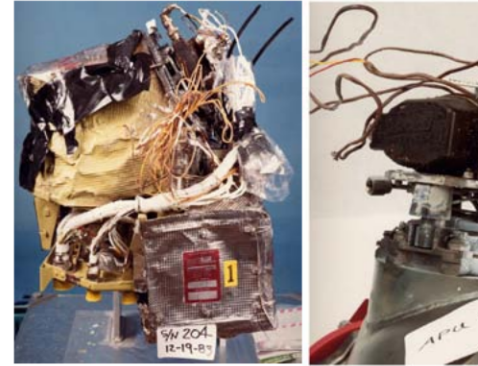
- STS-9 APU 1 and 2 fires during entry and APU detonations post landing caused by stress corrosion cracking in GG injector stems.
 - ☼ Reduce installation and removal stresses on critical materials; monitor if necessary.
 - ☼ Reduce residual carbon and stresses from manufacturing process.
 - ☼ Implement periodic inspections (e.g., borescope) and maintenance plan based on critical parameters and expand as data/experience is gathered.
 - ☼ Conduct qualification or fleet lead program to uncover time-related problems.
 - ☼ Change to a chromized-layer injector also brought up the unintended consequence of nitriding/flaking of chromium layer.
- See following pages for additional lessons

Damaged APU from STS-9

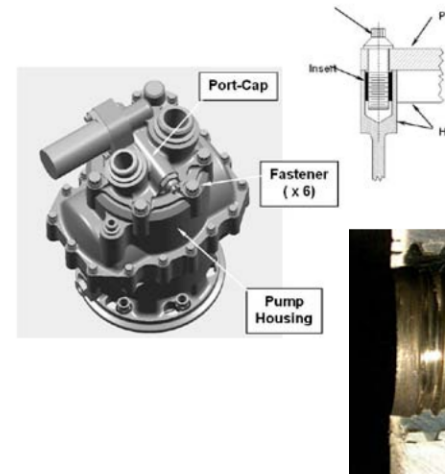
- On STS-76 ascent, a hydraulic system #3 leak developed, with the leak rate increasing to 1%/min.
 - ☀ Always verify the system integrity after any intrusive work is performed on the hardware.
 - ☀ Subjecting the component (e.g., flexhose) to vibrations could reveal a leak that could go undetected on the ground.
 - ☀ Design the system for ease of leak checking and integrity verification.
- Main Pump port cap to housing pulled out inserts due to incorrect use of bolts prior to STS-109.
 - ☀ Need adequate mandatory inspection points (MIP).
 - ☀ Careful assessment of helical coil inserts, and torque requirements.
 - ☀ Design critical joints to be: low maintenance, easy to inspect, prevent moisture intrusion/corrosion, high pullout strength, and preload consistency (nut factor).

Main Pump port cap pulled out

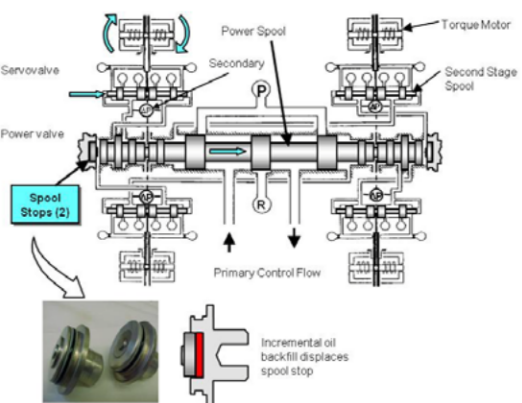
<p>Hydraulic actuator power valve showing displacement of 2-piece spool</p>	<ul style="list-style-type: none"> ☀ Avoid spool stop inserts, i.e., design valve with single spool sto ☀ Establish a maintenance plan to assess hardware condition and degraded components. ☀ Anomaly was present 2 years earlier (1998) during Orbiter Major Modification (OMM) at Palmdale, but there were no requireme secondary ΔP data other than during Frequency Response Test. always review of all critical parameter test data. ☀ Freeze-plug technique successfully developed and implemented hydraulic hardware removals on the pad without need to drain o hydraulic interface lines.

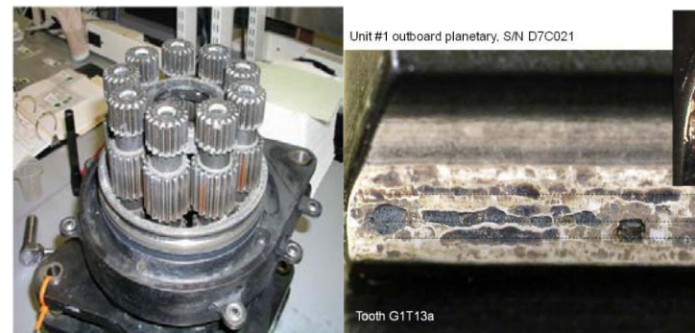
RSB actuator planetary gear corrosion damage

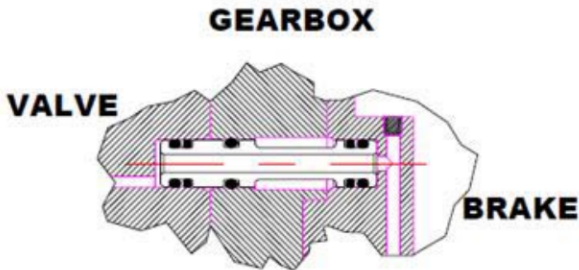
<p style="text-align: center;">Body Flap PDU transfer tube</p>	<ul style="list-style-type: none"> ☀ Assure correct alignment of interfacing seals and components to prevent leakage, e.g., transfer tubes. Build special alignment tooling if necessary. ☀ Conduct post-assembly leakage tests, particularly on components with no available insight post-assembly. ☀ Conduct periodic inspection of critical hardware components such as gearboxes.

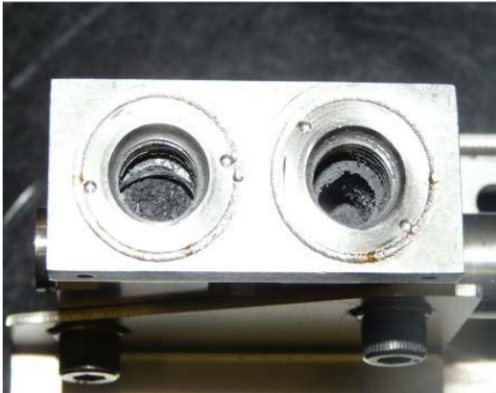
<p data-bbox="73 1255 667 1314">Pyro valve (post-fire) showing result of failure.</p>	☀ Debris in bore and/or manufacturing dimensional variations prevented the pyrovalve to not properly seal after firing/actuation. ☀ The NSI is an initiator and should not be used as a pressure cartridge, i.e., use NSI plus booster pressure cartridge.
