Thermal Protection Systems

Orbiter Thermal Protection System

External Tank Thermal Protection System

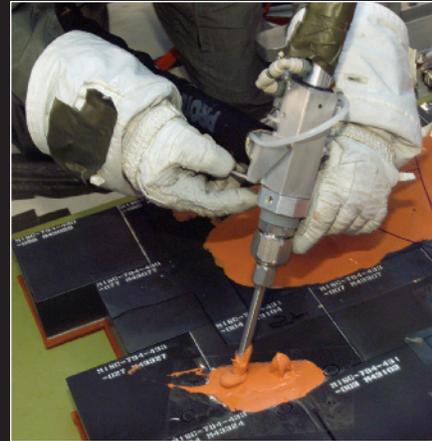
Ground test of Orbiter tile repair.

Simulating a damaged shuttle tile created dust that prevented the STA-54 from penetrating the surface of the tiles. This led to the development of additional materials: a gel cleaning brush that was coated with a sticky silicone substance used to clean tile dust from the repair cavity prior to filling; and primer material that provided a contact surface to which the STA-54 could adhere. Once the primer was cured, the bond strength was stronger than the shuttle tile.

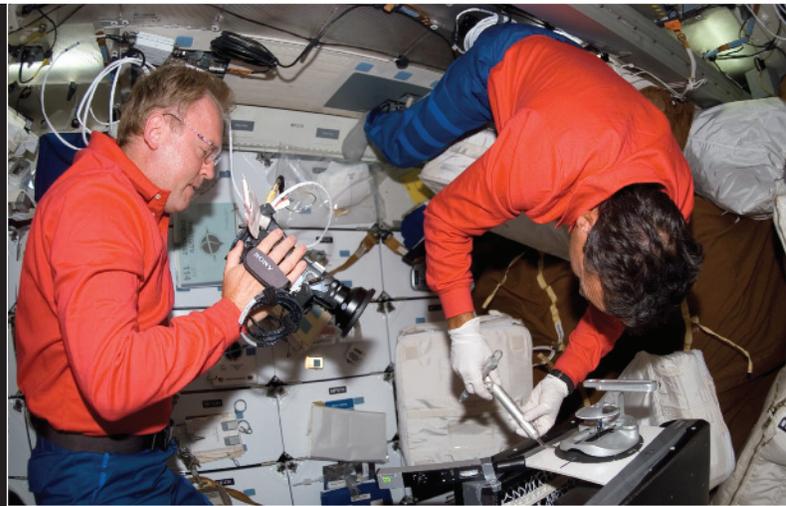
Astronaut Andrew Thomas (left) watches as Charles Camarda tests the reinforced carbon-carbon plug repair (STS-114 [2005]).

For larger damages, a plug repair system protected the reinforced carbon-carbon using a series of thin, flexible composite discs designed to fit securely against the curvature of the surface. Engineers developed 19 geometric shapes, which were flown to provide contingency repair capability. An attach mechanism held the plugs in place. The anchor was made up of a refractory alloy called titanium zirconium molybdenum that was capable of withstanding the 1,648°C (3,000°F) re-entry temperature.

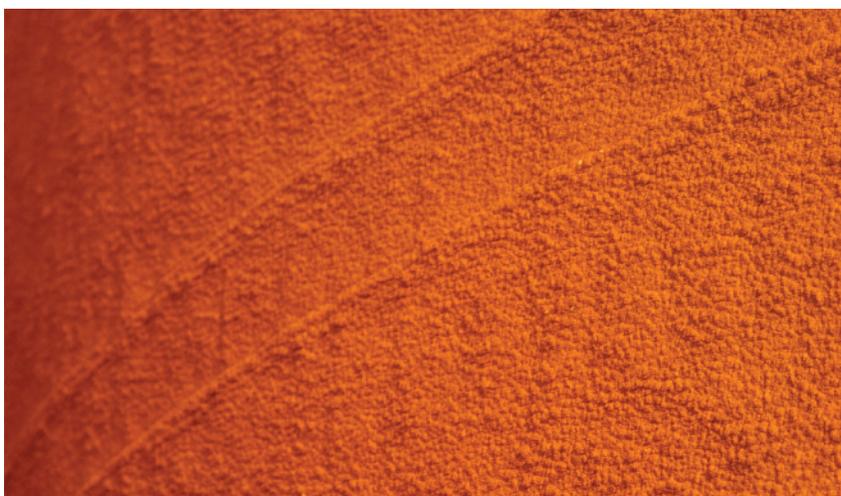
The key to the External Tank's foam Thermal Protection System insulating properties was its cellular structure, creating millions of tiny bubble-like foam cells. The sprayed foam (NCFI 24-124) can be seen here after application to an area of the tank's aluminum "acreage," consisting of the liquid oxygen tank, liquid hydrogen tank, and intertank.

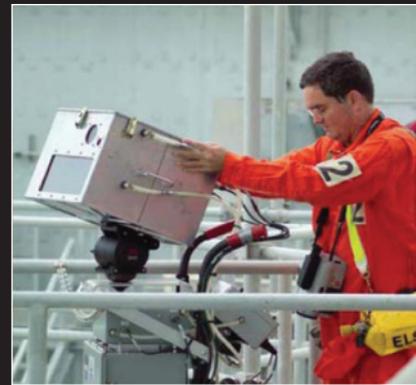
Robert Speece, NASA engineer, is shown operating the ice detection system at the pad, prior to shuttle launch.

pad. NASA and its partners initiated a program to develop a system capable of detecting ice on the External Tank spray-on foam insulation surfaces. This system was calibrated for those surfaces and used an infrared strobe, a focal plane sensor array, and a filter wheel to collect successive images over a number of sub-bands. The camera processed the images to determine whether ice was present, and it also computed ice thickness. The system was housed in nitrogen-purged enclosures that were mounted on a two-wheeled portable cart. It was successfully applied to the inspection of the External Tank on STS-116 (2006), where the camera detected thin ice/frost layers on two umbilical connections.

The system can be used to detect ice on any surface. It can also be used to detect the presence of water.

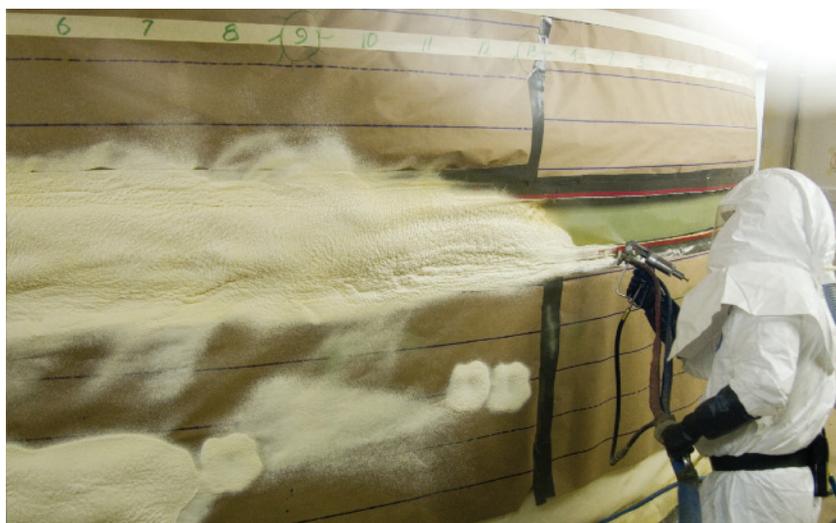
A technician at NASA's Michoud Assembly Facility sprays the flange that connects the intertank and liquid hydrogen tank. Stepanfoam® BX-265 was sprayed manually on closeout areas, exterior tank feedlines, internal tank domes, closeout areas of mating External Tank subcomponent surfaces, and small subcomponents.

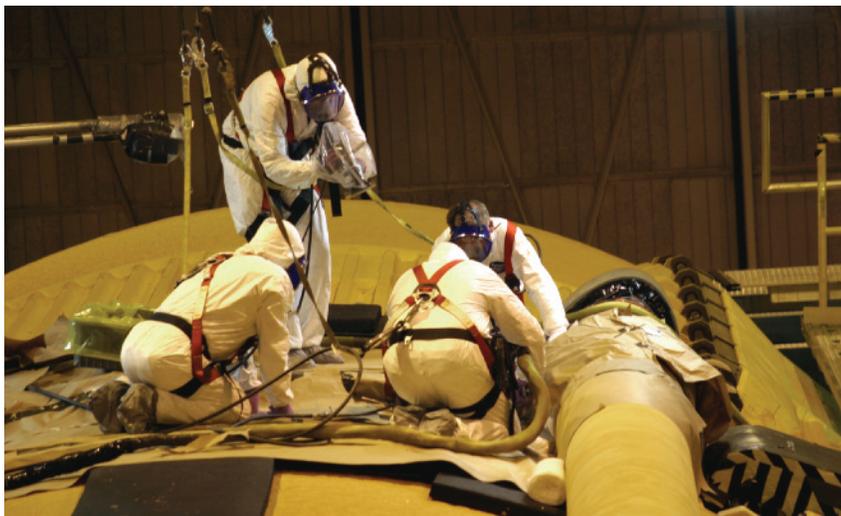
In what used to be a one-person operation, a team of technicians at NASA's Michoud Assembly Facility prepares to hand-spray BX-250 foam on the bipod attach fittings. The videographer (standing) records the process for later review and verification. A quality control specialist (left) witnesses the operation, while two spray technicians make preparations.
