COLUMBIA ACCIDENT INVESTIGATION BOARD (CAIB)/
NATIONAL AERONAUTICS AND SPACE ADMINISTRATION (NASA)
ACCIDENT INVESTIGATION TEAM (NAIT)

WORKING SCENARIO

FINAL VERSION: JULY 8, 2003

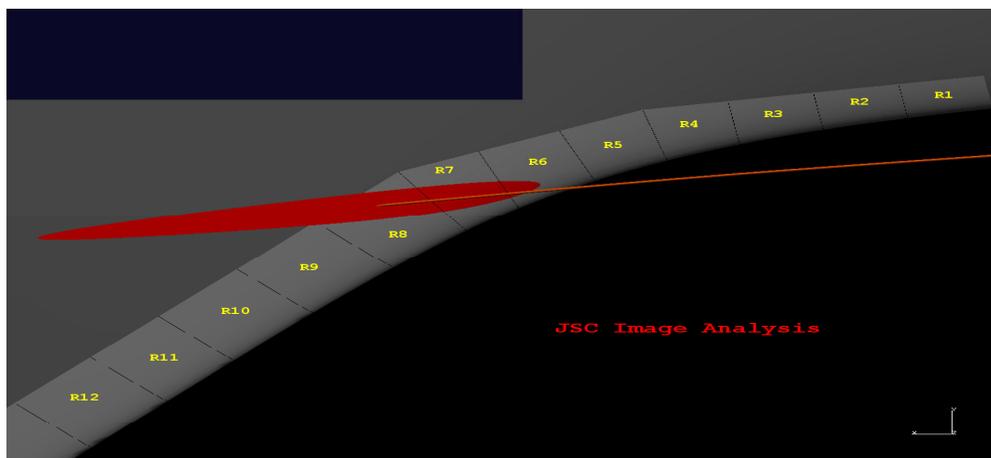
Video and Computer-Aided Design (CAD) analysis determined that the most likely impact location was leading edge RCC panels 6 through 8 (Figure 3-5). Due to the foam size, RCC panels 5 and 9 must also be included in this impact zone. The best estimate of the foam size, based on imagery measurements, is 21 to 27 inches long and 12 to 18 inches wide. The precise foam shape and thickness cannot be determined from the available imagery; however, a reasonable estimate is that it was a plate-like shape and several inches thick. The foam tumbled at a minimum rate of 18 times per second based on the imagery, although the actual rate may never be known more accurately. Figure 3-6 illustrates a portion of the photographic analysis techniques used to determine the size of the foam.

Figure 3-5. Multiple analyses determine foam impacted lower RCC panels 6 through 8 area

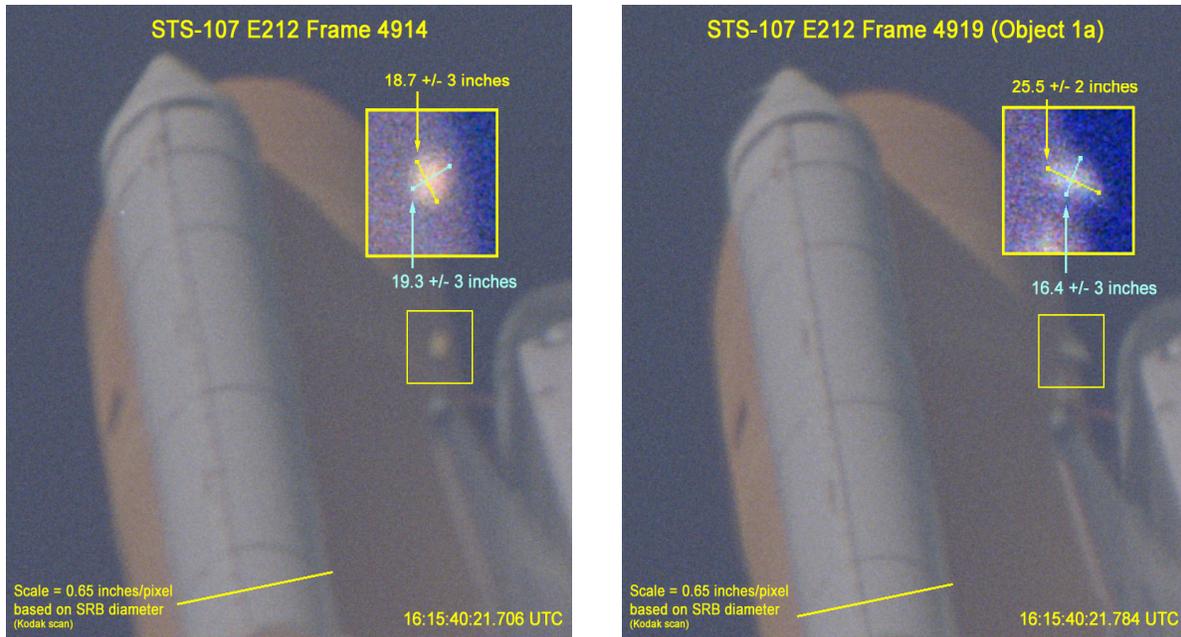
Figure 3-6. Photographic analysis techniques determined foam size: debris appears almost circular in frame 4914 and elongated in frame 4919

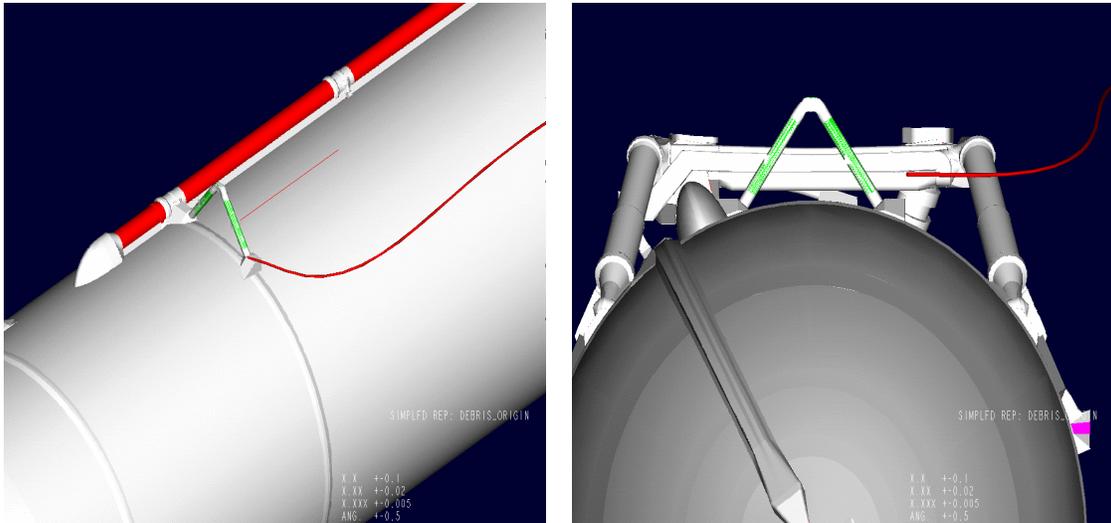
There is significant visual and debris trajectory information to implicate the left bipod ramp area as the source of debris. In Figure 3-9, the red line depicts the estimated foam trajectory as it moved from the bipod ramp area toward the left wing. In addition to locating the impact in the RCC panels 6 through 8 region, the video analysis has also shown that the impact was below the apex of the RCC panels since no foam or post impact debris was observed to traverse over the top of the wing. This is indicative of an impact below the wing leading edge aerodynamic stagnation line (Figure 3-10). The stagnation line, or dividing streamline, is the line along the leading edge of the wing where the airflow comes to rest; above this line, airflow moves over the upper wing surface and below this line, the airflow moves over the lower wing surface.

Figure 3-9. Multiple analyses indicate foam is from ET left bipod area. Red line depicts the estimated foam trajectory as it moved from the bipod ramp area toward the left wing.

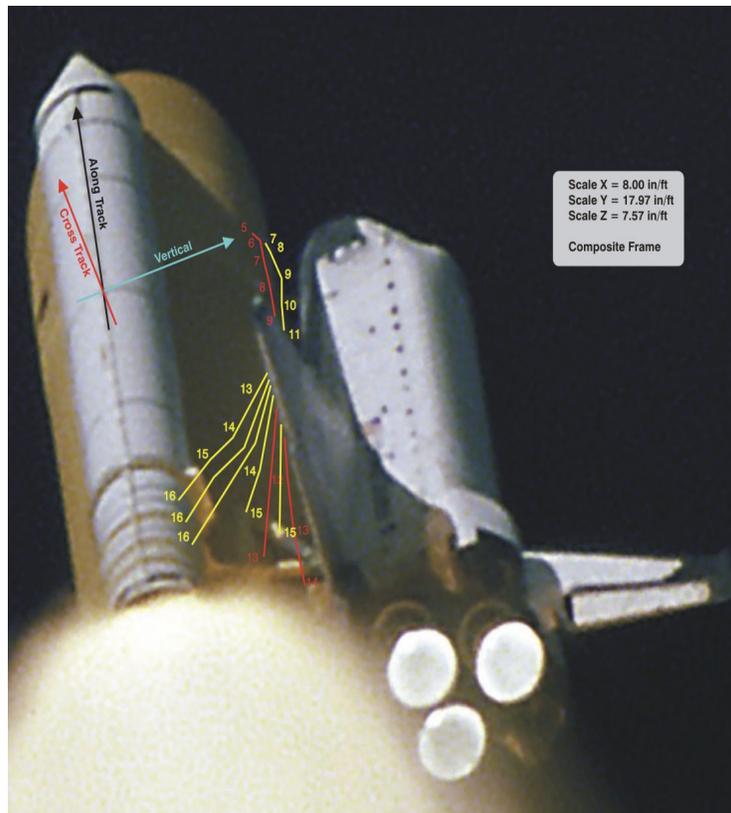
Figure 3-10. Video analysis shows impact is below wing leading edge stagnation line. Trajectories of particles are depicted after the impact.

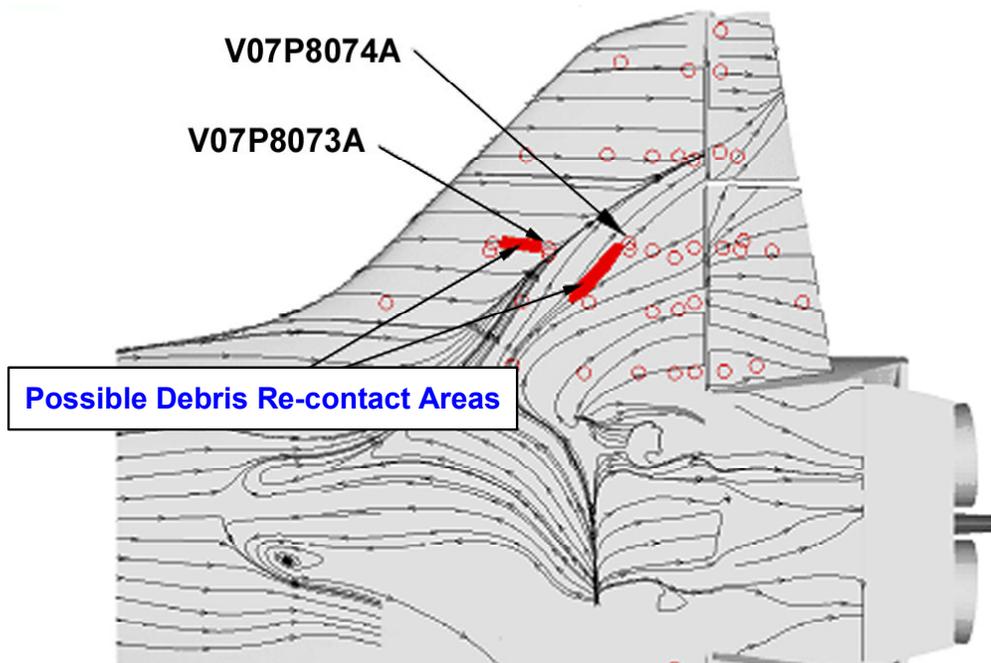
There are two other indications that the foam impact occurred in the panels 6 through 8 area. Two Modular Auxiliary Data System (MADS) lower surface pressure measurements behaved anomalously immediately after the time of the impact. Figure 3-13 shows the location of these measurements along with possible areas for post-impact debris re-contact in the vicinity of the sensors. The unusual behavior of one of the sensors is shown in Figure 3-14.

Figure 3-13. CFD surface flow with lower left wing pressure sensors

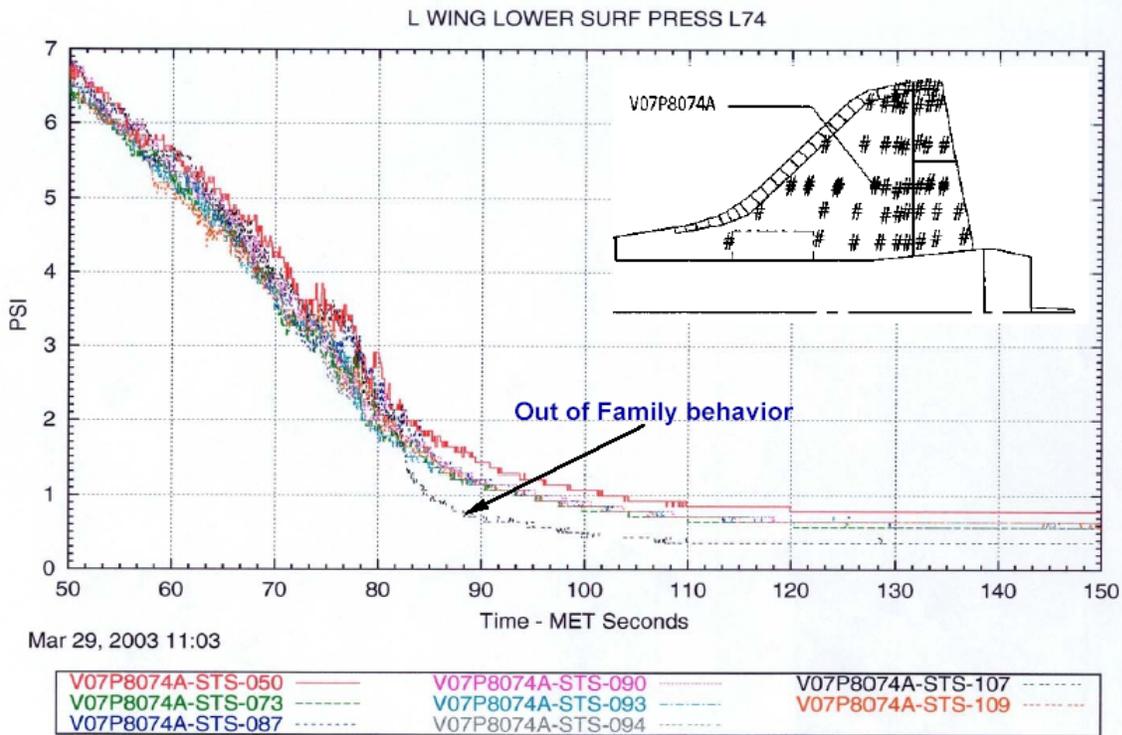
Figure 3-14. Unusual behavior of pressure sensor V07P8074A

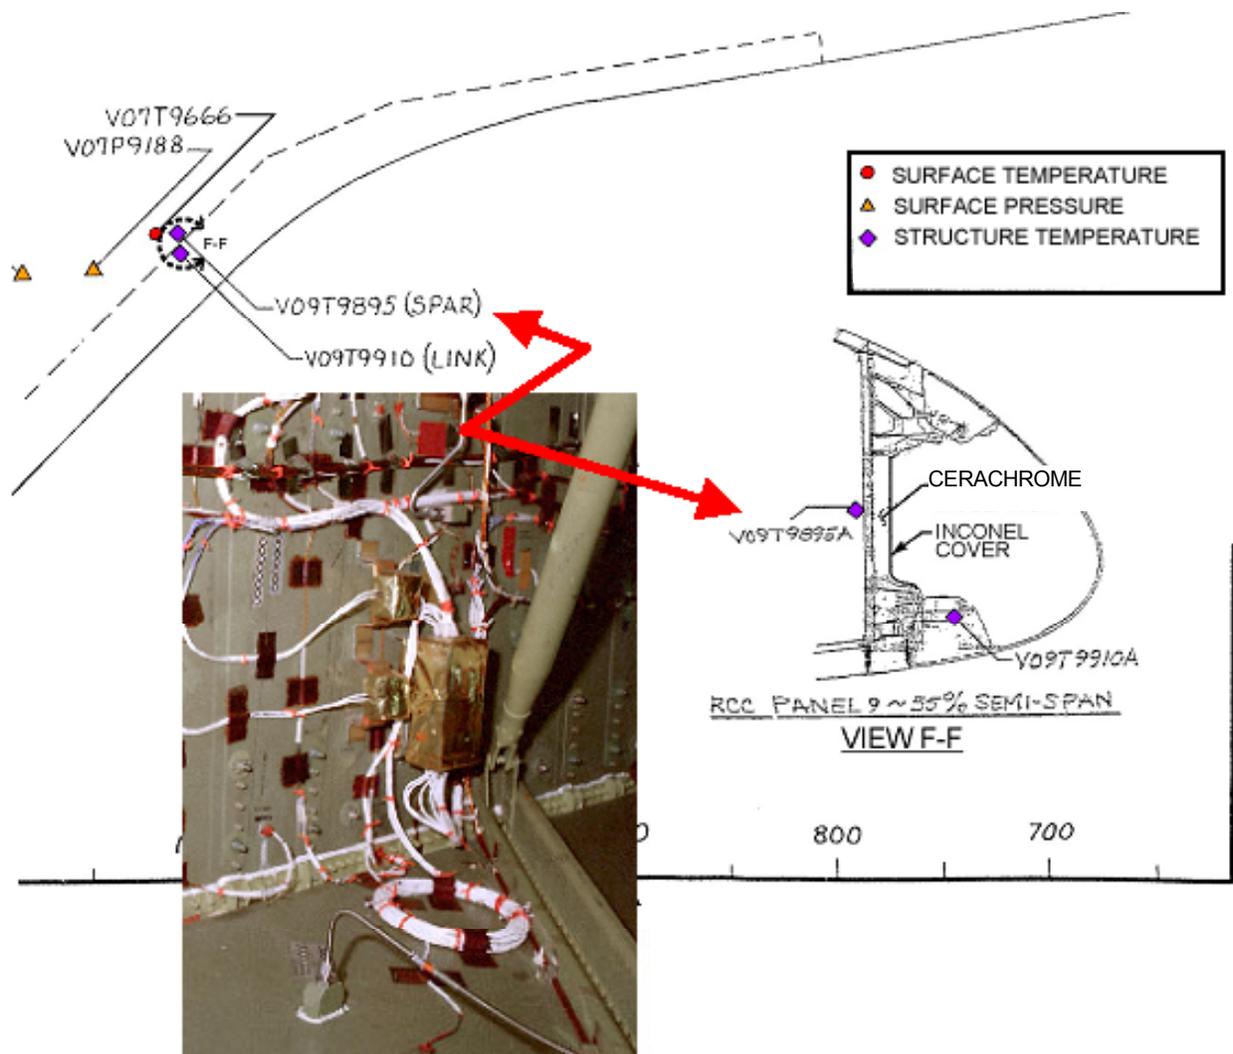
Additionally, there is another MADS measurement that had an off-nominal signature during the ascent timeframe. The temperature sensor on the leading edge spar behind RCC panel 9 showed a slightly higher temperature rise than seen on any previous Columbia flight. Figure 3-15 shows the location of the temperature sensor behind the wing leading edge spar inside the wing. The slight temperature rise can be seen in Figure 3-16. Note that most flights show a small rise in this temperature during ascent due to aerodynamic heating.

Figure 3-15. Close-out photo shows RCC panel 9 wing leading edge temperature measurement

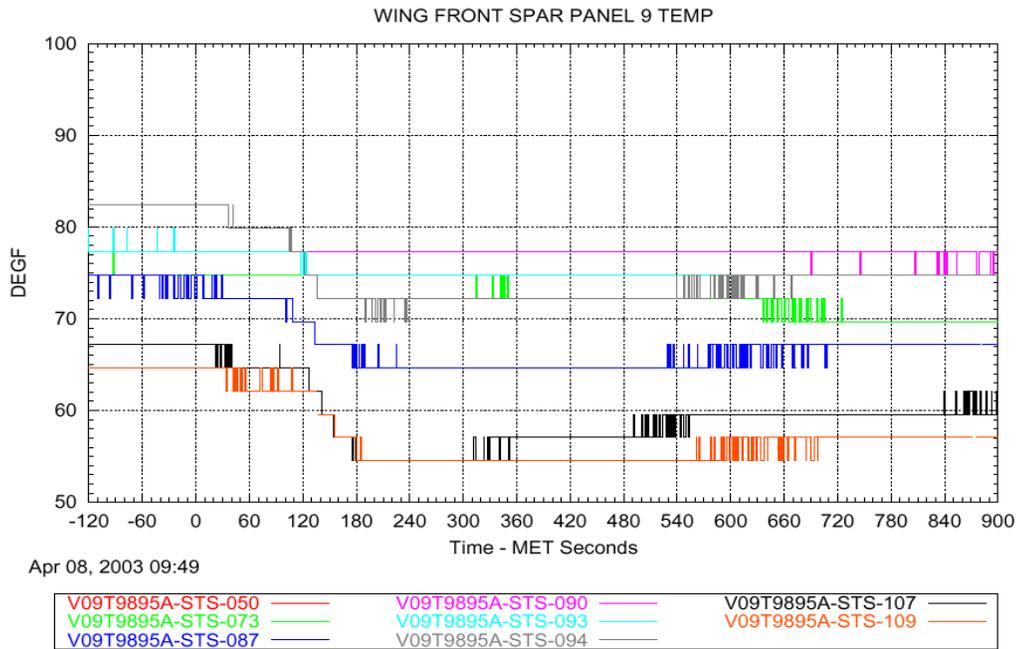
STS-107 had a 7.5 degree Fahrenheit rise that started very early during ascent (five to six minutes after launch). Although the data do not prove that the RCC was breached during ascent, the data are consistent with a possible flow path into the RCC cavity via damage in the RCC panels 6 through 8 area. A simplified thermal math model was constructed and verified with flight data from STS-5. The model was then correlated to the flight data from STS-107. Assuming the equivalent heating from a 10 inch diameter hole in RCC panel 8, this model nearly predicts both the ascent and entry temperature profiles for the wing leading edge spar temperature sensor. Figure 3-17 compares the model with the flight data for both ascent and entry. For comparison, Figure 3-18 shows the overall heating rate of the STS-107 ascent and entry environments on RCC panel 9. As shown, the heating on the wing leading edge is much greater during the entry profile than during the ascent profile.

Figure 3-16. Three-bit rise (7.5 degrees F) on MADS wing leading edge spar temperature measurement (V09T9895A) during ascent

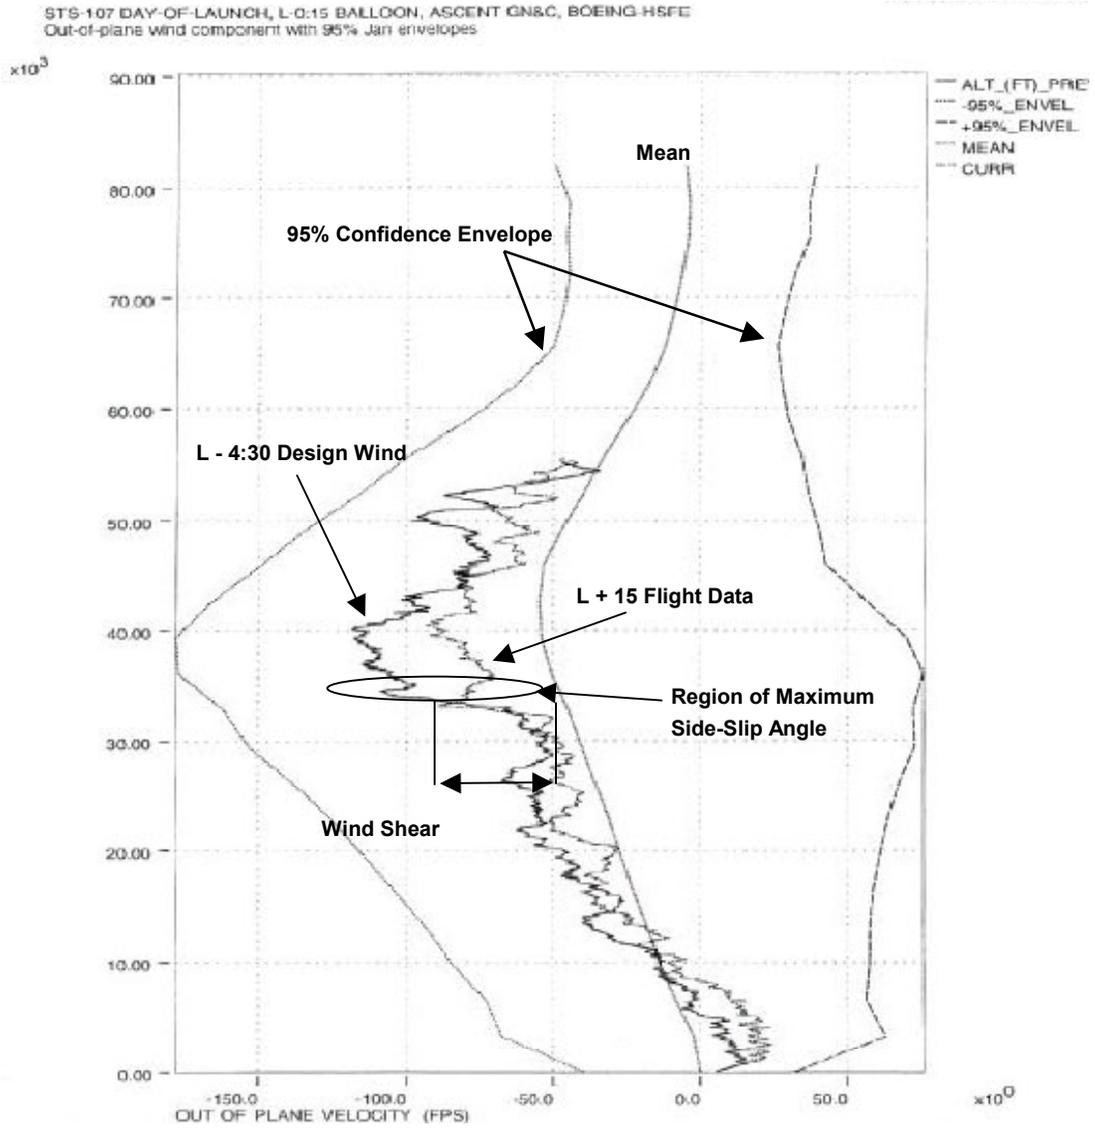
STS-107 experienced a wind shear during the period of maximum dynamic pressure starting at 57 seconds MET (Mach 1.27). The wind shear was due to a rapid change in the out-of-plane wind velocity of -37.7 feet per second over a 1200 foot altitude range starting at approximately 32,000 ft (as shown in Figure 3-21). Immediately after the vehicle flew through this altitude range, its side-slip angle began to increase in the negative direction, reaching a value of approximately -1.75 degrees at 60 seconds. This value of side-slip angle is a new flight experience value for MET 60 seconds (as shown in Figure 3-22). Post-flight data review indicates that the new flight experience side slip event not the result of the wind shear itself. Instead, it was the direct result of a difference in the L - 4:35 minutes balloon measurement, upon which orbiter guidance commands were updated on launch day, and the actual winds flown through by the orbiter during launch and ascent. Figure 3-21 highlights the difference in these two winds in this altitude region (a 25 foot per second increase in out-of-plane magnitude pre-launch compared to a 12 foot per second reduction in magnitude as experienced by the vehicle)

Figure 3-21. Out-of-plane wind velocity

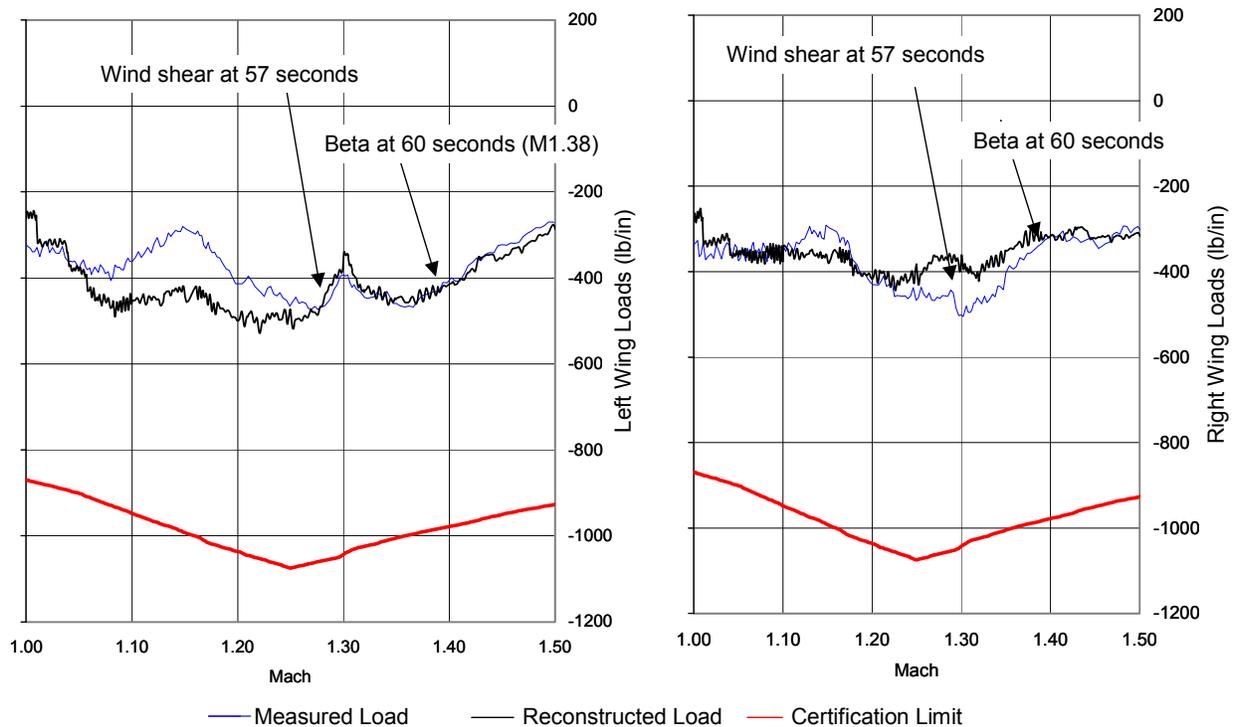
The wing loads analysis used a flexible body structural loads assessment that was validated by the MADS data. The wing loads analysis used reconstructed trajectory parameters to generate the loads on the orbiter wings during ascent. The assessment demonstrated that all orbiter wing loads were 50 to 60% of their design limit, or less, throughout the ascent. This includes the wind shear event at 57 seconds MET, and subsequent side-slip angle at 60 seconds MET (as shown in Figure 3-23).

Figure 3-23. Wing loads during wind shear and side-slip angle

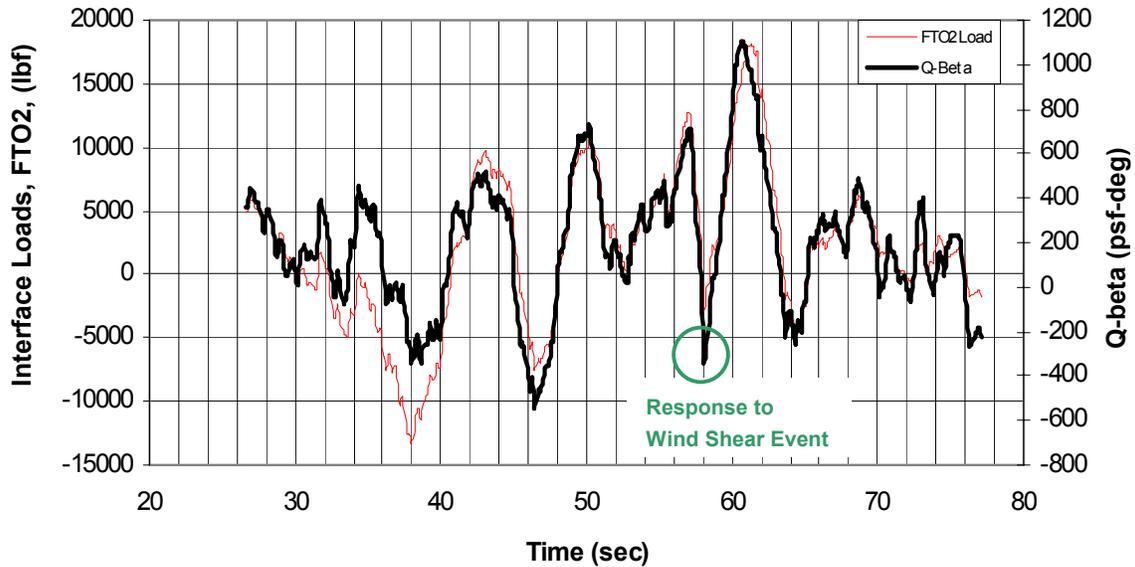
The ET/orbiter interface loads were generated using reconstructed trajectory parameters that included the effects of wind shear/crosswind, side-slip angle, and ET liquid oxygen (LOX) slosh. The loads analysis demonstrated that the ET forward attach loads were within certification requirements at all times. The wind shear event had only a small effect on the overall ET loads relative to the required limits (as shown in Figure 3-24), as did the ET liquid propellant slosh (as shown in Figure 3-25). The resulting load from the wind shear event was of the same order magnitude as the roll maneuver and other first stage events prior to SRB separation.

Figure 3-24. ET interface loads at forward attachment during wind shear and side-slip angle. Q-beta is side-slip angle multiplied by the dynamic pressure and represents the side-slip angle contribution of the interface load

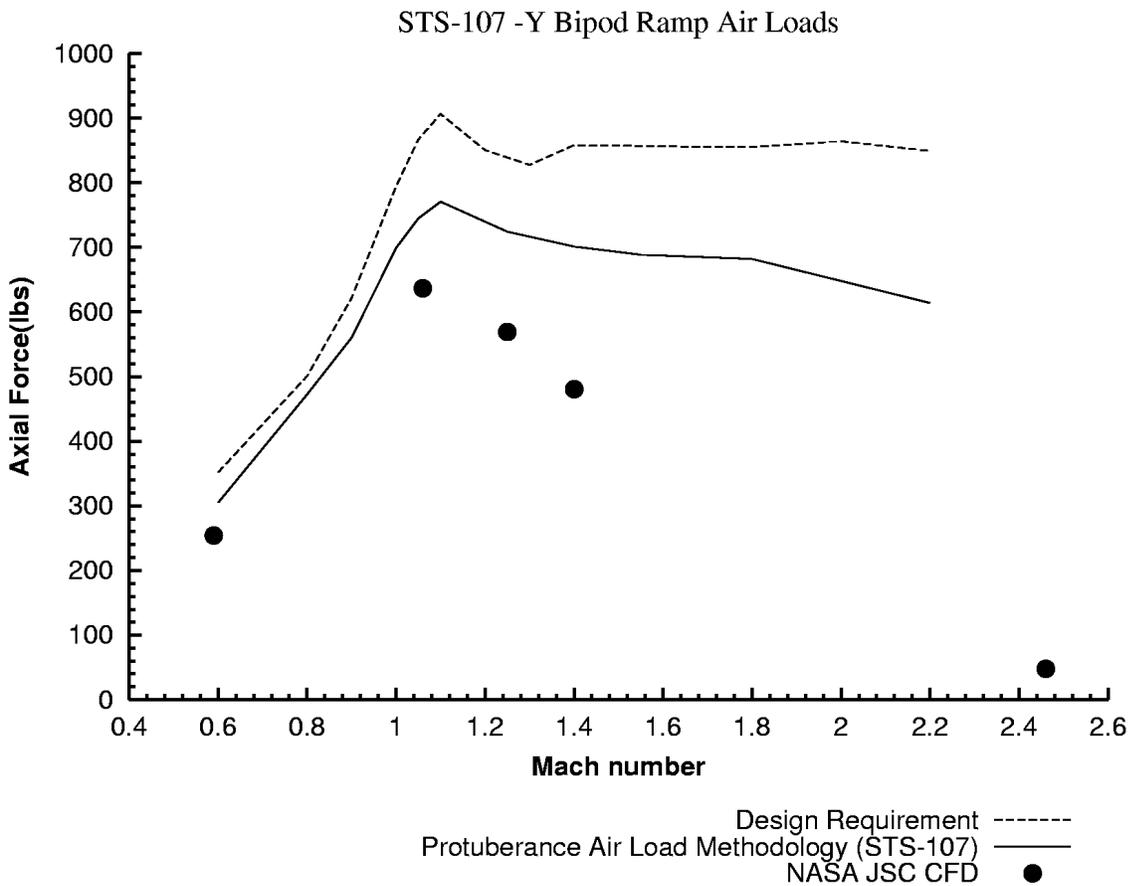
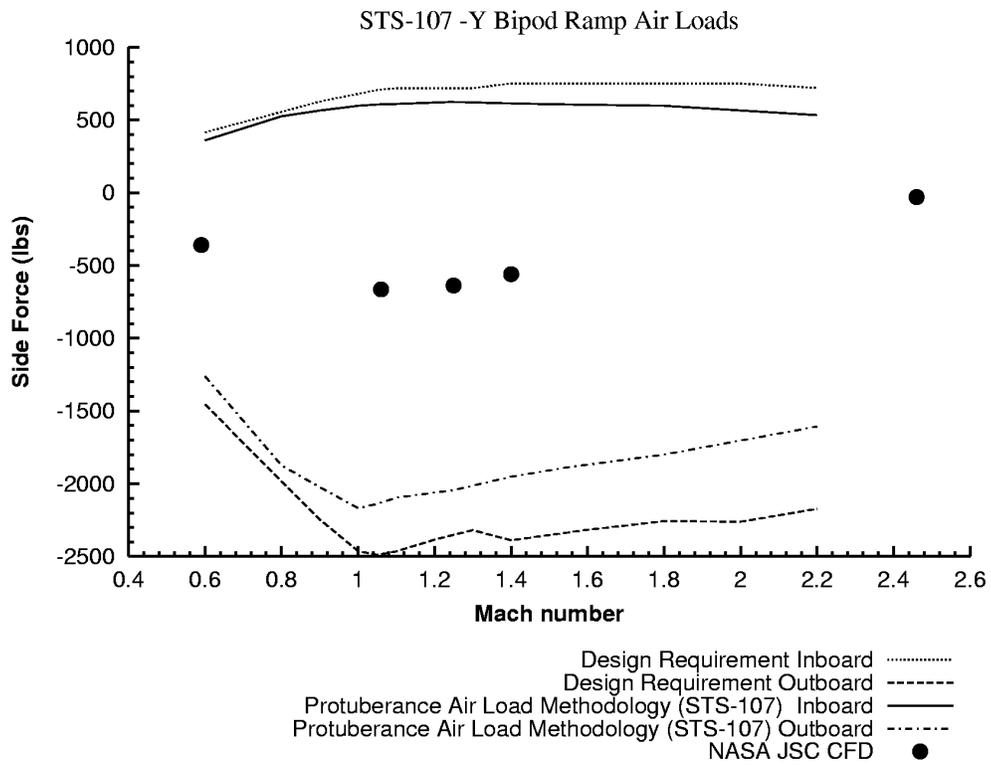
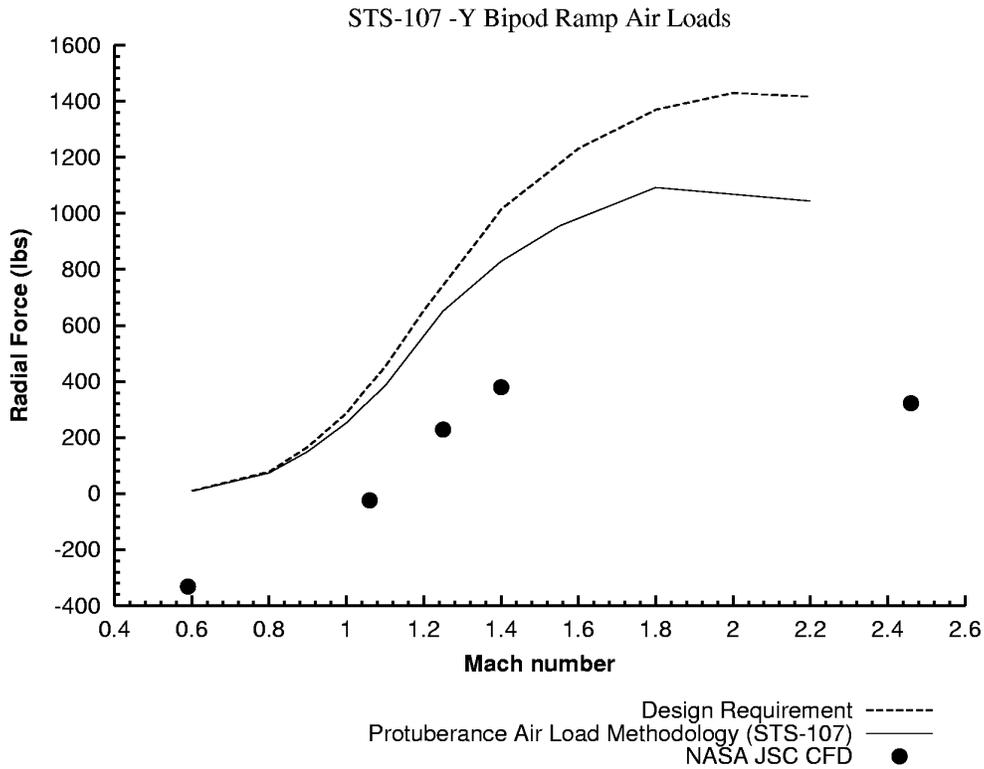
The external aerodynamic loads on the ET forward attach bipod were analyzed using a CFD simulation. The simulation produced axial, side-force, and radial loads as shown in Figure 3-26, Figure 3-27, and Figure 3-28, respectively. The CFD assessment of the bipod area indicated that the external air loads were below the design limit during the Hi-Q region and at the time of the bipod foam liberation.

Flexible body simulation results indicate that all vehicle elements and associated loads were within required limits. The reconstruction loads analyses indicate that the ascent environment-induced loads alone did not cause the ET bi-pod foam loss.

Figure 3-26. ET bipod axial aerodynamic loads

Figure 3-27. ET bipod side-force aerodynamic loads

Figure 3-28. ET bipod radial aerodynamic loads

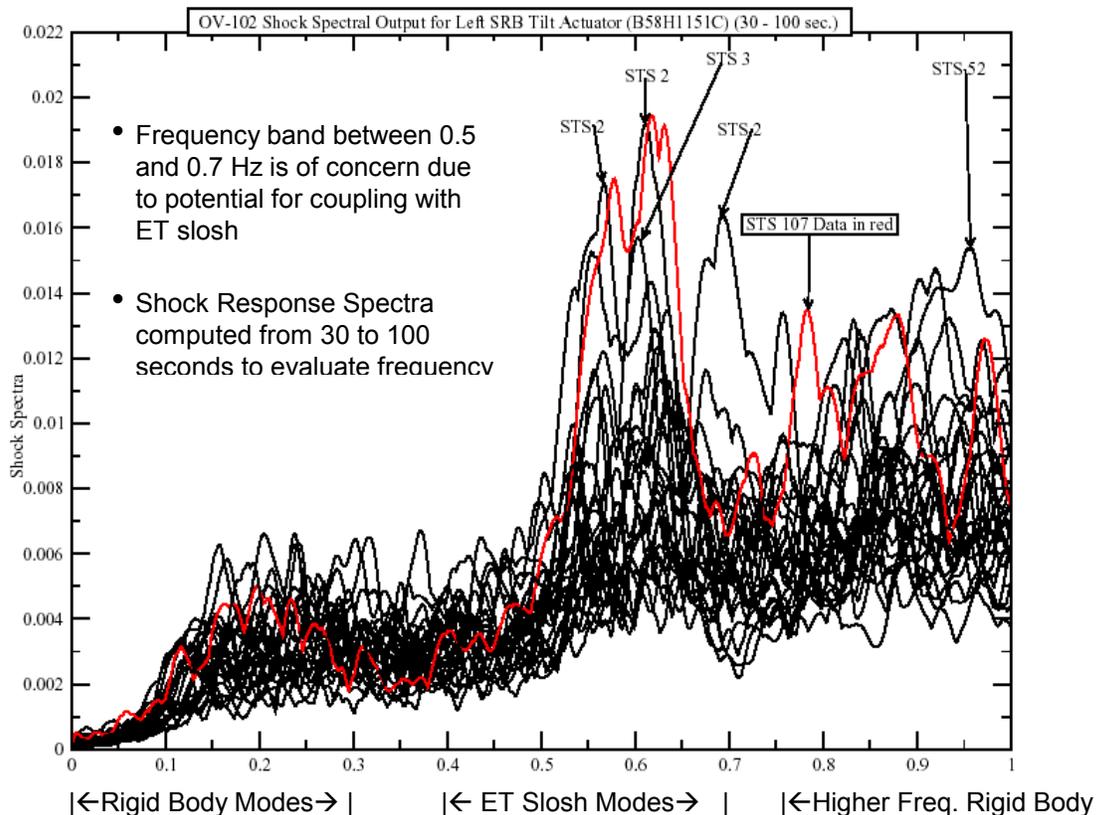
The STS-107 ascent data indicate a 0.6 Hz actuator oscillation frequency that peaks in amplitude at 55 seconds, and again at 77 seconds MET and continues through SRB separation. The peaks directly correlate to peaks in 0.6 Hz wind content. A 0.6 Hz oscillation in the Flight Control System output is of interest since it can couple with the ET Liquid Oxygen (LOX) slosh mode. Slosh refers to the repeated side-to-side movement of the center of gravity of the liquid oxidizer propellant in the external tank. The slosh mode frequency and amplitude cannot be measured directly through vehicle data. In order to determine if ET LOX slosh is present, a post-flight process of reviewing the vehicle SRB and SSME actuator frequency content must be conducted, as well as that of the launch wind. When this post-flight process was conducted for STS-107, it revealed that this flight experienced more than typical 0.6 Hz frequency content in the SRB tilt actuators with moderate content in the rock actuators. Figure 3-29 illustrates this point with the results of the SRB left tilt actuator frequency response as compared to previous Columbia flight history.

Figure 3-29. STS-107 SRB tilt actuators experienced more than typical 0.6 Hz content

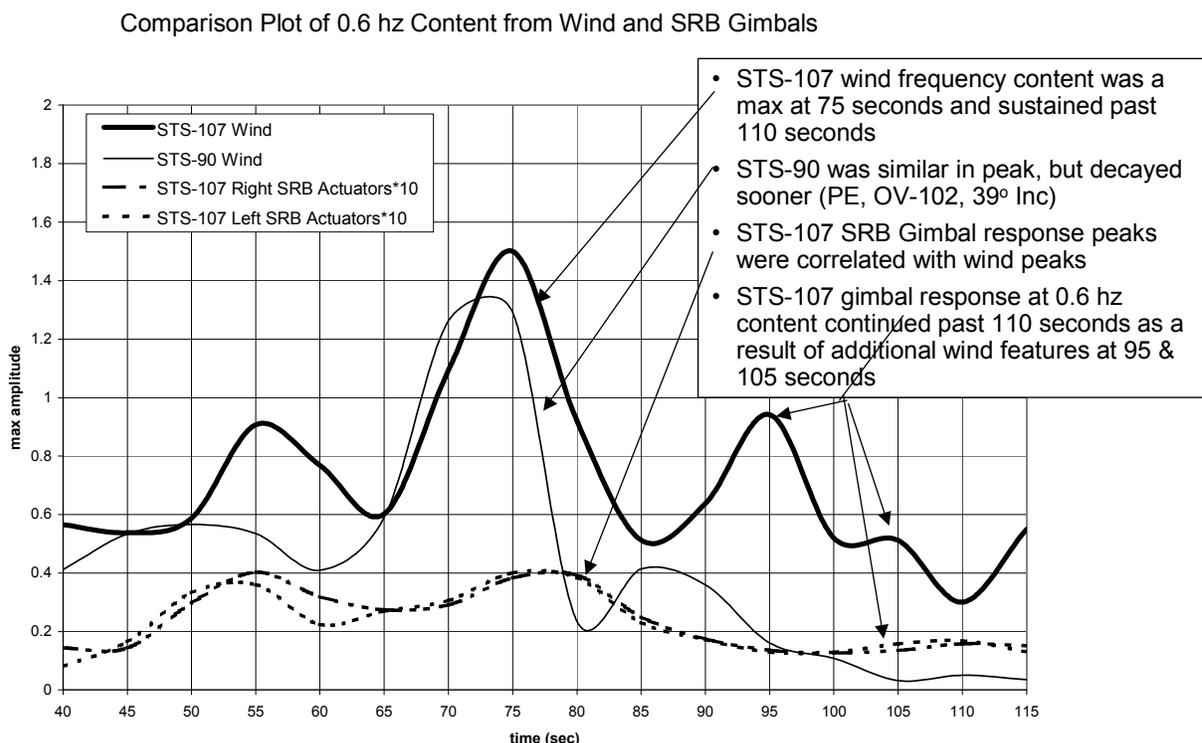
Figure 3-30 shows the relative time variation of amplitudes of the 0.6 Hz frequency content in wind and actuator data. The close correlation between the peaks in the 0.6 Hz content of the right and left actuator responses and the wind dynamics indicates that the actuators were responding primarily to wind rather than ET LOX slosh at this frequency through most of first stage (prior to SRB separation). As the 0.6 Hz content of the wind dynamics reduces in magnitude late in first stage, the remaining 0.6 Hz content in the actuator response may be attributed to a combination of the remaining wind dynamics and low-amplitude ET LOX slosh. STS-90 shows a similar wind frequency content.

Figure 3-30. STS-107 SRB gimbal responses at 0.6 Hz frequency correlated to wind

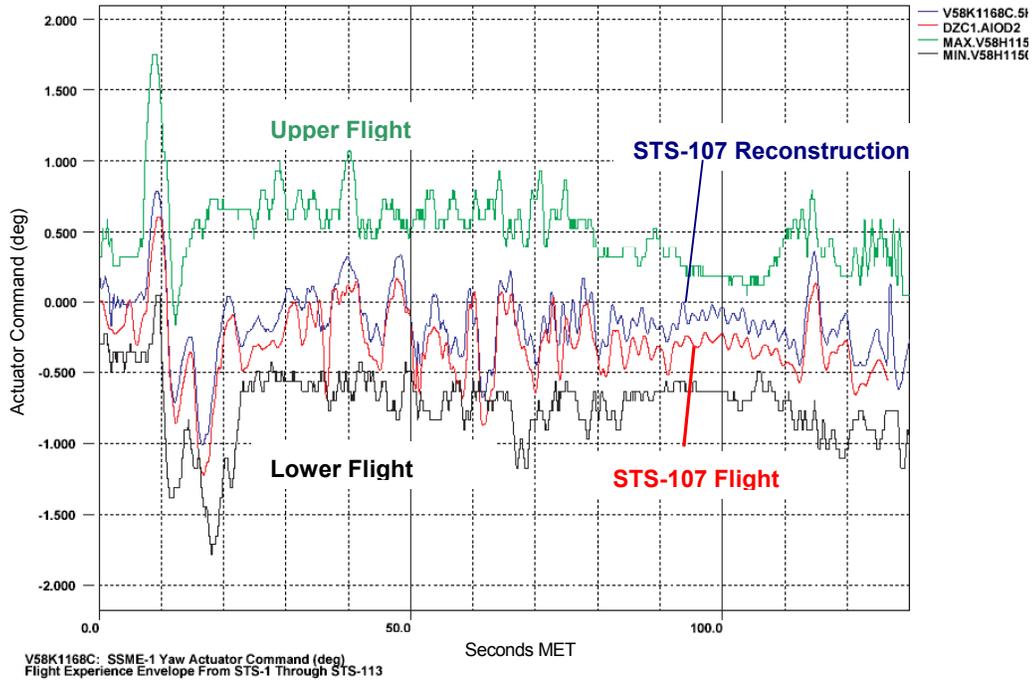
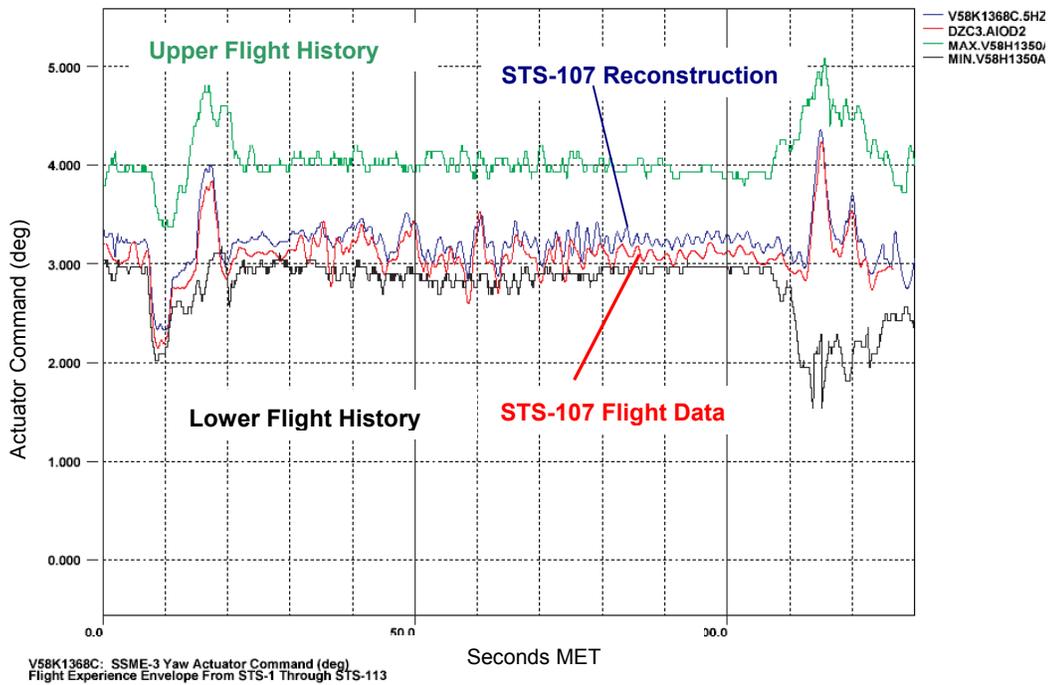
A review of the STS-107 ascent data identified two discrete points in time when the SRB and SSME nozzle positions exceeded the flight experience envelope for those respective times in the ascent profile. The first event occurred when the center and right SSME yaw deflections exceeded the previous flight experience envelope during the period of maximum dynamic pressure, as a result of the differences between predicted and actual flight wind conditions (as shown in Figure 3-31 and Figure 3-32).

The large offset in the Center and Right SSME yaw positions at 62 seconds MET was the reaction of the flight control system to the wind shear event and day-of-launch wind differences as compared to the DOLILU design. The nozzle motion was within the capability of the Shuttle flight control system, and the system operated as designed. As discussed in Section 3.5.1, the reconstruction loads analyses indicate that the ascent environment-induced loads alone did not cause the ET bipod foam loss.

Figure 3-31. Center SSME yaw position

Figure 3-32. Right SSME yaw position

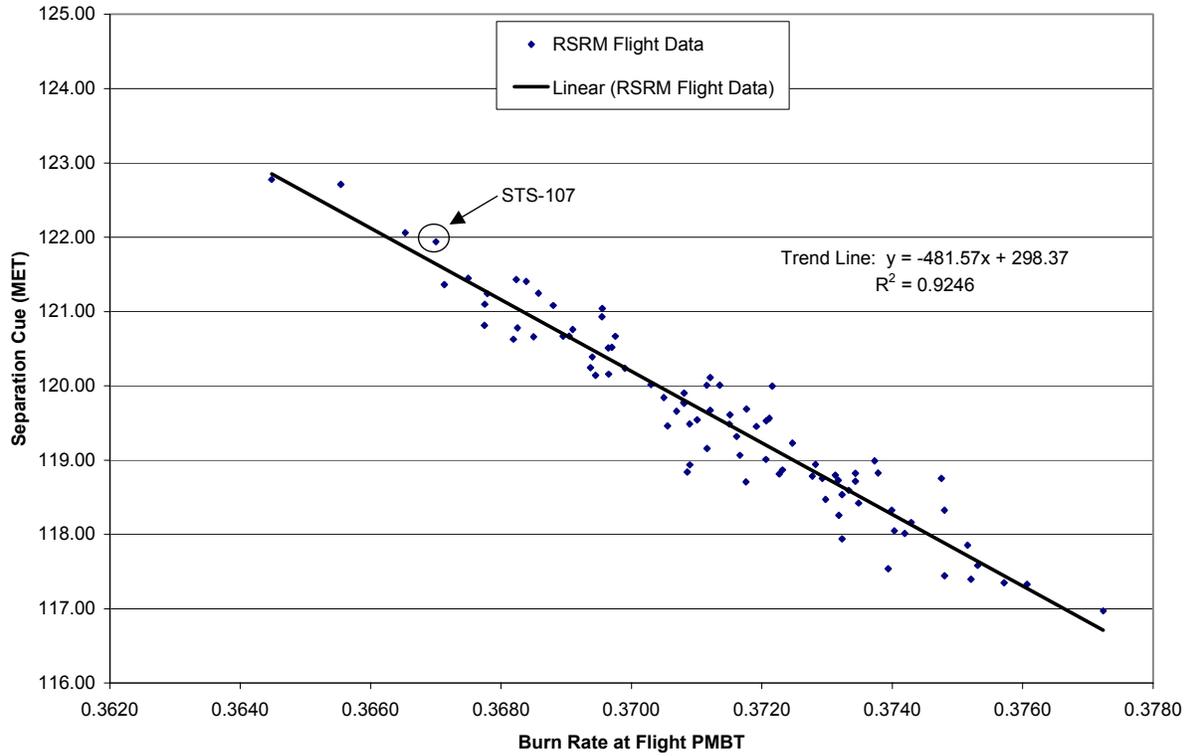
Figure 3-33. RSRM burn rate at propellant mean bulk temperature (PMBT)

The RSRM burn rate is a temperature dependent function, and are determined based on pre-flight tests of small samples of the actual motor propellant at a reference temperature. These values are then adjusted based on a Predicted Mean Bulk Temperature (PMBT) based on the actual weather conditions prior to launch day. For STS-107, the pre-flight predicted motor performance was very close to that determined by post flight reconstruction. A low RSRM burn rate does not affect the total impulse produced by the RSRM during first stage; it only affects the amount of time the RSRMs must burn to achieve the same level of impulse.

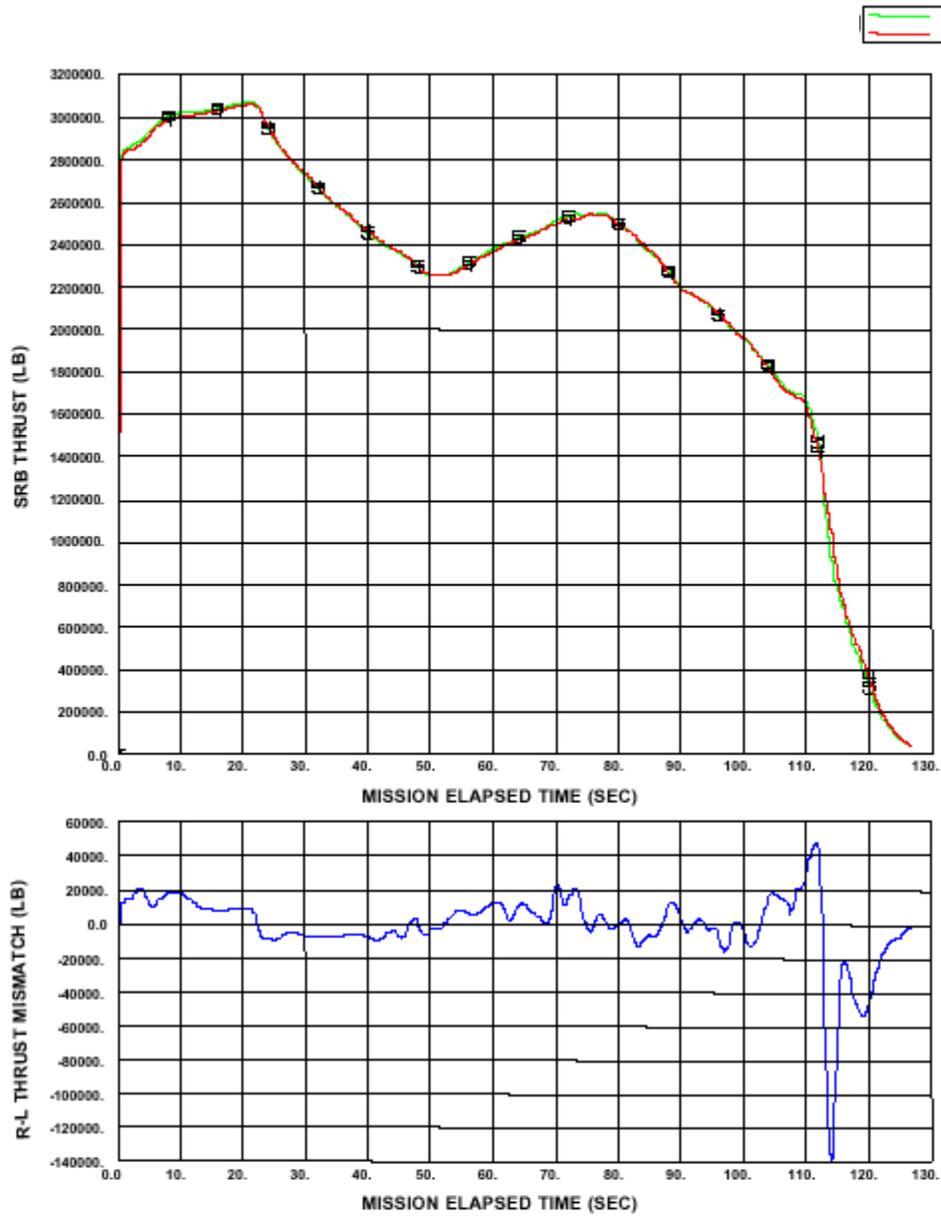
Figure 3-34. SRB thrust mismatch

The SRB thrust mismatch observed during tail-off was well within the design margin of the flight control system, and similar occurrences have happened numerous times during previous flights.

The data indicate that the SRB thrust mismatch on STS-107 was a direct result of SRB burn rate differences between the left and right SRB. The thrust mismatch observed on STS-107 and the new flight experience nozzle positioning occurred after the foam shedding event. The SRB thrust mismatch occurred on the majority of flights in both families of flights, including those that did not shed foam.

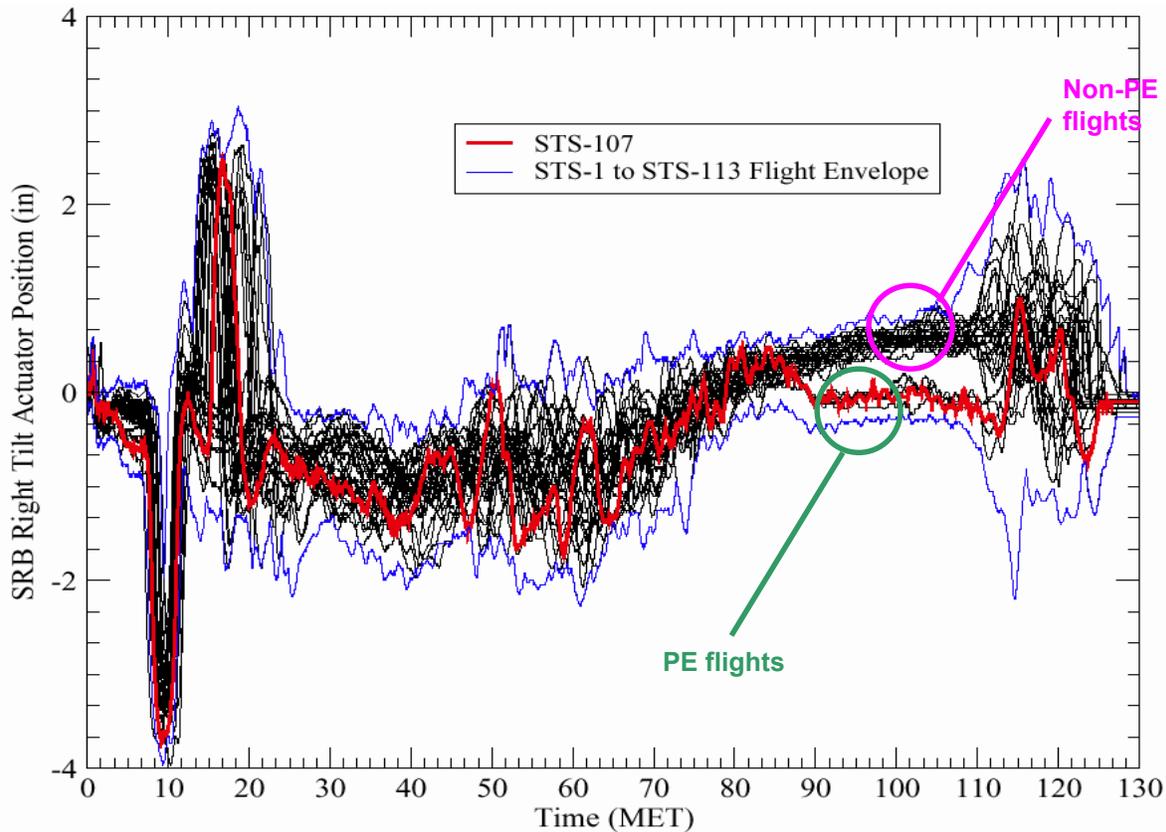
The second nozzle motion event occurred when the SRB and SSME Thrust Vector Control (TVC) pitch and yaw deflections exceeded the previous flight experience envelope during SRB tail-off (as the SRB thrust diminished). The new flight experience envelope for the SSME and SRB nozzle positions was primarily due to (1) low Reusable Solid Rocket Motor (RSRM) performance that caused a time shift of the SRB tailoff events relative to previous flight experience, as indicated by a low burn rate shown in Figure 3-33, (2) a thrust mismatch between the left and right SRB caused by lower than normal thrust on the right SRB during tail-off, the final seconds of SRB burn (as shown in Figure 3-34), (3) a small bias in the left SRB pitch actuator that shifted the actuator positions farther toward the edge of the flight experience envelope, and (4) flight control trim characteristics unique to PE flights (as shown in Figure 3-35).

Figure 3-35. SRB nozzle position for PE flights versus non-PE flights

Due to flight control gain settings unique to PE flights, PE flights have a nozzle position closer to zero inches deflection from 85 to 110 seconds MET. The flight data that coincides with the STS-107 data are all from PE flights, seen clearly in the 85 to 110 seconds MET timeframe in Figure 3-33. The other grouping of flights in this same timeframe (85 to 110 seconds MET) are all non-PE flights and have larger pitch nozzle deflections.

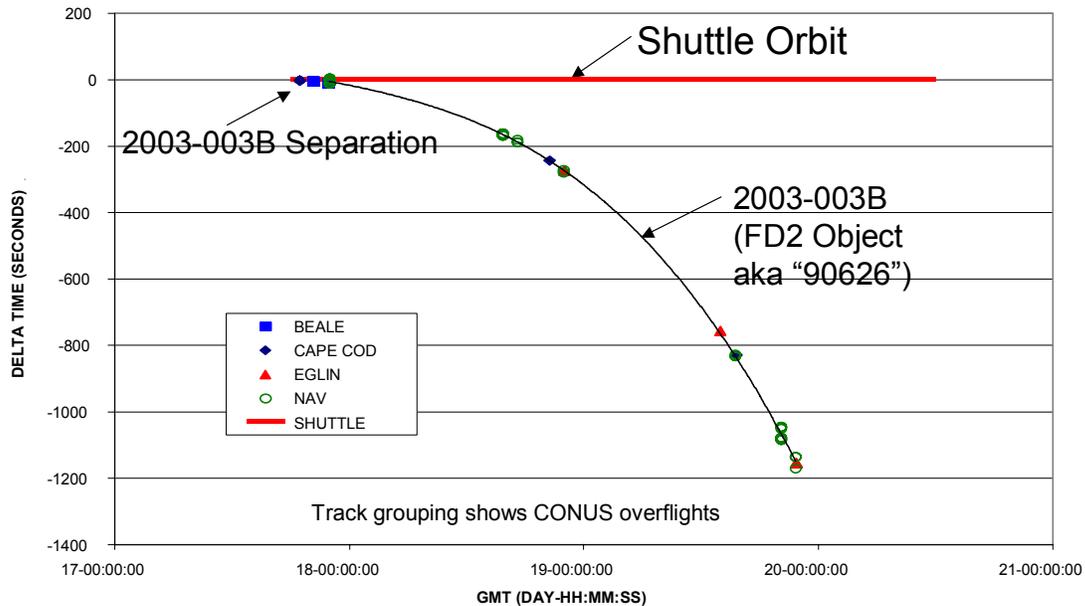
The calculated departure velocity was relatively low and was estimated to be 0.7 to 3.4 miles per hour with the lower velocity being more likely. An exact departure

direction relative to the orbiter could not be determined. Multiple ground sensors including Eglin Air Force Base (AFB), Beale AFB, Cape Cod Air Force Station (AFS), and the Navy Space Surveillance fence radar tracked the object. The object reentered the atmosphere on January 19 between 20:45 EST and 23:45 EST. Figure 4-4 depicts the tracking of the object including various sensor passes.

Figure 4-4. Tracking of flight day 2 object through various sensor passes
