COLUMBIA ACCIDENT INVESTIGATION BOARD (CAIB)/
NATIONAL AERONAUTICS AND SPACE ADMINISTRATION (NASA)
ACCIDENT INVESTIGATION TEAM (NAIT)

WORKING SCENARIO

FINAL VERSION: JULY 8, 2003

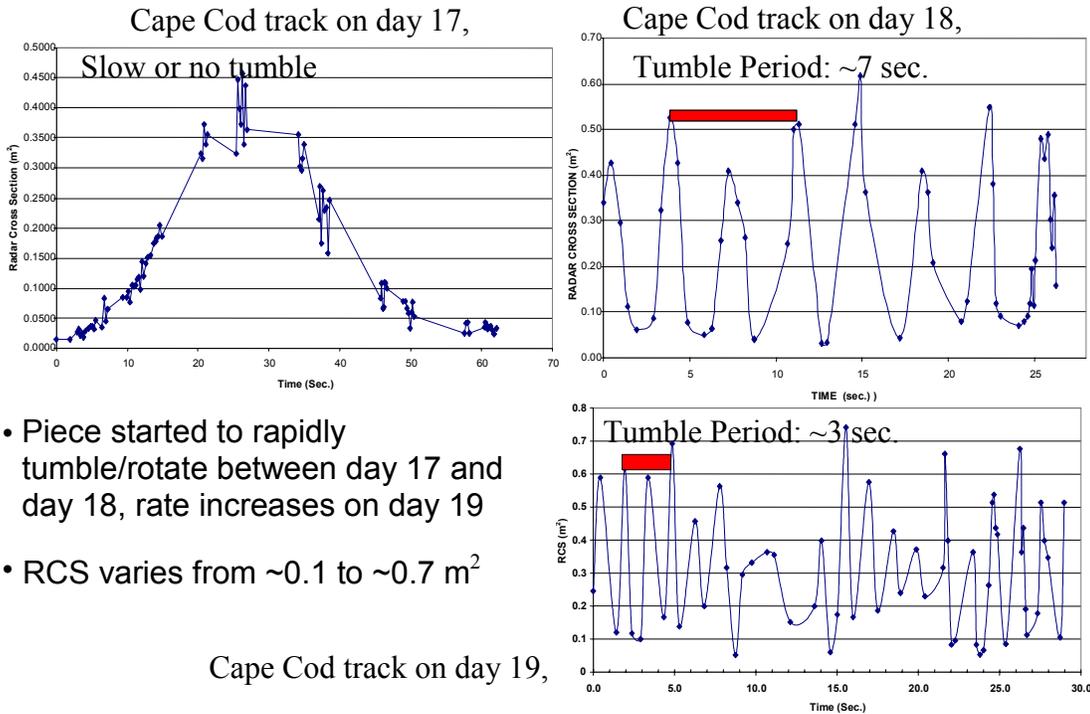
Based on the observed radar cross sections, the object appeared initially to have a minimal to no tumble/rotation rate, but it gradually developed a rate over the next two days. During a Cape Cod AFS sensor pass on January 18 at 15:29 EST, the tumble/rotation rate had a period of seven seconds. Later, on January 19 at 10:39 EST during another Cape Cod AFS pass, the apparent tumble/rotation rate had increased and the period was approximately three seconds. Figure 4-5 depicts the tumble/rotation rates during the timeframe that the object remained in orbit. The exact physical size and mass of the object are unknown, although it appeared to be a lightweight piece based on the observed ballistic coefficient.

Figure 4-5. On-orbit RCS shows increased tumble/rotation rate over time

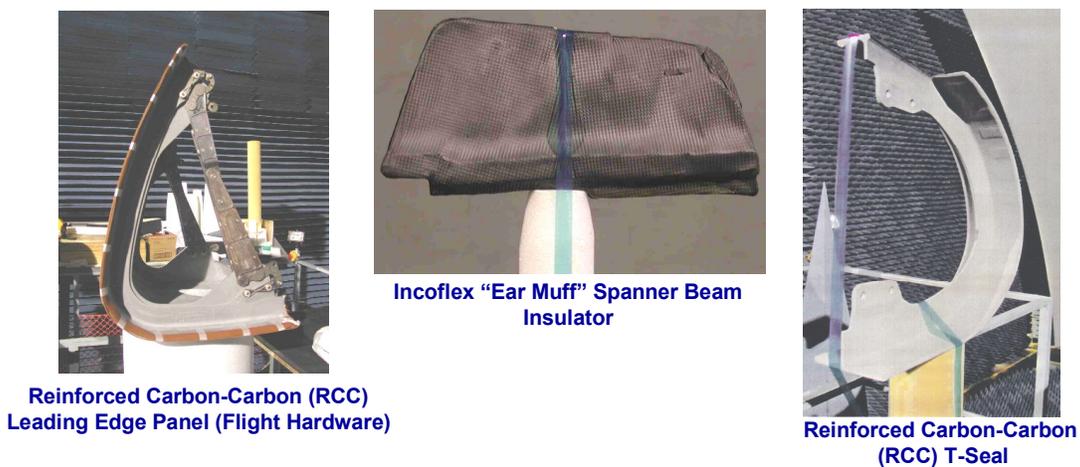
The results of this radar testing and ballistics analysis have excluded all external Shuttle materials with the exception of 1) a whole Tee seal, 2) a Tee seal fragment that includes an attachment flange and/or apex segment, or 3) RCC panel acreage no less than 90 square inches and roughly square in shape (+/- 20%), although curvature is possible, with a thickness on the order of 0.33 inches. An RCC panel segment matches the RCS and ballistic performance characteristics observed during the STS-107 mission.

A Tee seal fragment with an apex segment matched the RCS characteristics extremely well in any spin orientation; however, the ballistic match required a very specific spin orientation that was shown to be feasible in one analytical simulation. Therefore, it is possible that the flight day 2 object was either a partial Tee seal or RCC panel acreage piece. The Incoflex spanner beam “ear muff” insulation was also a good match for both ballistics and RCS. Because the “ear muff” is situated behind the RCC panel, it is excluded from being considered a very likely candidate because of the lack of a mechanism for exposing it to the space environment. If the damage to the wing were actually a 10-inch diameter, uniformly round hole, then an “ear muff” would be a more plausible candidate. However, it is considered unlikely that the wing damage was a 10-inch diameter round hole. The damage is considered to be the equivalent of that which would provide the same thermal response during entry as a 10-inch diameter hole did in the analyses and simulation. It is not likely that the actual wing damage was geometrically uniform. The damage was more likely a combination of cracks and holes, or a slot, such as a Tee seal or partial Tee seal missing or displaced. Therefore, the ear muff is not considered to be a good candidate for the flight day 2 object. Figure 4-6 shows the three leading edge components that match both RCS and ballistics analysis. It should be noted that a full Tee seal and RCC panel are shown in these photos while there are specific partial Tee seal and RCC panel configurations that match the test results.

Figure 4-6. Leading edge structural subsystem components matching RCS and ballistics

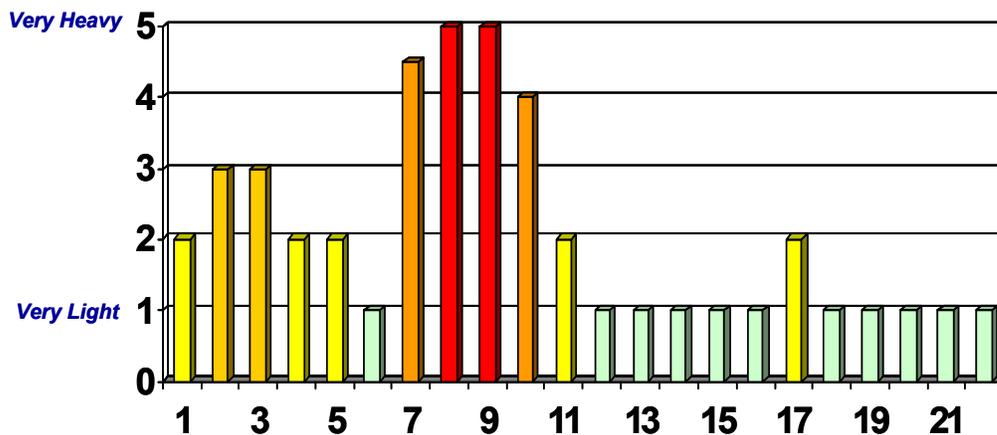
The forensic data indicate that the panel 8/9 area was subjected to extreme entry heating over a long period of time leading to RCC rib erosion, severely slumped carrier panel tiles, and a substantial slag deposition on the upper portion of RCC panels 8 and 9. Figure 5-2 shows the slag deposition (both metallic and oxide) in the RCC panel 8/9 area relative to the other parts of the wing leading edge, and Figure 5-3 shows samples of the severe slag deposition on the panel 8 rib. A review of all recovered debris indicates that this is the most probable area of a breach into the wing since there are no other debris pieces that exhibit the unique characteristics observed in this area.

Figure 5-2. Slag deposition in the RCC panel 8/9 area relative to the other parts of the left wing leading edge

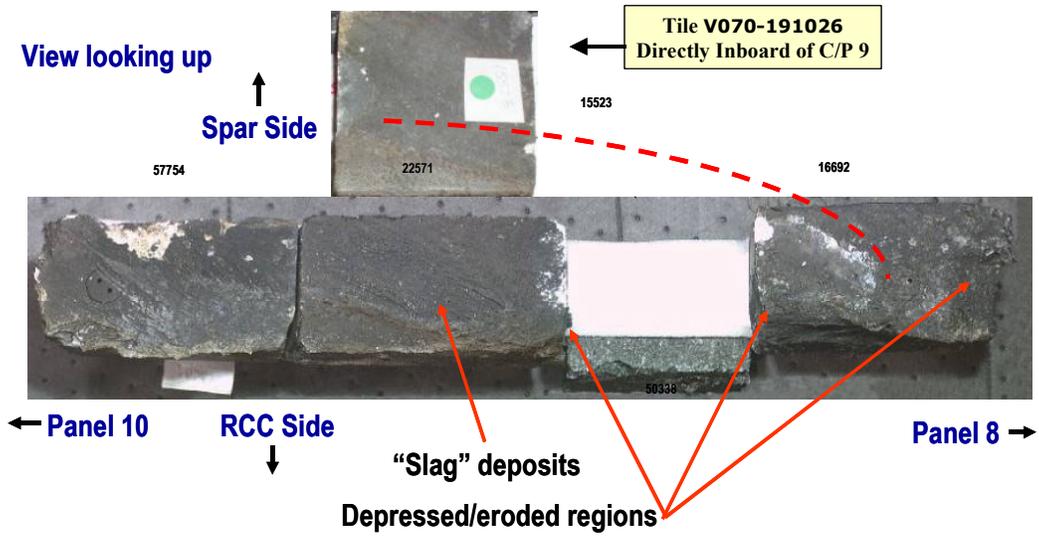
Based on the slag deposition on the upper RCC panel 8 and the rib erosion at the panel 8/9 interface, the most likely area of damage was the bottom portion of RCC panel 8. The outboard apex on the panel 8 upper inboard rib shows knife edge erosion, and the rib tapers from a design thickness of 0.365 inches to 0.05 inches. The surface of the panel 8 outboard rib and matching heel piece show a similar sign of erosion, as does the panel 9 upper inboard rib. The erosion on both the panel 8 and 9 rib is on the inboard side, indicating that flow is coming from the panel 8 location. Additionally, several lower carrier panel tiles in the RCC panel 9 area also show significant slumping and erosion that is consistent with a hole or breach in the lower part of RCC panel 8. Figure 5-4 and Figure 5-5 show an example of the rib erosion and the flow on the lower carrier panel 9.

Figure 5-5. Flow on the lower carrier panel 9 tiles

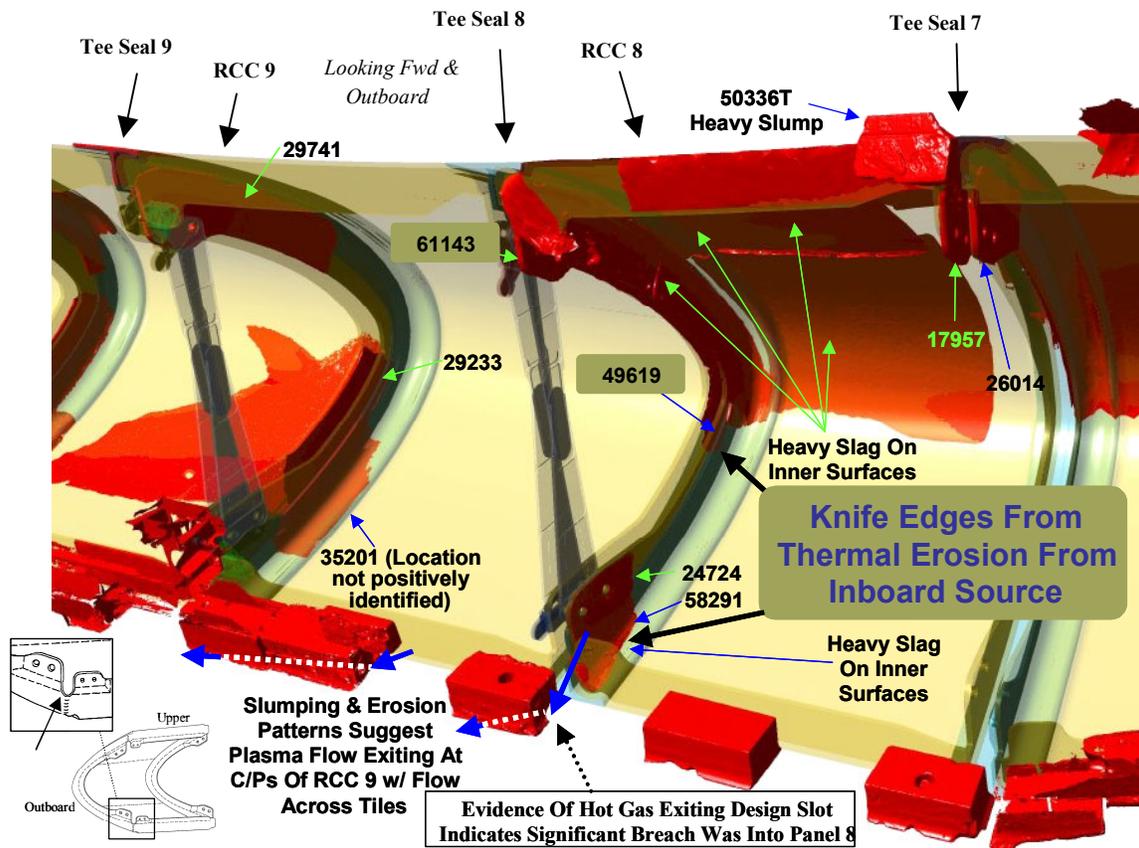
Figure 5-6 is a CAD drawing of the recovered debris showing overall slag deposition and erosion patterns. The drawing is a view from behind the RCC panels since this provides the best view of the erosion and slag deposition. Three full Tee seals can be seen in this drawing; the leftmost, Tee seal 9, divides panel 9 and 10; Tee seal 8 in the center divides panel 8 and 9; the rightmost, Tee seal 7, is the division between panel 7 and 8. The drawing shows the heavy slag deposition of the upper portion of panel 8 indicating that the probable breach area was the bottom of panel 8. The severely eroded RCC ribs are also visible near the RCC panel 8/9 Tee seal. The heavy slag on

these inner surfaces indicate flow from the panel 8 direction toward panel 9. This is also consistent with the knife-edge erosion shown in Figure 5-4 below. The proposed flow direction leading to the erosion and slag deposition on the lower carrier panel 9 tiles can be seen in this view as well. The detailed flow, erosion, and deposition are best viewed in Figure 5-5. The last significant feature in Figure 5-6 is the heavy slumping that is observed on the upper carrier panel 8 tile (50336T) in the upper right portion of the drawing.

Figure 5-6. CAD drawing of the recovered debris showing overall slag deposition and erosion patterns

The data shown in Figure 5-6 is important when combined with the analysis of the slag deposition. The slag deposition on the upper RCC panel 8 was analyzed using sophisticated cross sectional optical and scanning electron microscopy, microprobe analysis, and x-ray diffraction to determine the content and layering of the slag deposition. This analysis indicated that the materials in this area were exposed to extremely high temperatures, since Cerachrome insulation was deposited first and its melting temperature is greater than 3200 degrees Fahrenheit. The analysis also showed no presence of Aluminum 286 in the slag indicating that the RCC attach fittings were not in the direct line of the breach and that the Inconel 718 spanner beam was one of the first internal items to be subjected to heating. Inconel slag was prevalent in much of the analyzed slag indicating melting of the spanner beam, foil, and associated insulation. Aluminum was found in the last deposited layer indicating the wing honeycomb spar was the last area to be subjected to hot gas flow.

This forensics analysis further corroborates the breach location to be the lower portion of RCC panel 8 below the apex, approximately midway between the apex and where the RCC panel meets the carrier panel. Based on the flow patterns, the breach was in an area that caused the flow to impact the spanner beam associated with Tee seal 8 and create the knife edge erosion shown in this area in Figure 5-6.

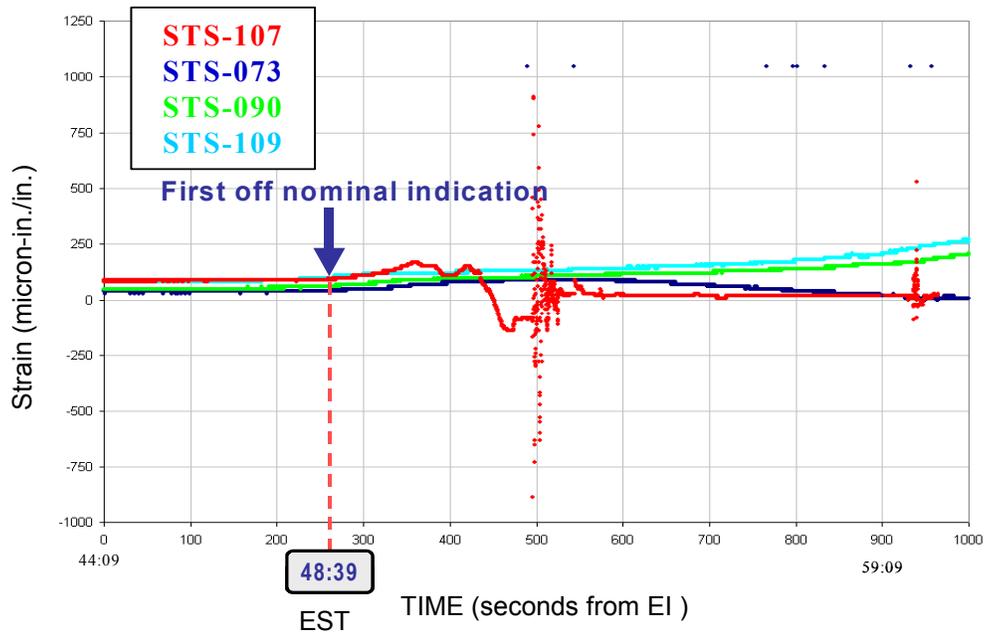
At approximately 8:48:39 EST (EI + 270 sec.), a left wing leading edge spar strain gauge began a small off-nominal increase. Figure 5-11 shows the STS-107 response of this strain measurement along with three other previous Columbia missions. Figure 5-12 shows the location of this sensor (WLE Strain V12G9921) and others on the wing leading edge. The damage in lower RCC panel 8 is believed to be the cause of this strain increase. The breach allowed hot gas intrusion onto the panels 8 through 9 wing leading edge spar area leading to extreme heating and thermally induced strain. The strain increase grew over time and reached a maximum at approximately 8:50:09 EST (EI + 360 sec.). Thermal and structural analyses indicate that a breach would need to be within approximately 15 inches of the strain gauge to create the observed strain increase.

Figure 5-11. Left wing RCC panel 9 strain gauge is first measurement to indicate an off-nominal event. Note that EI was at 8:44:09 EST.

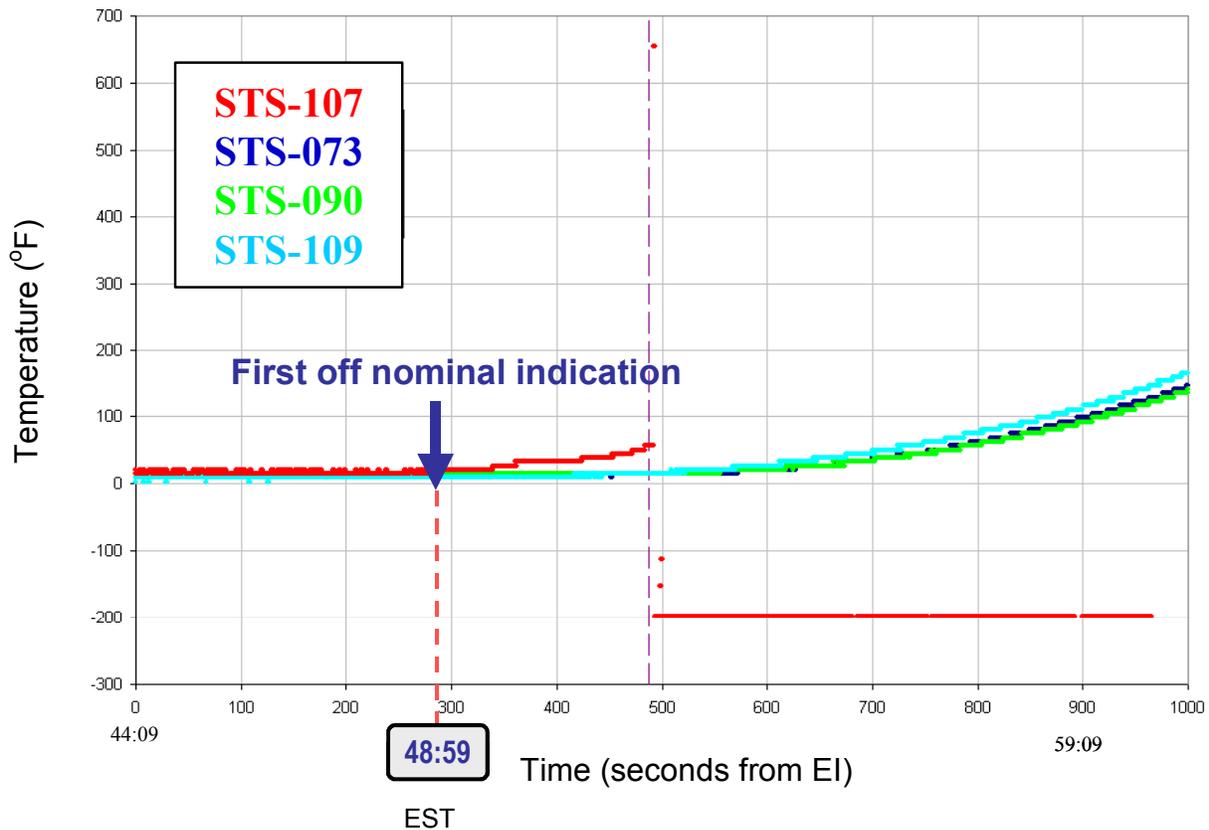
Twenty seconds later at 8:48:59 EST (EI + 290 sec.), the left wing lower attach clevis temperature sensor (between RCC panel 9 and 10) began an early off nominal temperature trend. Figure 5-13 shows the abnormal temperature response when compared to other Columbia missions. This temperature rise is consistent with an early entry of hot gas into the RCC cavity. This Modular Auxiliary Data System (MADS) measurement (V09T9910) is the only temperature measurement located in the RCC cavity along the left wing leading edge. It is positioned on the lower attach fitting between panel 9 and 10 and is well protected thermally by Inconel foil insulation. The sensor is also thermally isolated since it sits on the attach fitting away from other structure as shown in Figure 3-15. In order to get an early temperature rise for this sensor, unlike that observed on any other flight, there must be a path in the RCC cavity to allow hot gas to reach the sensor.

A thermal analysis was performed with heating rates from various hole sizes in the bottom of RCC panel 8 in an attempt to match this temperature rise. The analysis used a thermal math model of the wing leading edge (Inconel Cerachrome insulation, Inconel 718 and A-286 steel attach fittings, and aluminum honeycomb spar). The results indicated that the heating equivalent of a 6 to 10 inch diameter hole with a 10 percent “sneak flow” around the insulation would be required to match the thermal response of the clevis temperature. In the same timeframe several MADS lower surface temperatures on the left wing showed a slight off nominal early temperature rise when compared to previous flights of Columbia of the same inclination.

Figure 5-13. Left wing RCC panel 9/10 clevis temp sensor is second measurement to indicate an off-nominal event

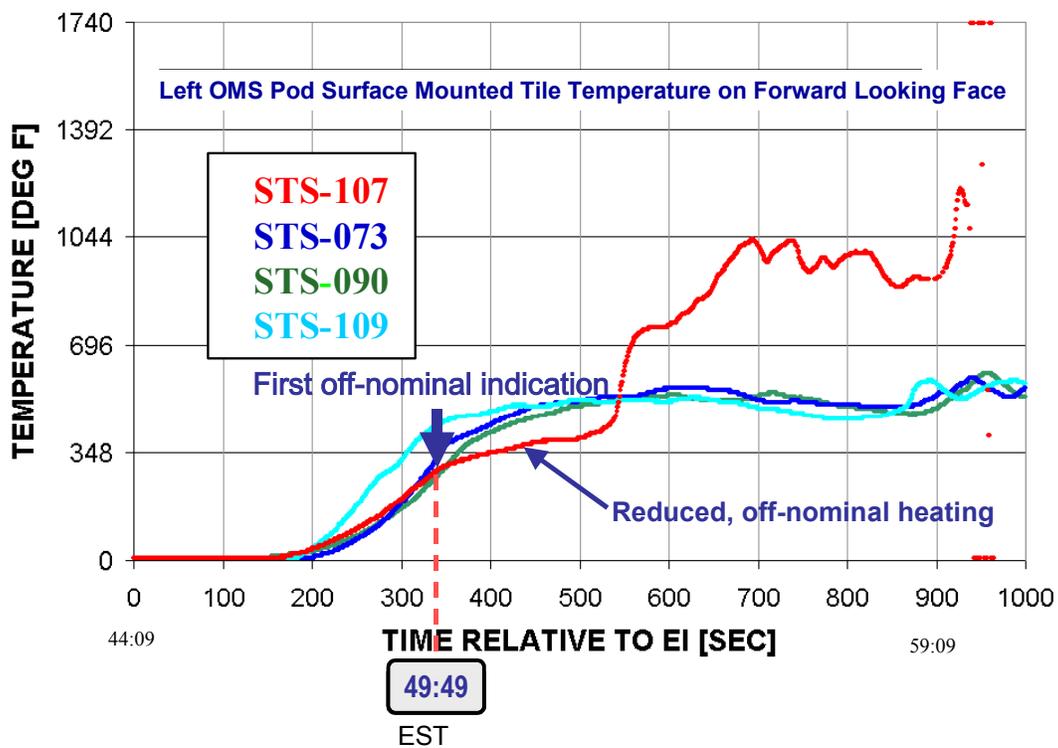
Columbia executed a nominal roll to the right at 8:49:32 EST (EI + 323 sec.) as the entry guidance software began to actively control energy (i.e., closed loop guidance) to land at KSC. This initial roll command is also timed to ensure atmospheric capture by reducing the lift on the vehicle. Within 17 seconds of this maneuver, at 8:49:49 EST (EI + 340 sec.), four left OMS pod surface temperature measurements showed an off-nominal trend with lower temperature rises when compared to similar Columbia missions. A sample of these measurements compared to other Columbia missions is shown in Figure 5-14, and the location of these measurements on the left OMS pod forward face can be found in Figure 5-15.

Figure 5-14. Typical off-nominal OMS pod thermocouple (V07T9220A)

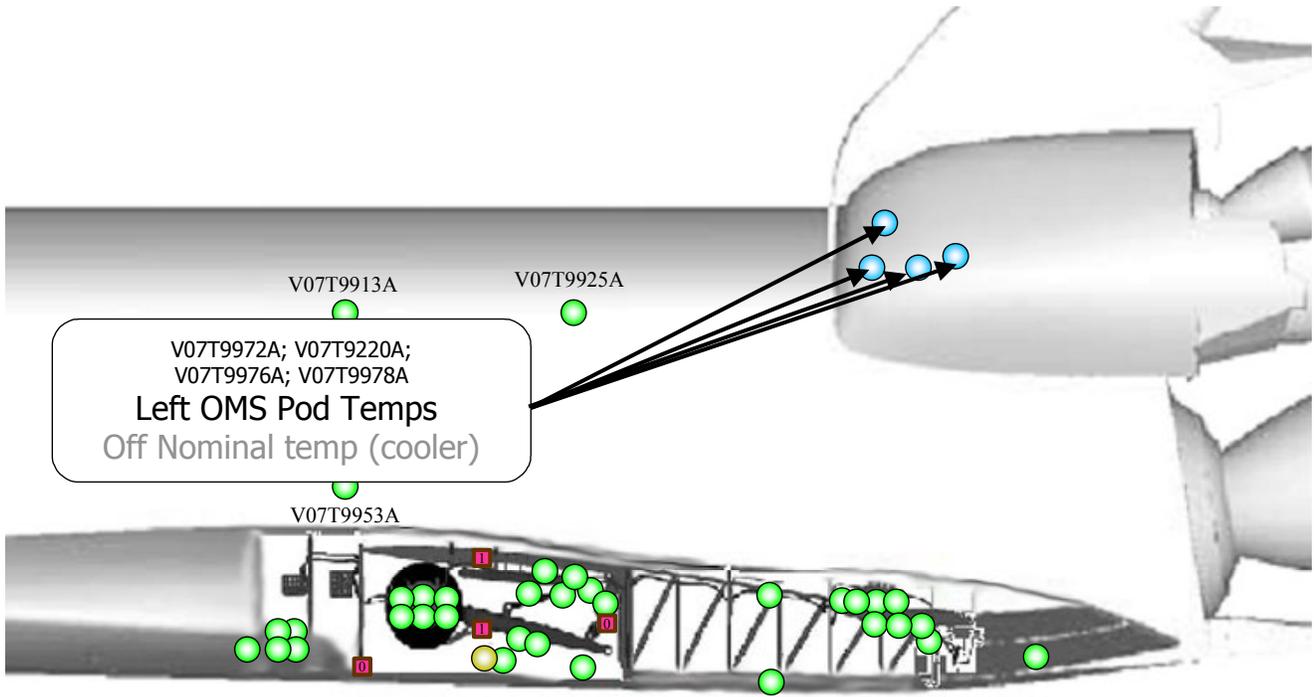
Figure 5-15. Location of OMS pod thermocouples off-nominal low

The reduced heating is not completely understood since the weak aerodynamic flow field on the upper surface of the orbiter is difficult to model and is extremely sensitive to disturbances. The best explanation for this reduced heating is that flow into the RCC cavity was venting through to the upper surface of the wing through an existing 0.1-inch vent between the RCC and upper surface carrier panels. This vent exists all along the leading edge from RCC panel 1 through panel 22 and has an approximate area of 66 square inches. This upper surface RCC venting and the flow disturbance created by the panel 8 and upper carrier panel 8 damage caused the vortices from the canopy or area where the wing meets the orbiter fuselage to move from their normal positions, thus reducing the heating on the OMS pod. Figure 5-16 depicts the change in the upper wing surface vortices and the weak upper surface flow.

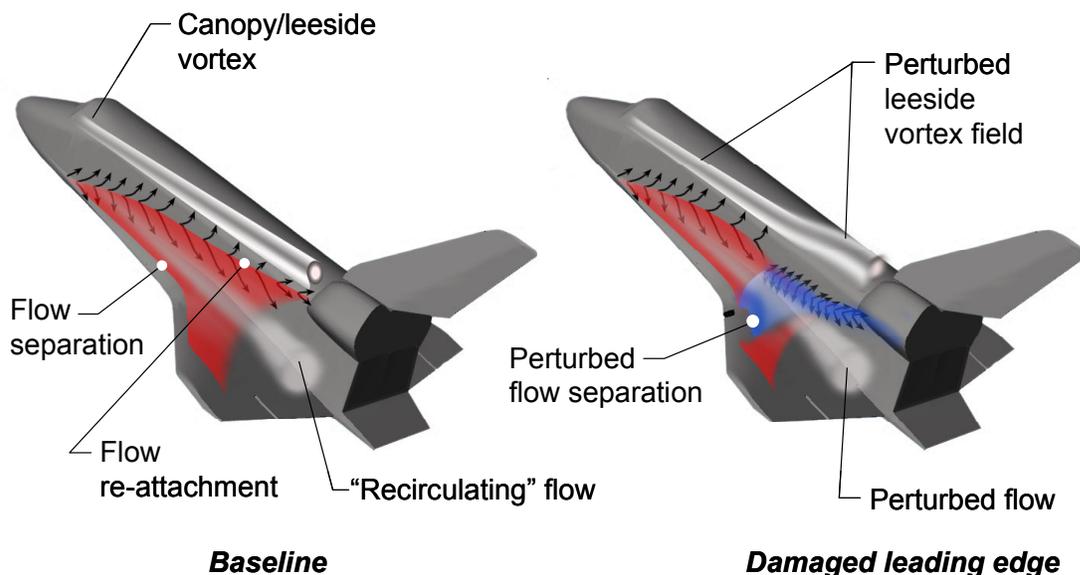
Figure 5-16. Postulated orbiter leeside flow field associated with wing leading edge damage

Wing leading edge damage perturbs leeward flow separation and re-attachment locations as well as leeward embedded shocks (not shown)

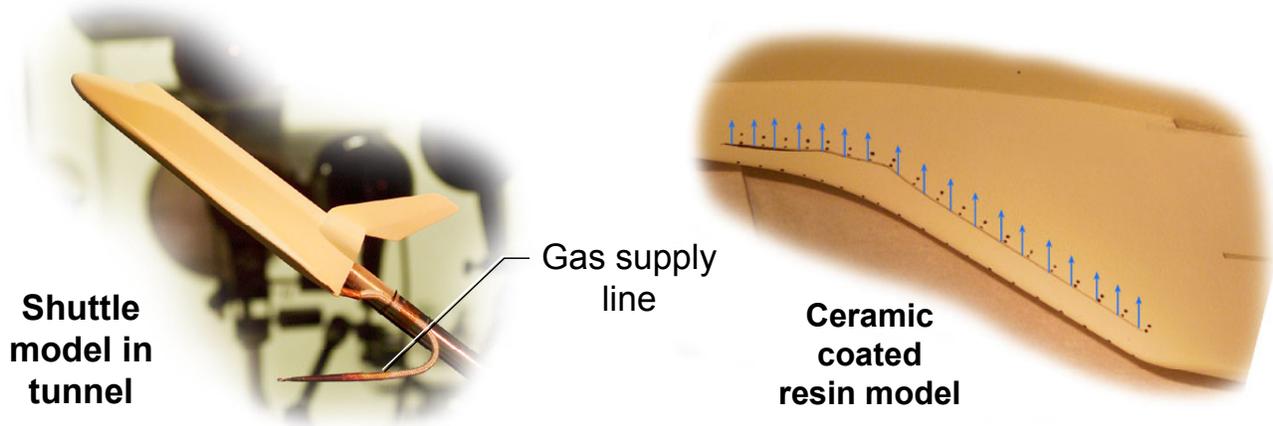
Figure 5-17. Orbiter wind tunnel model with vent gap along wing leading edge

In order to verify this theory of a weak upper surface flow being disturbed from venting on the upper surface, several wind tunnel tests were performed in the NASA Langley Research Center Mach 6 Tetrafluoromethane (CF₄) Wind Tunnel. The use of CF₄ as the gas for the flow analysis is required to best replicate the Mach number environment during this timeframe. These wind tunnel tests used a ceramic model and a 0.01-inch leading edge vent to mimic the postulated venting. Nitrogen gas was allowed to flow through this upper surface vent via a gas supply line. A picture of this model is shown in Figure 5-17. Results of this testing show that it is feasible to obtain reduced heating on both the left OMS pod and the left fuselage as a result of flow through the RCC upper surface vent. Figure 5-18 shows the change in heating as the vent velocity is altered.

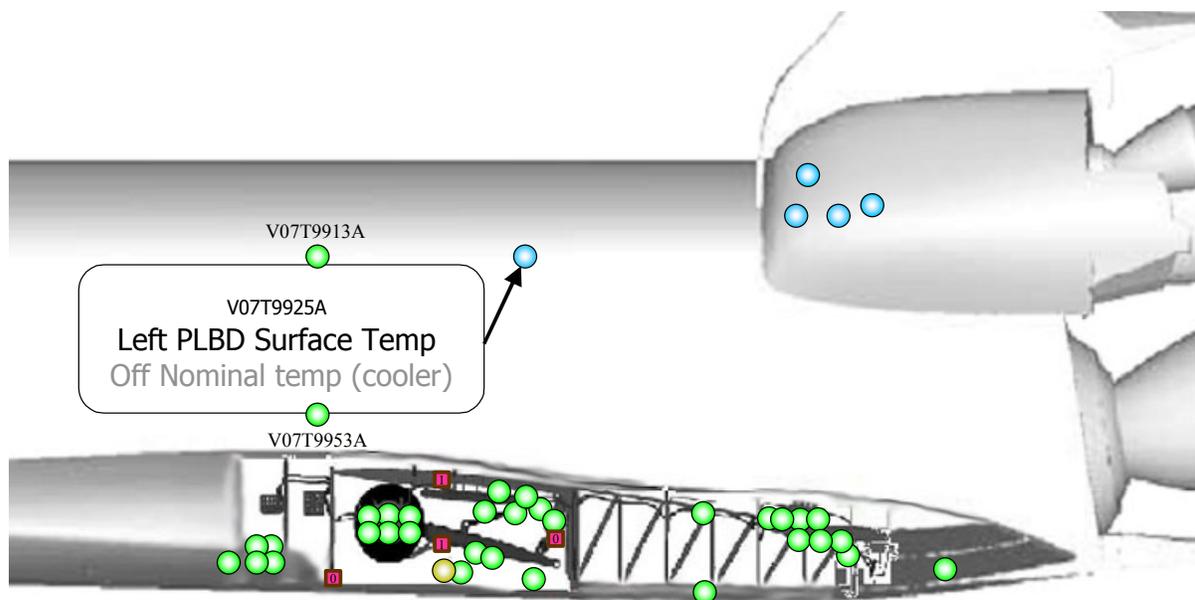
Figure 5-19. Location of left sidewall temperature sensor

In the same timeframe, at 8:50:09 EST (EI + 360 sec.), a left payload bay fuselage MADS surface temperature measurement (Figure 5-19) showed an off-nominal temperature trend. This trend is a reduced rise rate when compared to other previous Columbia missions, as shown in Figure 5-20. The previously discussed theory of venting and or disturbed flow due to panel 8 damage, causing a shift in the vortices on the upper surface of the wing, is also believed to be the cause of this off-nominal behavior. The flow field and venting on the upper surface rate are constantly increasing since the mass flow rate into the RCC breach is increasing as the orbiter descends lower into the atmosphere.

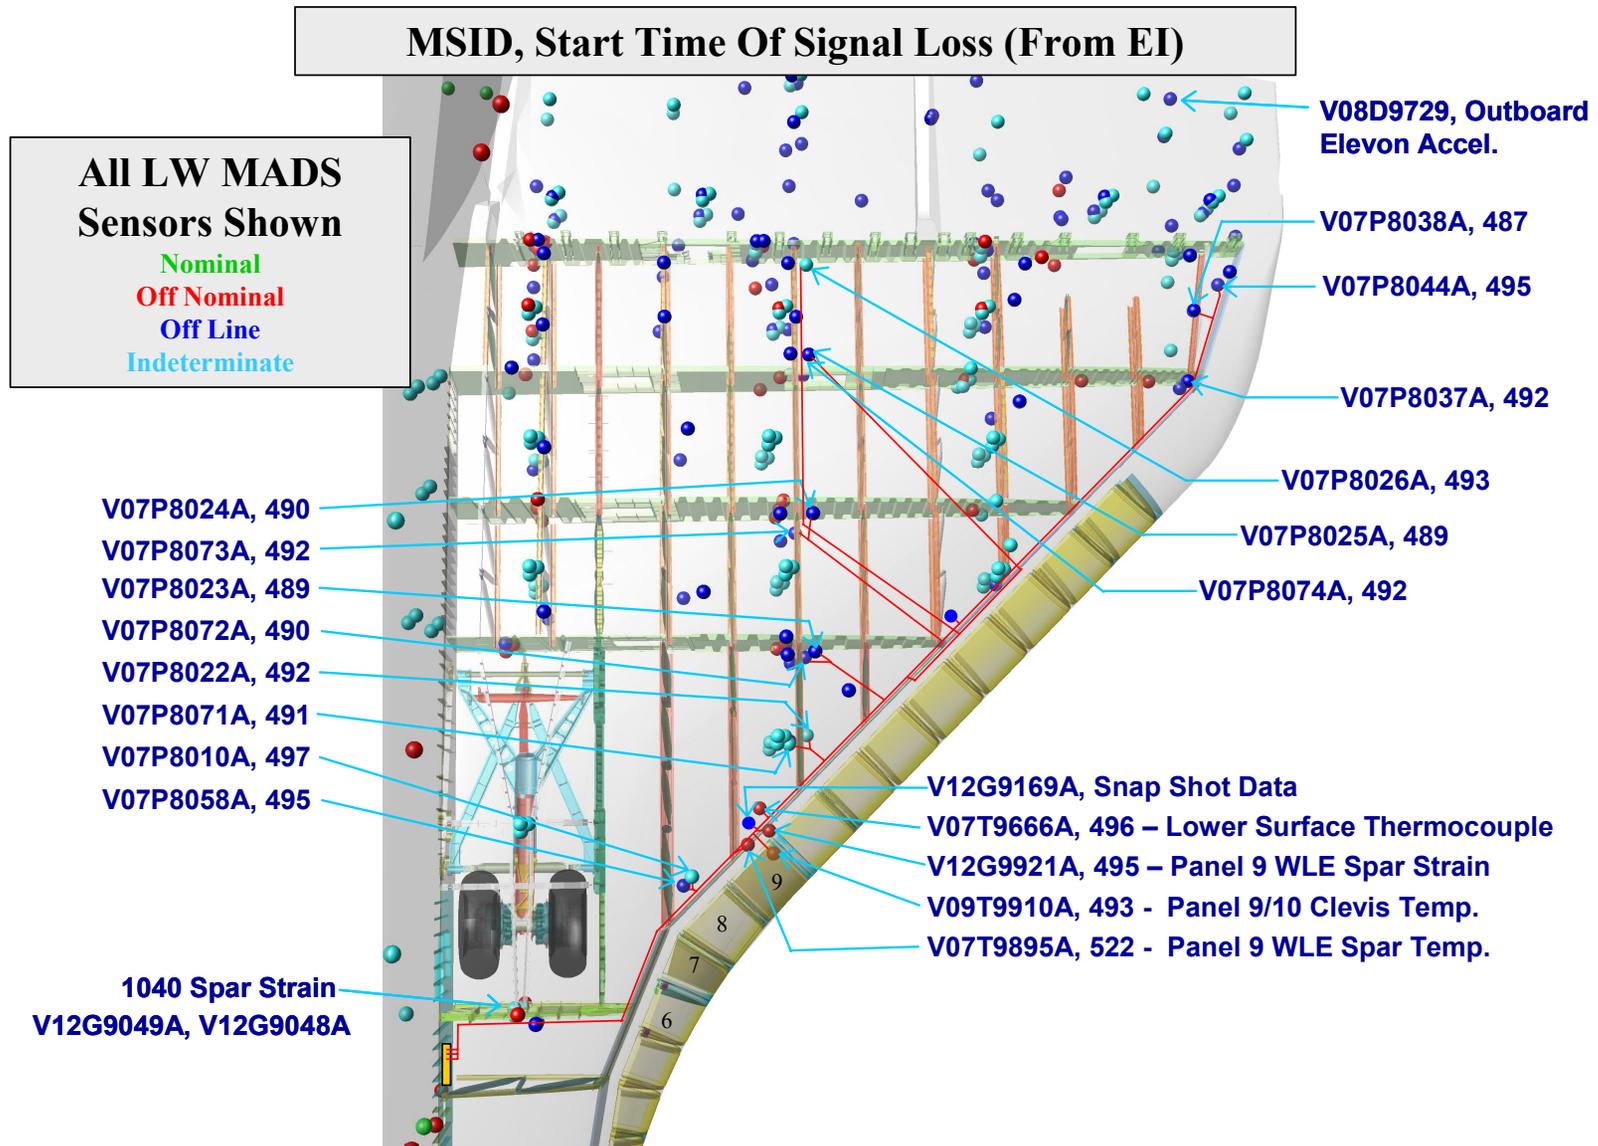
Figure 5-22. Left wing MADS sensors, including Measurement Stimulation Identification (MSID) number, and start time of loss of signal (EI + sec.)

At 8:50:19 EST (EI + 370 sec.), a lower surface thermocouple showed signs of off nominal, increased heating. The best explanation for the increased heating in this area is severely disturbed, turbulent flow caused by the leading edge damage on the bottom of RCC panel 8 and flow from the lower corner of this panel as discussed in Section 5.3. Langley Research Center wind tunnel testing has confirmed that wing leading edge damage (notch or protuberance) near panel 8 will cause increased heating to the lower wing surface. As previously discussed, the eroded lower carrier panel tiles on panel 9 indicate this strong flow from panel 8. This is consistent with flow patterns observed on many recovered lower surface wing acreage tiles along the flow lines aft of the RCC panel 8 area. Figure 5-21 shows this temperature response as compared to other Columbia missions. The location of the sensor can be seen in Figure 5-22.

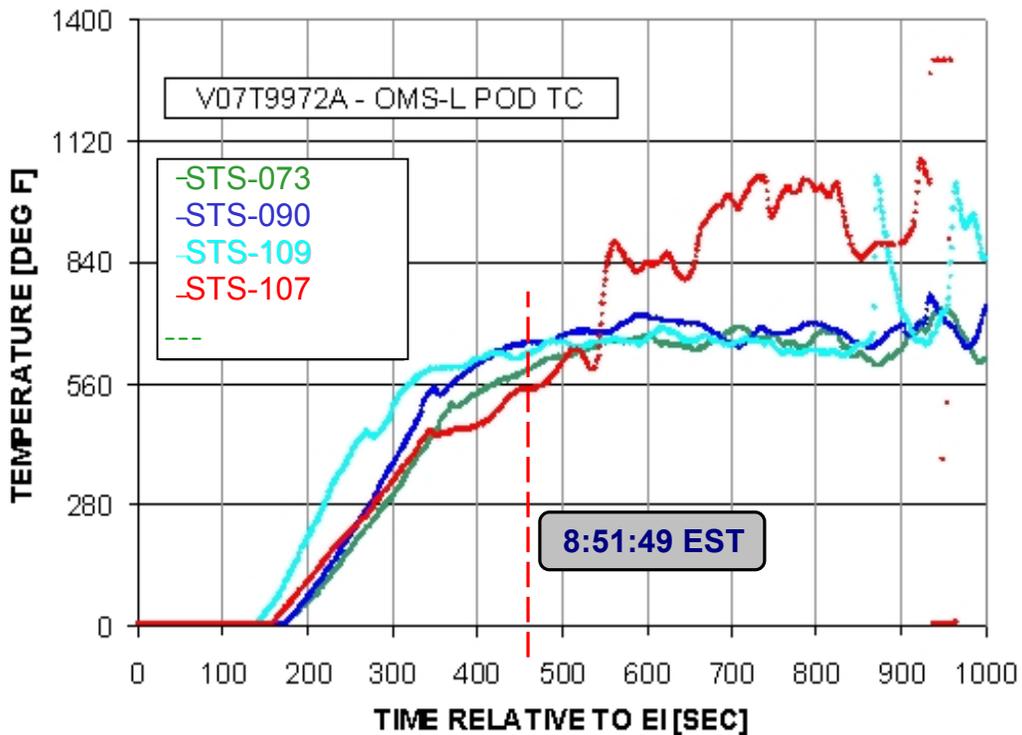
Figure 5-24. Off-nominal low OMS pod thermocouple (V07T9972A)

At 8:51:49 EST (EI + 460 sec.), one of the left OMS pod measurements (V07T9972A) began to show an increased temperature rise, indicating that the upper surface flow has changed again. This is shown in Figure 5-24 along with this measurement on other Columbia missions. It is evident that the measurement rises to a higher temperature and at a faster rate than has been observed on previous missions within the next few minutes. Figure 5-25 shows other left OMS pod and fuselage temperature measurements that exhibit an off-nominal rise later in time. The sensor locations on the left side of the orbiter are also shown in Figure 5-25.

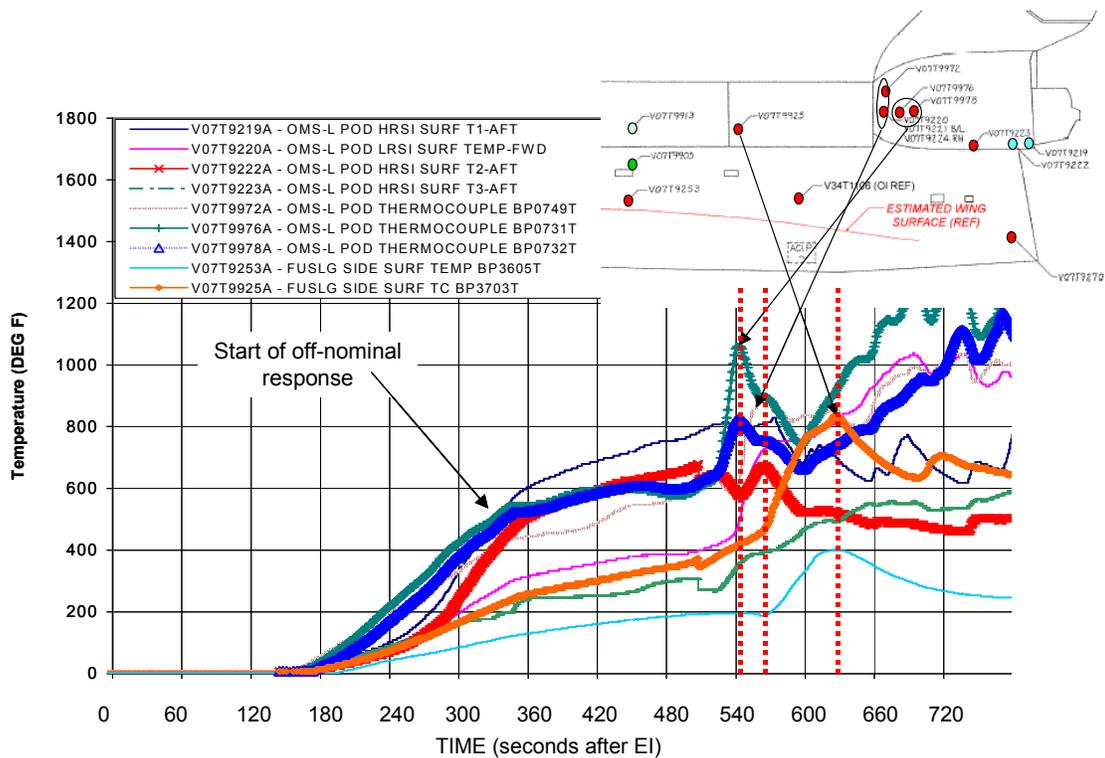
Figure 5-25. Left side fuselage/OMS pod off-nominal responses indicate increased heating

These off-nominal temperature rises were caused by a change in the flow field along the upper portion of the left wing as the wing leading edge (WLE) and wing spar damage progressed. The mechanism was a shift in the vortices due to venting on the upper portion of the wing and is similar to the previous discussions on lower than expected OMS pod temperatures. Wind tunnel testing and CFD analysis confirmed that WLE damage on RCC panels 8 and 9 could cause increased heating to the OMS pod due to disturbed upper surface flow or flow impingement caused by re-directed flow from the lower surface. Additionally, the molten Inconel 718 and A-286 spray onto this area are indications that this flow is the cause of these temperature rises. Figure 5-26 (from wind tunnel test results) is a representative example of increased heating on the left fuselage and OMS pod due to RCC panel 9 damage from wind tunnel test results. Figure 5-27 shows a similar picture of the left side as determined by CFD analysis. Note that neither the wind tunnel testing nor the CFD analysis accounts for increased heating that is likely due to molten metal contacting the OMS pod.

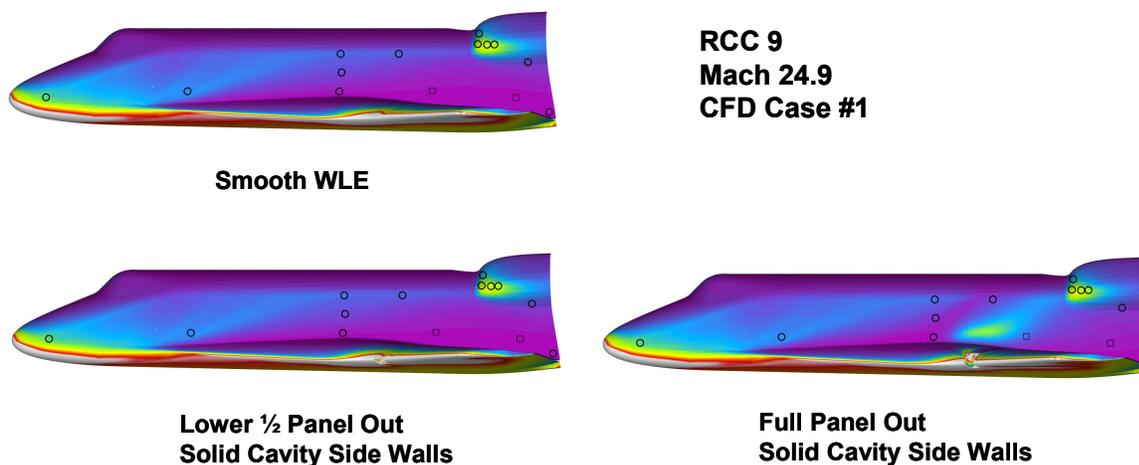
Figure 5-27. CFD results for no damage, partial damage, and full damage to RCC panel 9 show increased heating on side fuselage and OMS pod

The increased heating implies that damage/erosion to the RCC panel 8 area had increased or that at least one carrier panel had been lost. The increased heating is also consistent with an increased mass flow rate due to the nature of the entry environment. The dynamic pressure and stagnation heat flux had more than doubled by this timeframe when compared to a few minutes after EI. There are three additional communication dropouts that follow at approximately 8:52:09 EST to 8:52:31 EST (EI + 480 to 502 sec.). Again, these dropouts are consistent with molten aluminum and other metals being released into the environment surrounding Columbia.

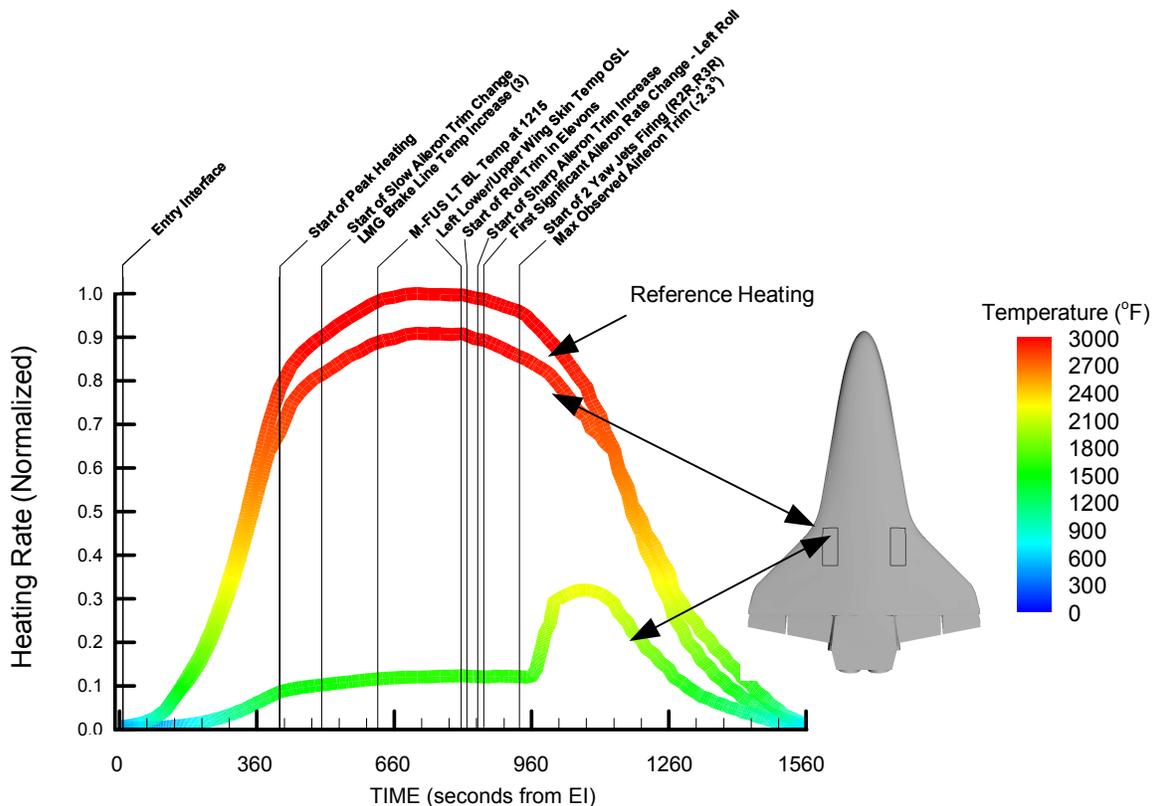
Figure 5-28. STS-107 entry heating rate profile

The next significant event was a breach through the left wing leading edge spar leading to many wire measurement failures and eventual deformation of the left wing. As discussed in Section 5.4.2, by approximately 8:52:00 EST (EI + 471 seconds), strain and temperature measurements indicated that hot gas had begun to weaken the wing spar. Figure 5-28 shows that the orbiter has entered the peak-heating region during this timeframe and would remain there for many of the ensuing events that will be discussed later.

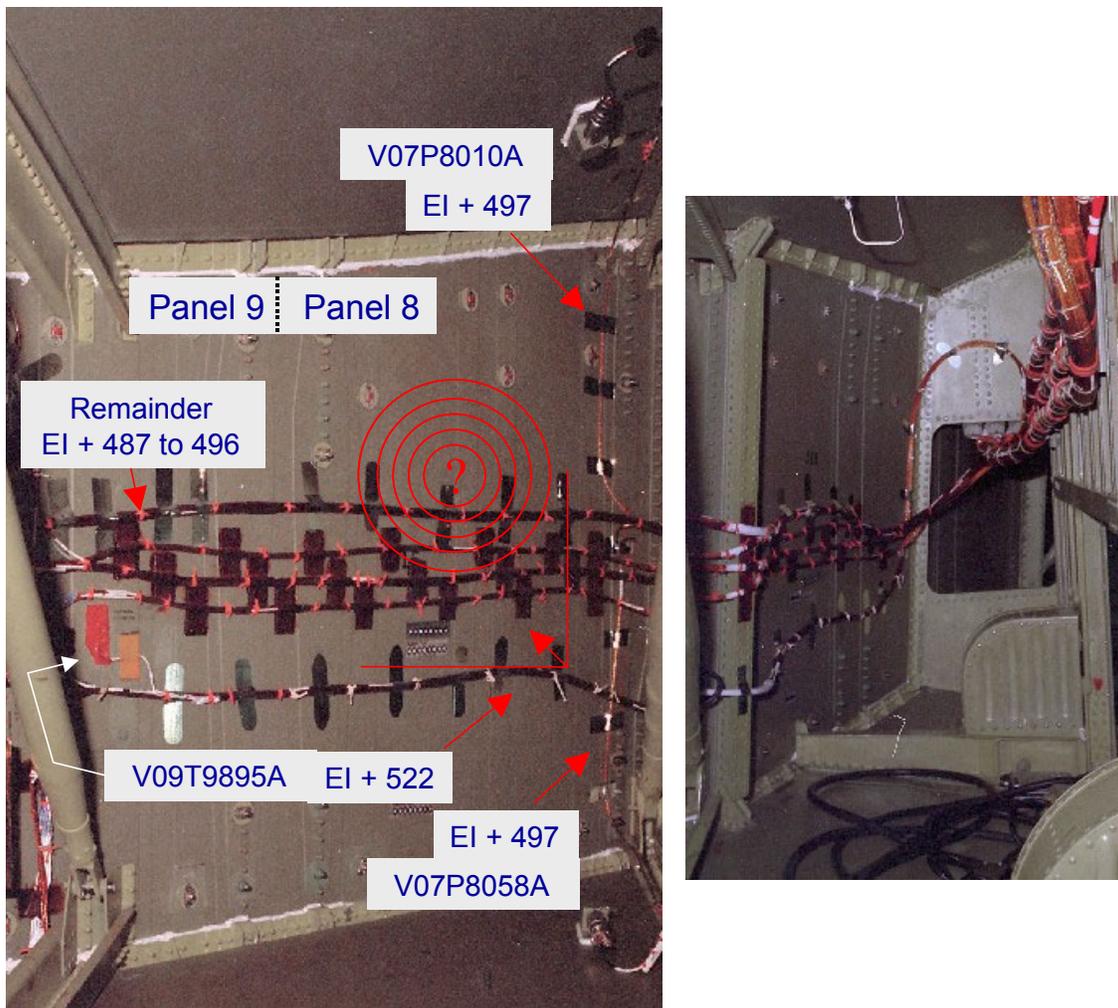
Figure 5-29. Cable routing on wing leading edge and wheel well wall

The final technique used was an examination of the wire failures on the wing leading edge spar. These wire runs are shown in Figure 5-29. The first measurement loss was a MADS upper left wing pressure measurement, which failed at approximately 8:52:16 EST (EI + 487 sec.). This measurement is contained in the upper wire bundle in the left photo in Figure 5-29. The combination of these three separate and distinct analyses results in a range of wing spar breach times as early as 8:51:14 EST and as late at 8:52:16 EST (EI + 425 to 487 sec.).

Immediately after the breach, hot gas inside the wing began to heat the remaining wire bundles that contained real-time telemetry and the recorded MADS measurements. Figure 5-29 shows an inside-the-wing view of the approximate breach location based on this wire failure analysis. The view on the left is of the panel 8/9 spar location. This area is not visible in the right photo, which contains the transition spar and a view of the three wire bundles along the outside of the wheel well wall. Figure 5-31 shows the overall spar breach location with respect to the rest of the wheel well. The distance from the spar to the wheel well wall in this area is approximately 56 inches, as shown in Figure 5-32. Figure 5-33 shows a sketch of the venting of the left wing into the payload bay, driving the direction of the internal flow depicted in Figure 5-31. Note the 142 square inch vent into the midbody fuselage located forward of the wheel well.

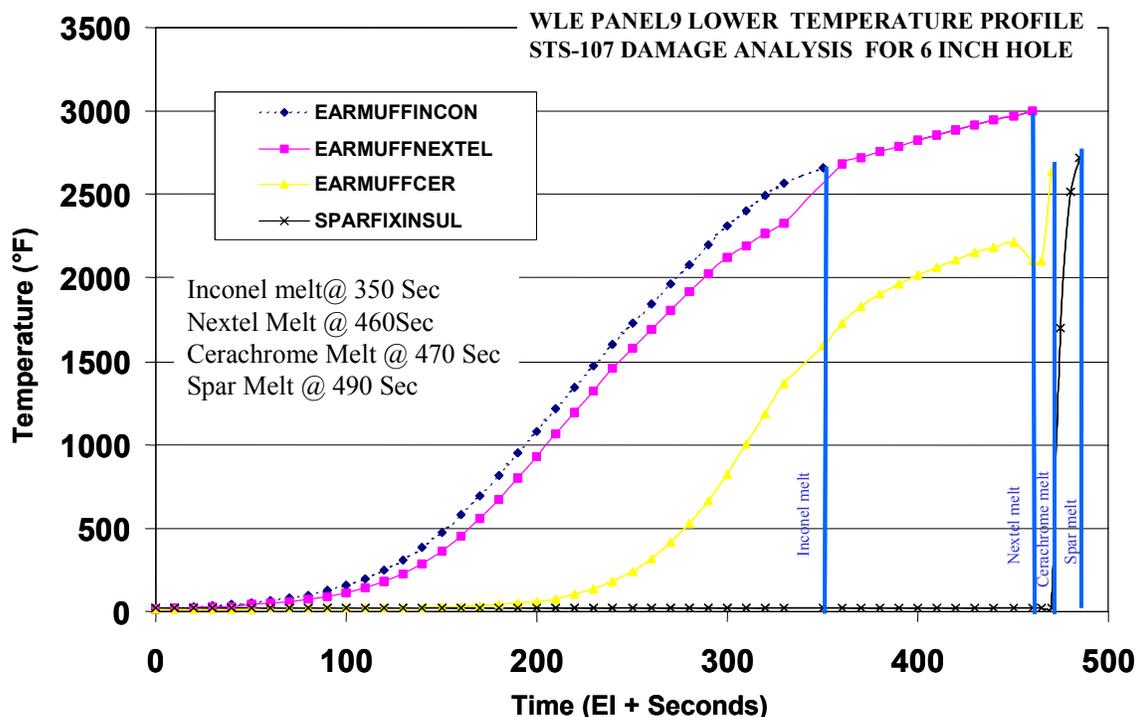
Figure 5-30. Thermal model prediction of wing spar burn through

The second technique used a detailed thermal model to determine the time required to burn through the various insulations immediately in front of the wing leading edge spar (Inconel, Nextel, Cerachrome) and then the honeycomb spar. This model assumed the equivalent heating of a six-inch diameter hole in the bottom of RCC panel 8. Using the expected aero heating rate and the various material properties, the spar burn through occurred at 8:52:19 EST (EI + 490 sec.). This time would be accelerated slightly for a larger diameter hole. The results of this thermal model are shown in Figure 5-30.

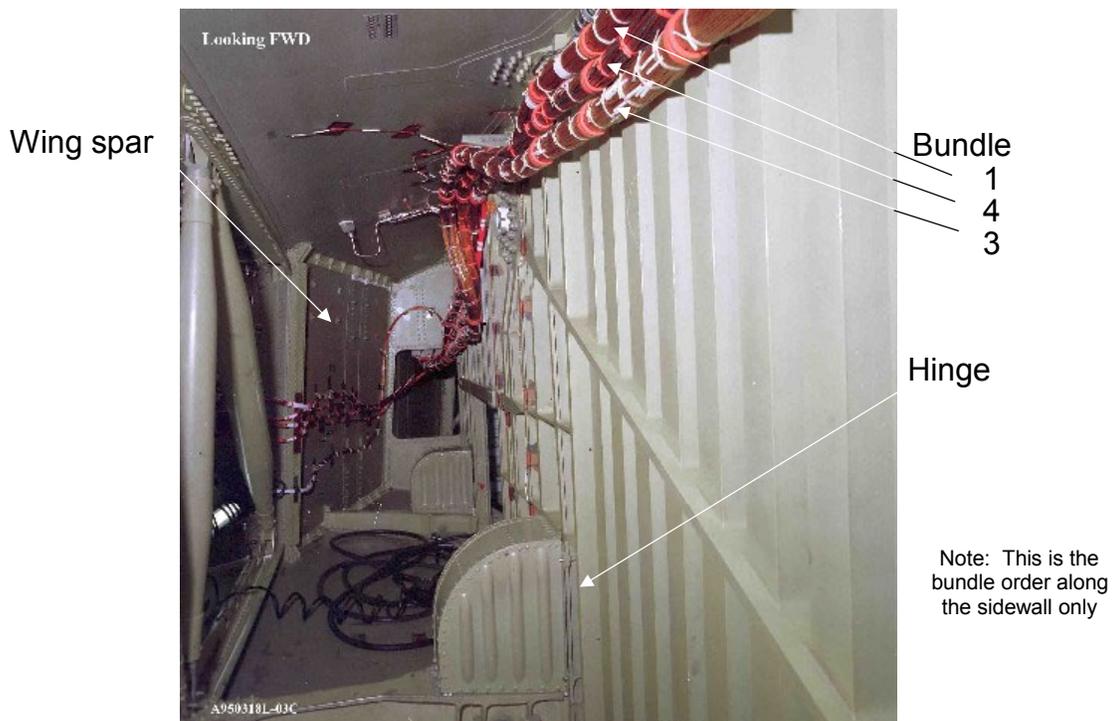
Figure 5-35. View of cables running along outside of wheel wall cavity bulkhead

Four additional measurements failed after 8:54:16 EST (EI + 605 sec.) with the last starting to fail at 8:56:24 EST (EI + 735 sec.). This last measurement failure took over a minute to fail completely. Figure 5-34 and Figure 5-35 show the measurement loss timing and the wire bundle runs along the wheel well. Although almost all measurements internal to the wing failed, two strain measurements on the 1040 spar (forward of the wheel well) were unaffected and produced data until loss of all MADS data at 9:00:13 EST (EI + 964 sec.). Figure 5-36 shows the location of the sensors on the forward wheel well spar. The fact that these measurements are available until loss of data are important indicators that the RCC breach could not be forward on the panel 6 area since these measurements would have been lost as well (see Figure 5-32). These measurements also record key changes in strain that help indicate some of the changes that the left wing underwent as the remainder of the entry events unfolded.
