COLUMBIA ACCIDENT INVESTIGATION BOARD (CAIB)/
NATIONAL AERONAUTICS AND SPACE ADMINISTRATION (NASA)
ACCIDENT INVESTIGATION TEAM (NAIT)

WORKING SCENARIO

FINAL VERSION: JULY 8, 2003

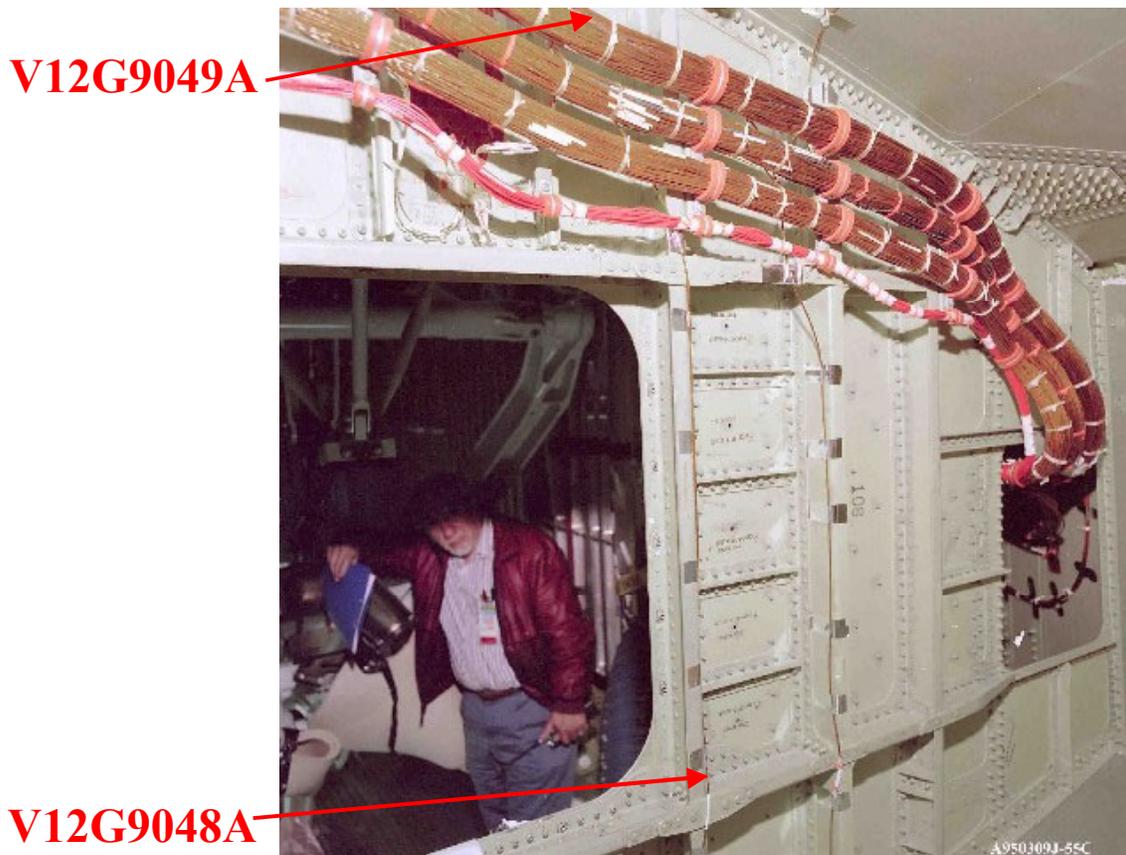
Figure 5-36. Strain measurements on 1040 spar

Four additional measurements failed after 8:54:16 EST (EI + 605 sec.) with the last starting to fail at 8:56:24 EST (EI + 735 sec.). This last measurement failure took over a minute to fail completely. Figure 5-34 and Figure 5-35 show the measurement loss timing and the wire bundle runs along the wheel well. Although almost all measurements internal to the wing failed, two strain measurements on the 1040 spar (forward of the wheel well) were unaffected and produced data until loss of all MADS data at 9:00:13 EST (EI + 964 sec.). Figure 5-36 shows the location of the sensors on the forward wheel well spar. The fact that these measurements are available until loss of data are important indicators that the RCC breach could not be forward on the panel 6 area since these measurements would have been lost as well (see Figure 5-32). These measurements also record key changes in strain that help indicate some of the changes that the left wing underwent as the remainder of the entry events unfolded.

A comprehensive evaluation of all MADS measurement failures in the left wing was performed to attempt to determine the spar breach progression. Each measurement's failure signature was evaluated to determine both the start time of the failure and when the wire failure was complete. As the wire burns, the short between the twisted pairs of wiring increases thereby producing the time delay effect between failure initiation and complete failure. Eighteen measurements routed on the wing leading edge and over 100 measurements in three wire bundles routed on the outboard side and external to the wheel well were used for this assessment. Seventeen of the 18 wing leading edge measurements failed in 10 seconds starting at 8:52:16 EST (EI + 487 sec.). No other MADS measurements failed during this time. The one measurement that did not fail in this time span was located in the bottom of five harnesses on the WLE. The remaining 17 measurements are in the upper four harnesses with the majority being in the top harness. This would indicate that the spar breach started near the top wire bundle and worked toward the bottom of the spar. Additionally, two of the 18 measurements join the harnesses at the panel 7 to 8 interface, making the wing spar breach outboard of panel 8 very unlikely.

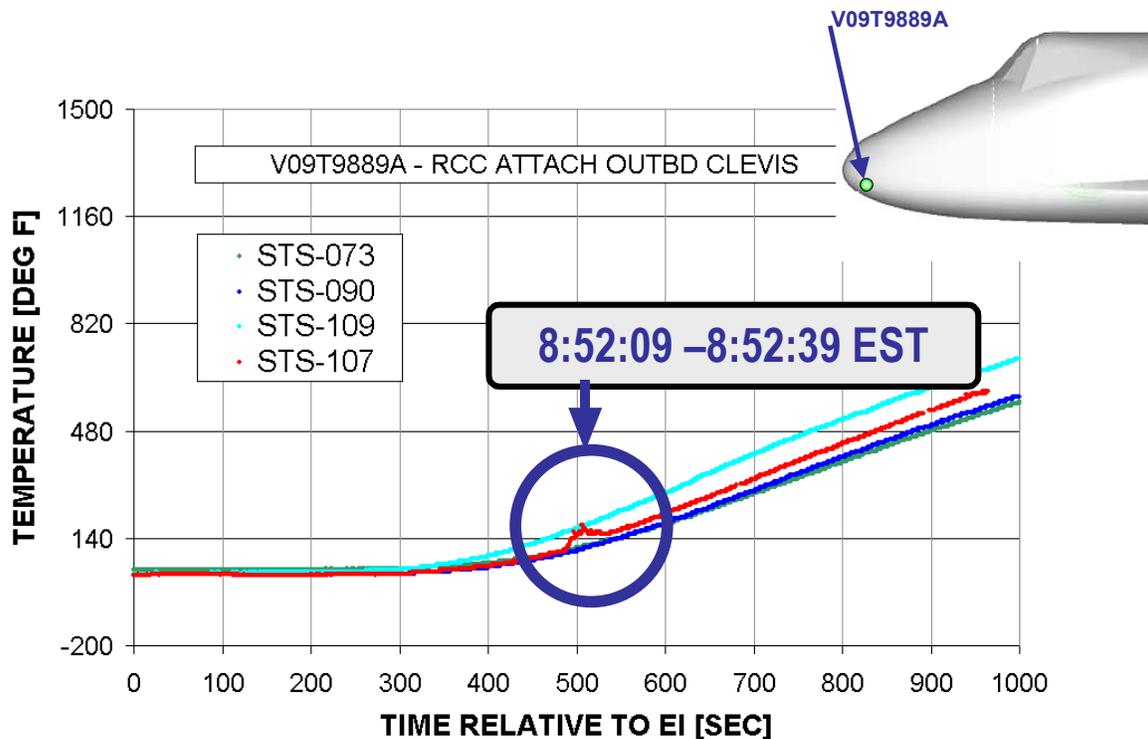
Figure 5-37. Off-nominal temperature rise rate in nose cap RCC attach clevis

Coincident with the spar breach at approximately 8:52:09 EST (EI + 480 sec.), the nose cap RCC attach clevis temperature had an off-nominal change in rise rate when compared to previous missions. This rise rate was abnormal for approximately 30 seconds and ended at 8:52:39 EST (EI + 510 sec.). The exact cause of this abnormal temperature rise is not known, but the timing is coincident with the breach of the wing leading edge spar. An explanation is that the abnormal rise is an instrumentation anomaly caused by multiple wire failures in this timeframe. This measurement response is shown in Figure 5-37 along with the same measurement for several other Columbia missions. This figure also shows the location of this internal nose cap measurement on the very forward portion of the left fuselage.

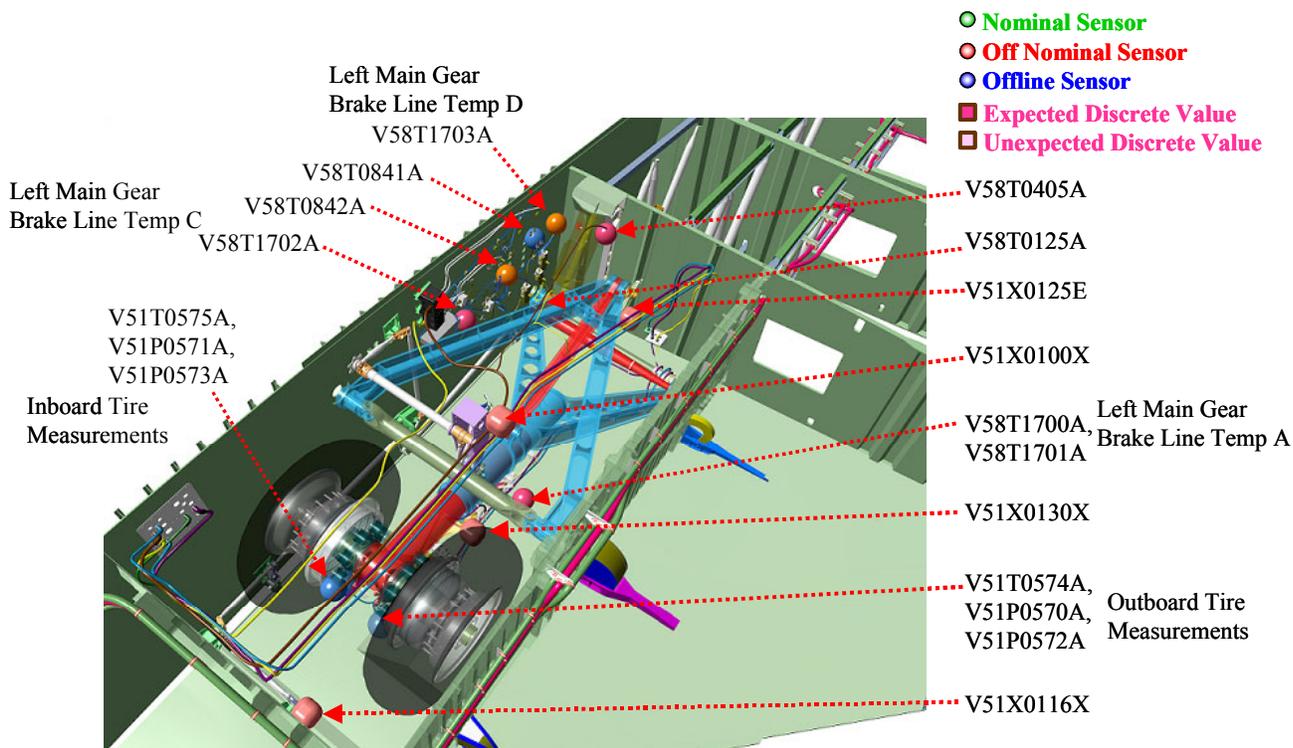
Figure 5-38. Location of sensors in the LH wing wheel well

Until approximately 8:52:17 EST (EI + 488 sec.), there was no indication of any off-nominal situation that could be observed by the MCC or the crew in real-time. The flight control response and all orbiter telemetry measurements were nominal. The first indication of any anomalous Operational Instrumentation (OI) was a small increase in the left main gear brake line temperature D measurement at this time (see Figure 5-38). Within one second of this time, there is a lower 1040 spar (forward wall of the wheel well) strain measurement that shows an off-nominal increase in strain (see Figure 5-39). These are both indications that the breach in the wing leading edge spar had allowed hot gas to reach the wheel well area, most likely through vent paths around the hinge covers, which allowed hot gas into the wheel well cavity.

At the same time as the stress was relieved on the lower 1040 spar, two left main gear outboard tire pressures began trending toward an off-scale low reading. This was preceded by a slight upward trend at 8:57:19 EST (EI + 790 sec.) for both pressure measurements. This is an indication of extreme heating of both the left outboard tire and the surrounding instrumentation. The tire has significant thermal mass and substantial heating would be required to produce the slight temperature rise. By 8:58:56 EST (EI + 887 sec.), all left main gear inboard and outboard tire pressure and wheel temperature measurements were lost indicating a rapid progression of damage or wire burning inside of the wheel well. Figure 5-38 shows the location of these pressure sensors.

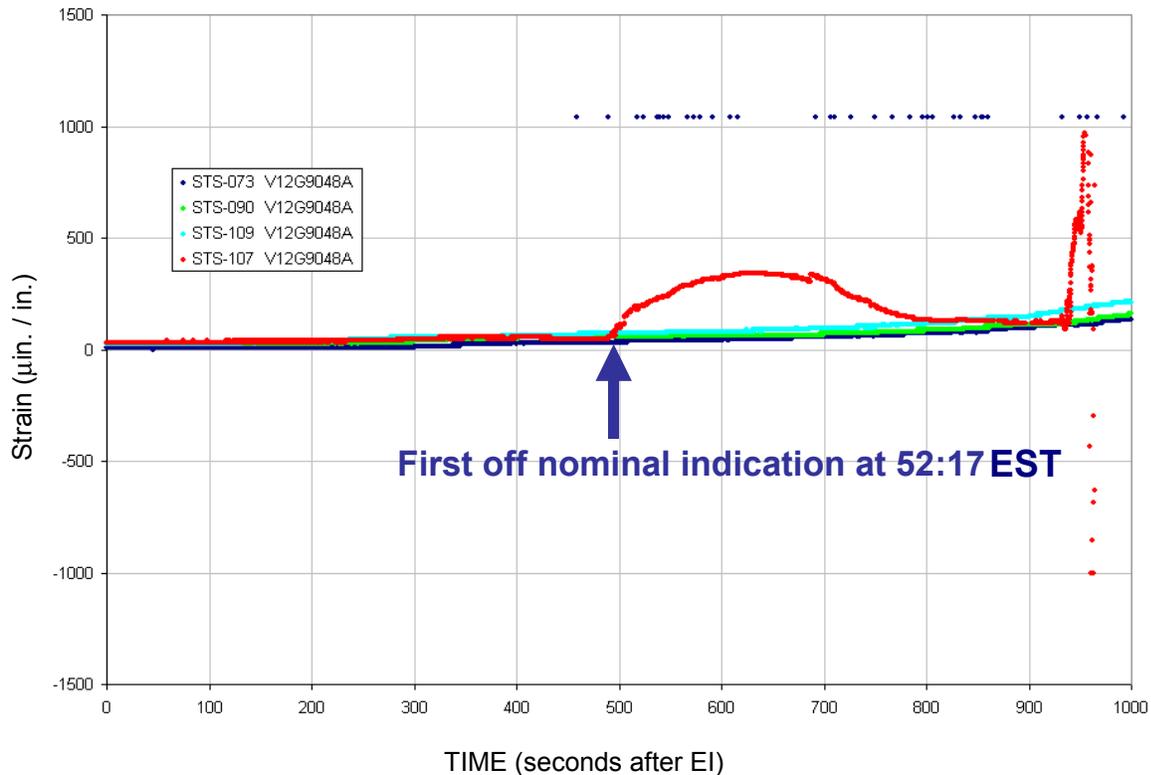
Figure 5-39. Strain rise in lower 1040 spar cap

At 8:58:32 EST (EI + 863 sec.), there was a change in stress measured on the left wing 1040 spar (main landing gear forward wall spar), as indicated by strain gauge measurements that began trending up at 8:52:18 EST (EI + 489 sec.). At 8:58:32 EST (EI + 863 sec.) the lower cap strain (near the bottom of the 1040 spar) essentially returned to a normal measurement when compared to previous flights (see previous Figure 5-39). The upper strain measurement continued to increase during this timeframe indicating that the heating was different on the upper and lower portions of the wheel well and 1040 spar. Although the response of the 1040 spar strain is not completely understood, structural analysis indicates that the strain response can be completely explained by thermal stresses caused by severe heating of the wheel well wall and internal wing components.

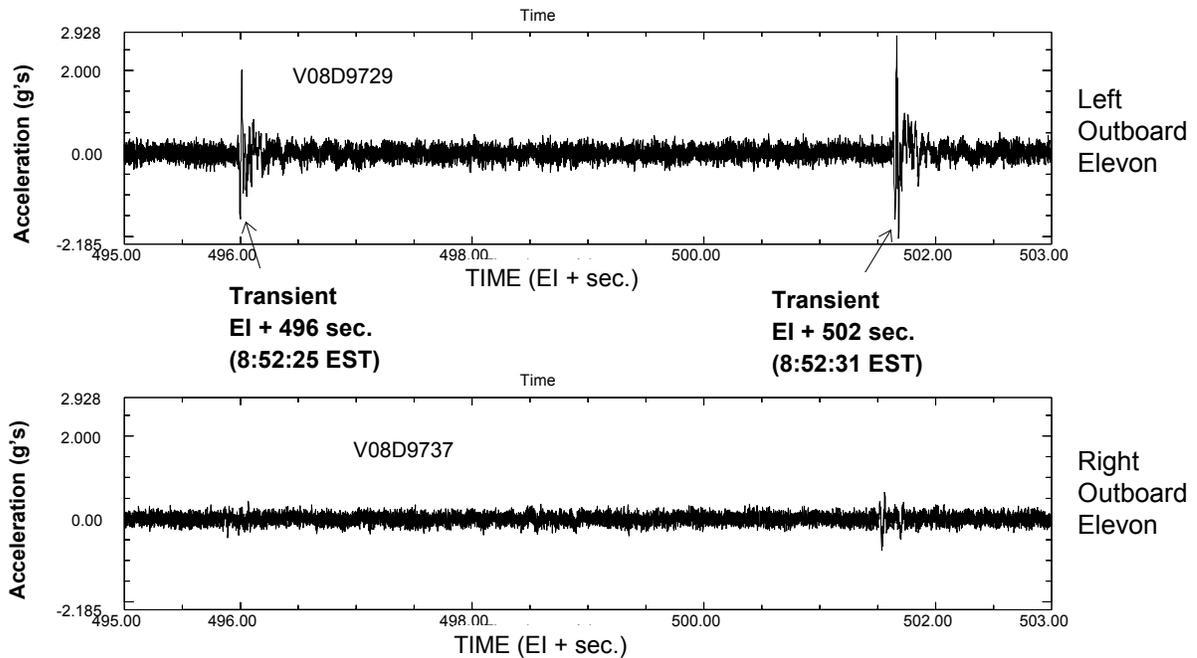
Figure 5-40. Outboard elevon accelerometer responses at 8:52:25 and 8:52:31 EST (EI + 496 and 502 sec.)

At approximately 8:52:25 EST (EI + 496 sec.), the left outboard elevon wideband accelerometer showed an unusual 2 g peak-to-peak acceleration (see Figure 5-40). This is consistent with the timing of the many wire failures within the left wing and the timeframe when the spar breach occurs. Additionally, there are two unexplained communication dropouts in this same timeframe. Another 3 g peak-to-peak acceleration anomaly was observed at 8:52:31 EST (EI + 502 sec). Additional temperature measurements (left main gear brake line temp A and C) in the wheel well area (see Figure 5-38) began an off-nominal rise at 8:52:41 EST (EI + 512 sec.).

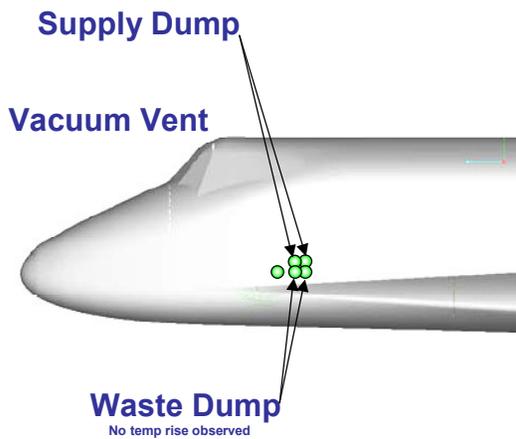
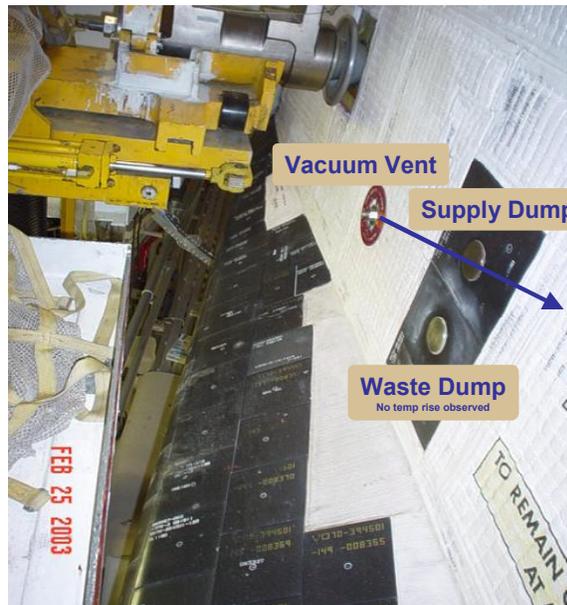
Figure 5-41. Location of supply dump and vacuum vent nozzles

The elevon response event was followed by a change in the rise rate for two supply nozzle temperatures and the vacuum vent nozzle temperatures at 8:52:32 EST (EI + 503 sec.). The off-nominal rise rate occurred for approximately 15 seconds for the supply nozzle temperatures and 23 seconds for the vacuum vent temperatures. The location of these nozzles on the left side of the fuselage is shown in Figure 5-41, and the arrow indicates that they could have been located along a line of disturbed flow. The short, abnormal rise rate is unexplained, has not been observed on any previous Shuttle missions, and may not be associated with the upper wing disturbed flow caused by the leading edge damage. Unlike the RCC nose cap clevis temperature, the instrumentation appears to have been valid for both nozzles. Plots of this off-nominal temperature rise for one of the supply nozzle temperatures and the vacuum vent nozzle are shown in Figure 5-42.

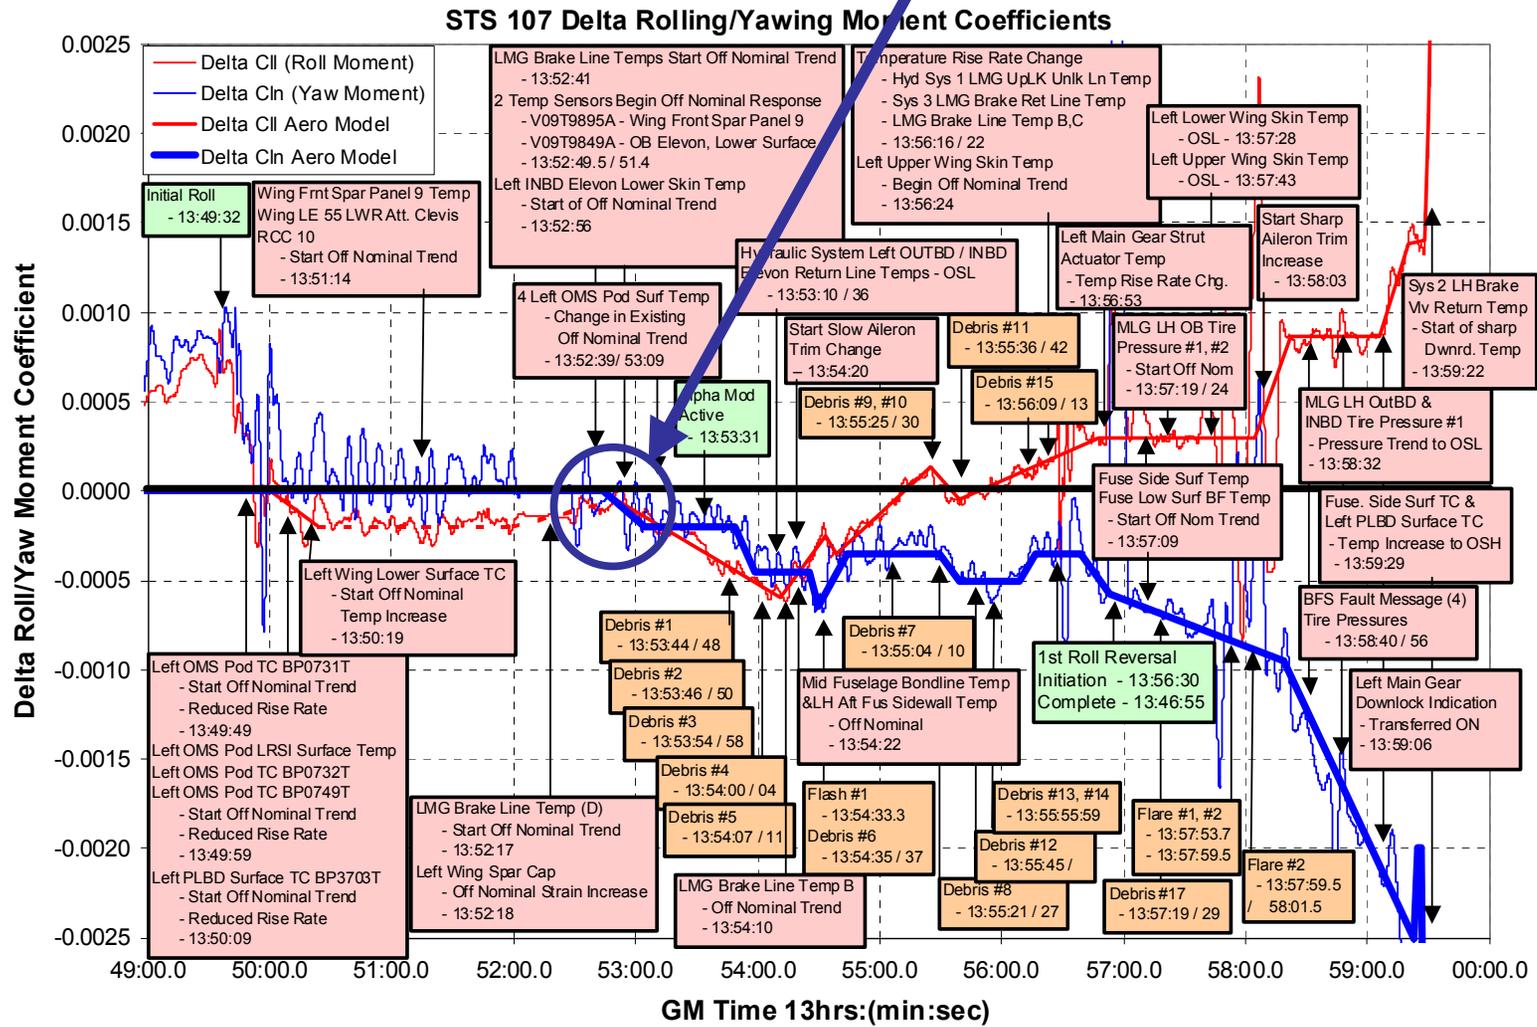
Figure 5-43. First noted off-nominal aero event (Greenwich Mean Time, GMT, is EST + 5 hours)

Immediately following these events, at 8:52:44 EST (EI + 515 sec.), the aerodynamic roll and yaw coefficients that have been extracted from the flight data showed a slight negative trend (see Figure 5-43). This is indicative of more drag and decreased lift on the left wing.

Hypersonic wind tunnel tests indicate that both the slight negative roll and yaw deltas can be explained by leading edge damage in the lower half of RCC panel 8. This will be discussed in more detail in Section 5.4.5.

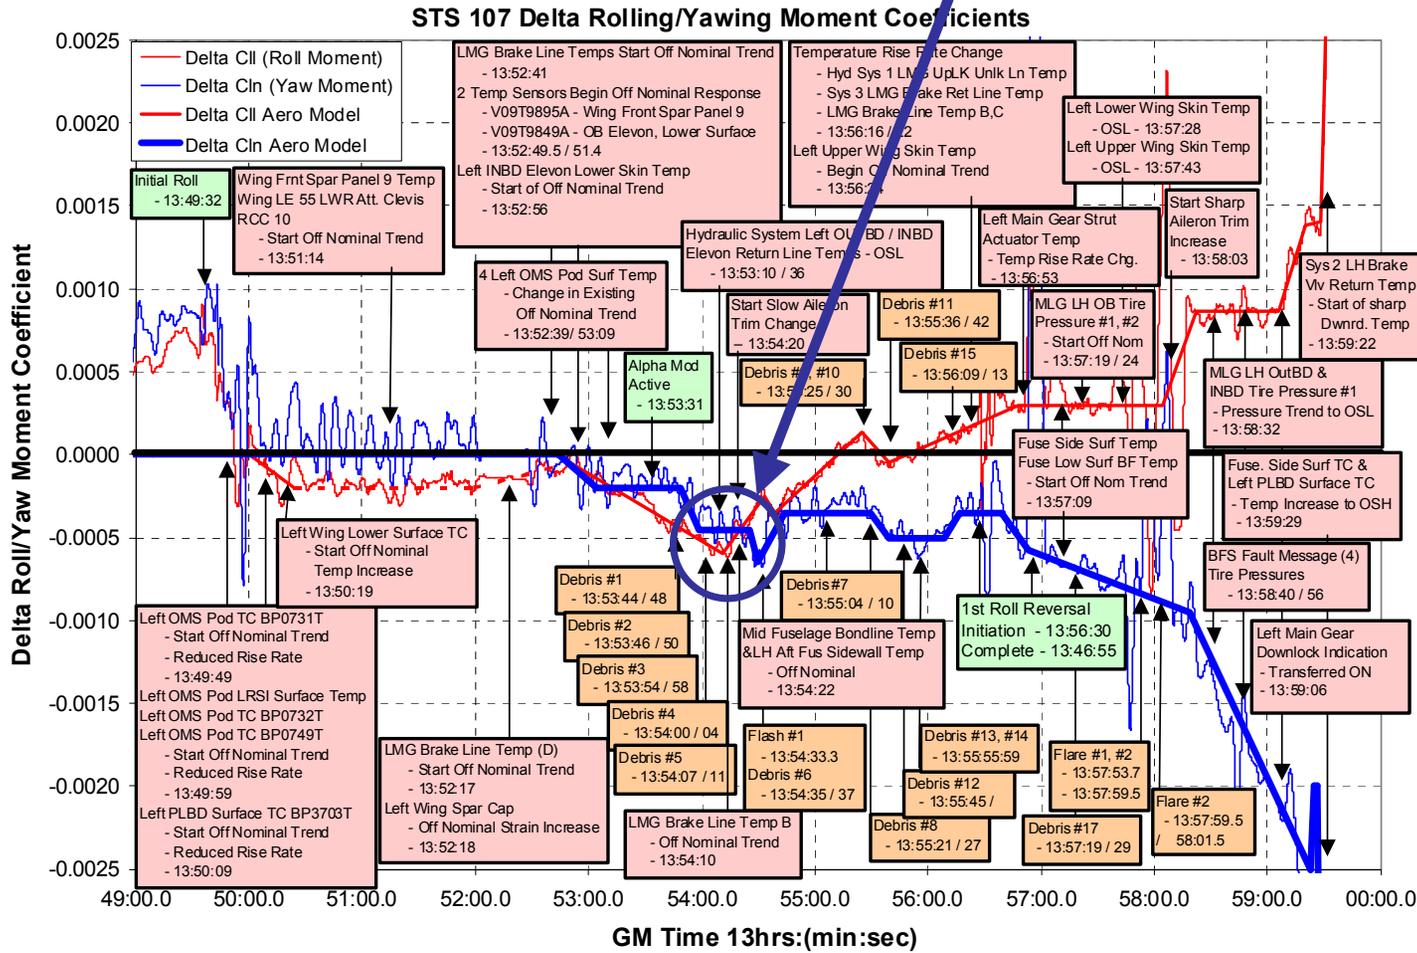
Figure 5-44. Sharp change in rolling moment (GMT is EST + 5 hours)

In the 8:54:10 to 8:54:35 EST (EI + 601 to 626 sec.) timeframe, several key events occurred. The first event at 8:54:10 EST (EI + 601 sec.) was an indication that the temperatures in the wheel well had a greater rise rate, indicating the sneak flow or breach into the wheel area had increased. The roll moment trend changed sign at 8:54:11 EST (EI + 602 sec.) almost simultaneously with the change in wheel well temperature rise rate as shown in Figure 5-44, followed by a debris flash event at 8:54:33 EST (EI + 624 sec.). A large debris item, labeled debris event six, was seen leaving the orbiter two seconds later. This debris event and the roll moment trend change are believed to be created by growing damage to Columbia's left lower wing.

There are several theories that attempt to explain this response including a change in the wing camber or shape due to deformation and a lower wing recession, caused by the loss of much of the support structure internal to the wing. Wing recession here is in reference to structural deformation of the wing surface. In this case, one or more areas on the lower wing form a more concave shaped depression of wing skin and tiles as a result of the structural support in those areas being weakened or lost. A structural analysis of both wing deformation due to the loss of three ribs internal to the wing, and the wing recession concept was performed.

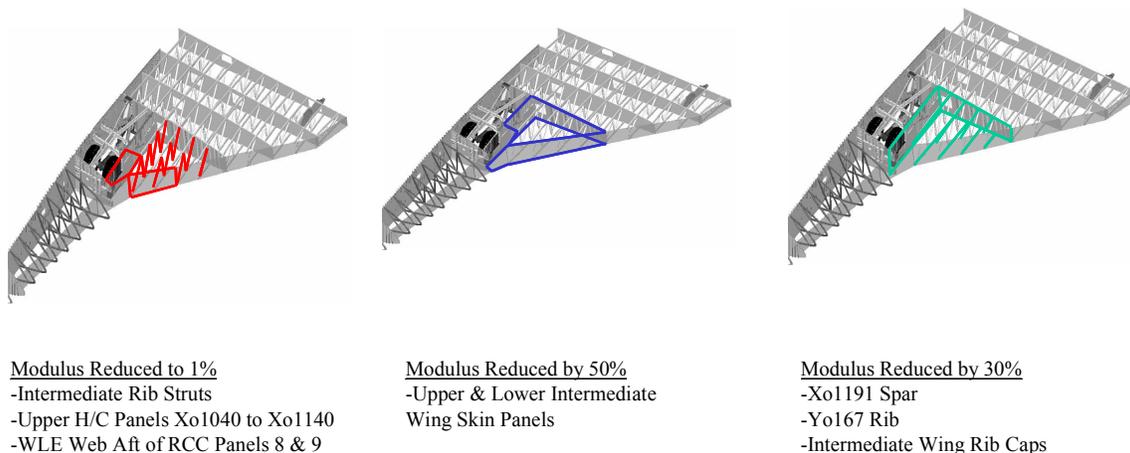
Figure 5-45. Modeling results show potential area of damage and that significant deformation of the intermediate wing area and/or a recession in the lower surface are possible

Based on the structural analysis, it appears feasible that a wing recession occurred and resulted in the large positive slope in the delta rolling moment. The recession was caused by severe prolonged heating internal to the left wing that melted many of the support struts. Once the struts were lost, the wing skin lost structural support, a concave cavity developed, and some lower surface tiles may have been lost. Wind tunnel testing has shown that this type of cavity can cause the change in delta aero moments derived from the aerodynamics reconstruction in this timeframe. The aero moment change is a negative yaw moment due to increased drag and a positive roll moment due to increased lift on the left wing. This testing will be discussed in more detail in the next section.

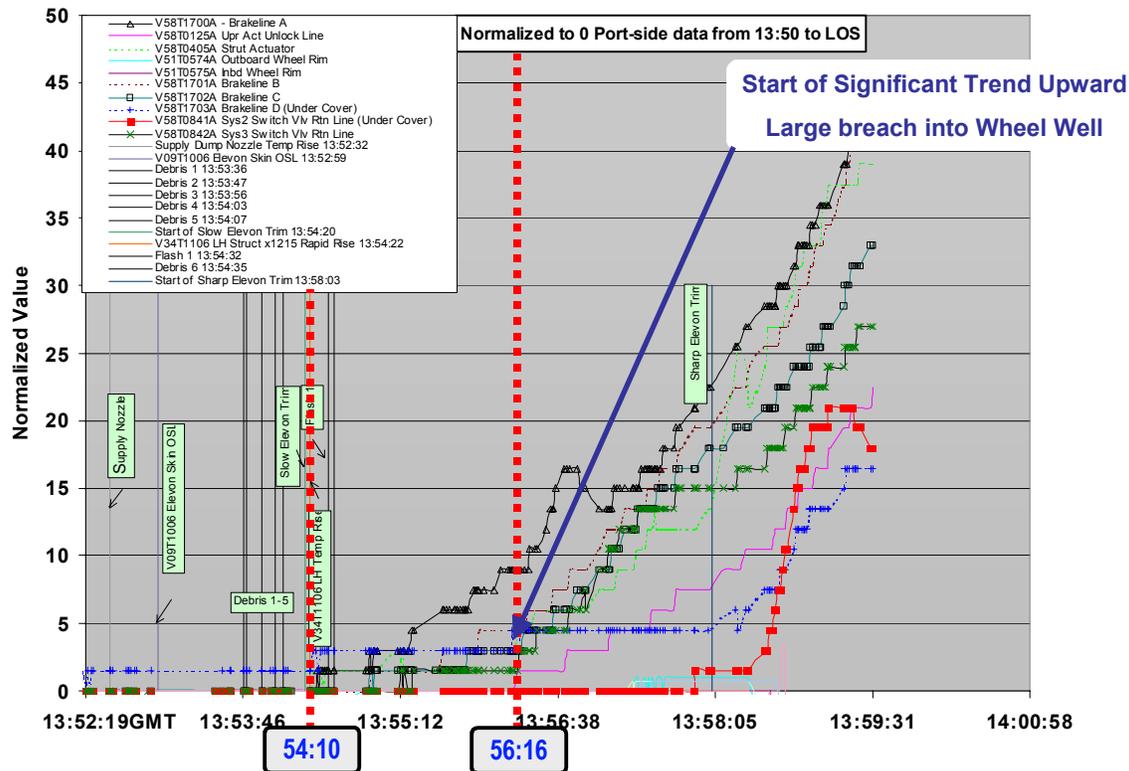
By 8:56:16 EST (EI + 727 sec.), hot gas had penetrated the wheel well wall as indicated by off-nominal rates rise rates in several hydraulic line temperatures (see Figure 5-46). Preliminary analysis indicates that it is feasible to have had some gas intrusion into the wheel well area as early as 8:52:39 EST (EI + 510 sec.) since a honeycomb access panel could melt as quickly as 22 seconds after the wing spar is breached. Additionally, there are various vent paths into the wheel well around the landing gear door hinge covers.

Figure 5-46. Temperature data in left wheel well trends up (GMT is EST + 5 hours)

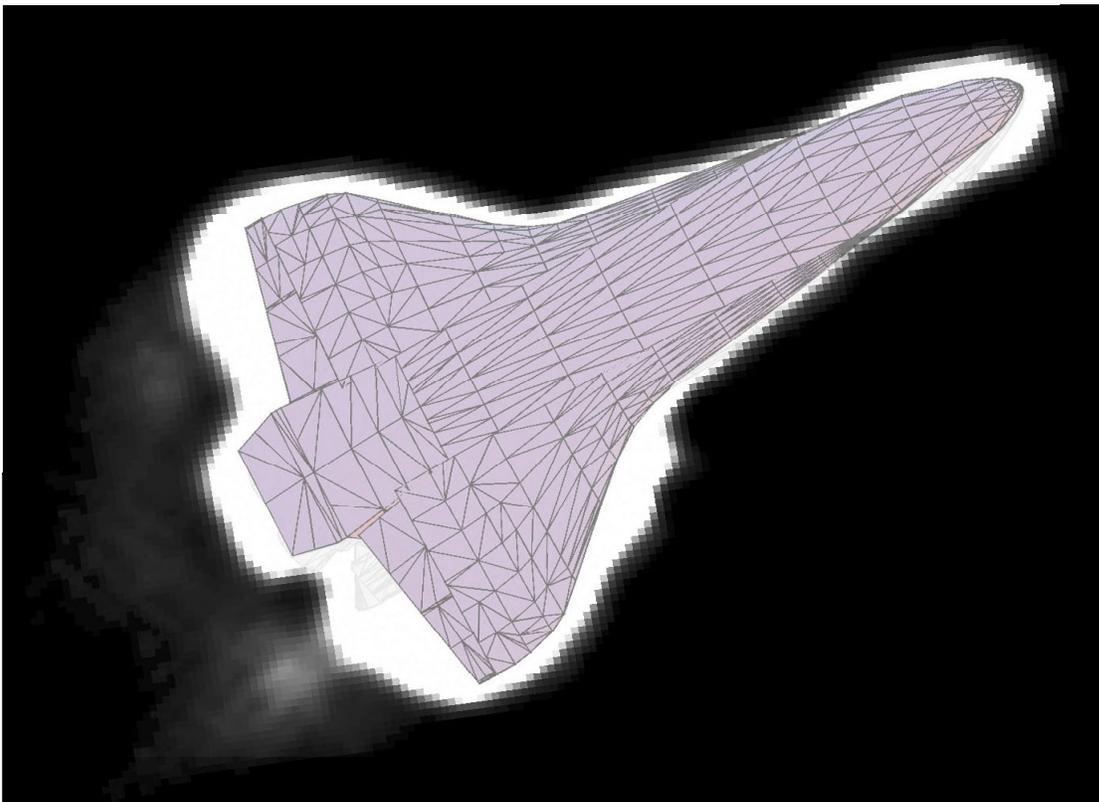
Imaged at 8:57:14 EST (EI + 785 sec.), the Kirtland photo could indicate a flow disturbance on the leading edge of the left wing and/or flow leaving the leading edge of the left wing (see Figure 5-48). It also appears to show a disturbed flow leaving the trailing edge of the left wing. Other images, not shown here, also show disturbed flow on the upper side of the left wing, indicating that the damage and venting through the upper RCC vent was deflecting the flow upward. The Kirtland photo is a digital still image taken by off-duty employees of the Starfire Optical Range at Kirtland Air Force Base, New Mexico, during the STS-107 entry using a 3.5 inch telescope through a computer controlled 1 meter rotating mirror.

Figure 5-48. Kirtland photo

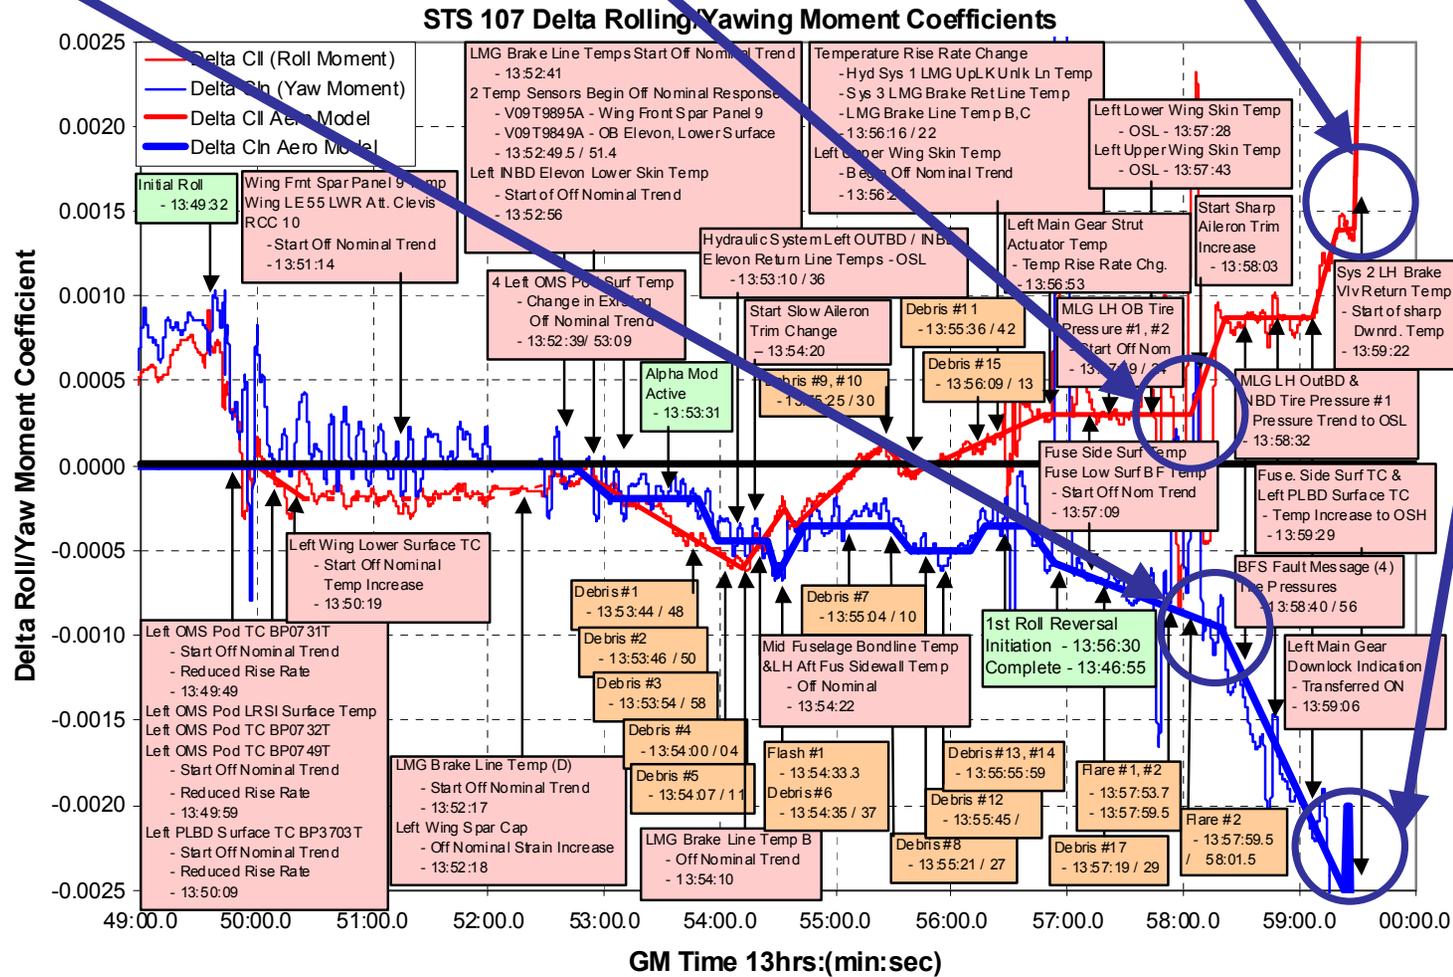
As shown in Figure 5-49, this strain response appears to be consistent with another sharp change in the slope of the derived delta rolling moment coefficient that occurred slightly earlier at 8:58:03 EST (EI + 834 sec.), along with several additional debris events. The vehicle responded to this event with a sharp change in the aileron trim. These events indicate that there was another significant change to the left wing configuration at this time. Wing deformation and an increase in the lower surface recession along with a loss of additional bottom tiles are possible explanations for this behavior.

Figure 5-49. Increased wing deformation and wing recession leads to significant vehicle aerodynamic changes (GMT is EST + 5 hours)

As shown in Figure 5-49, there was another abrupt change in the vehicle aerodynamics caused by the continued progression of left wing damage at 8:59:26 EST (EI + 917 sec.). This change was a significant increase in the positive delta roll moment and negative delta yawing moment, indicating increased drag and lift from the left wing. Columbia attempted to compensate for this by firing all four right yaw jets. By this point the MCC had lost all telemetry data at 8:59:23 EST (EI + 914 sec.). Even with all four right yaw jets and a maximum rate of change of the aileron trim, Columbia was unable to control the side-slip angle that was slightly negative (wind on the left side of the fuselage) during much of the entry. The side-slip angle changed sign at 8:59:36 EST (EI + 927 sec.) indicating that vehicle loss of control was imminent (side-slip angle is an aerodynamics terms for the angle between the relative wind velocity and the vehicle direction of motion, or velocity vector).

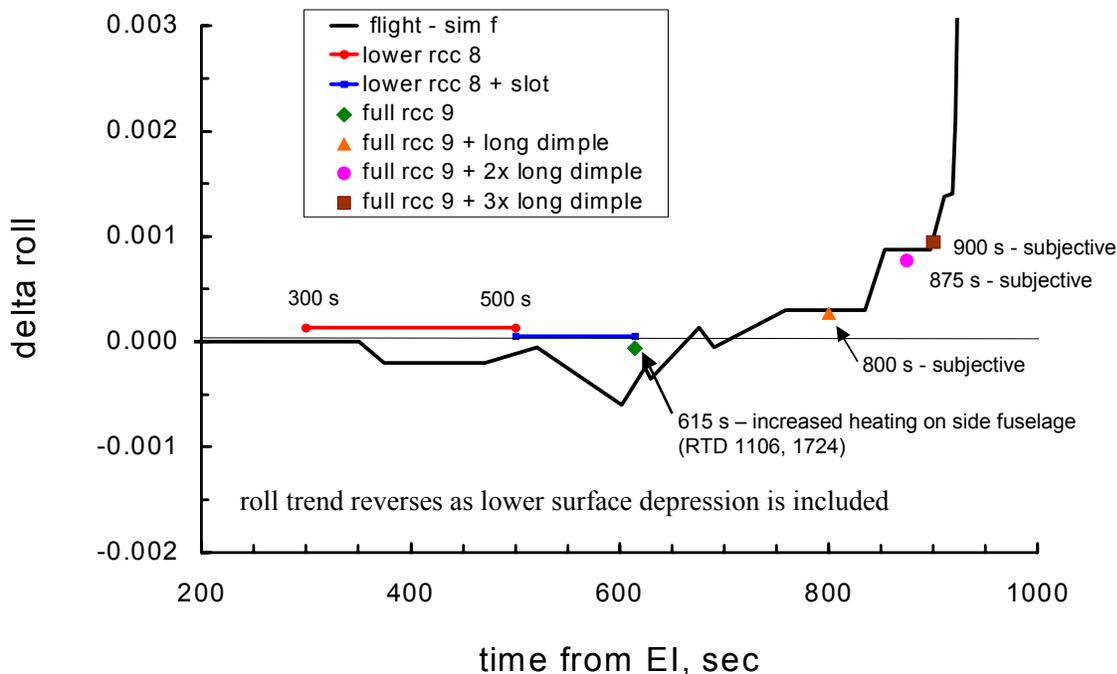
Figure 5-50 through Figure 5-52 show the flight derived delta roll, yaw, and pitch aerodynamic moments, respectively, along with the tested damaged configuration results that are consistent with the flight data. The intent of the remainder of this section is to briefly discuss the CFD analysis and wind tunnel testing used to replicate the derived delta aero moments. Note the time scale on these plots is in seconds from EI.

Figure 5-50. Wind tunnel testing configurations that match delta roll moment data

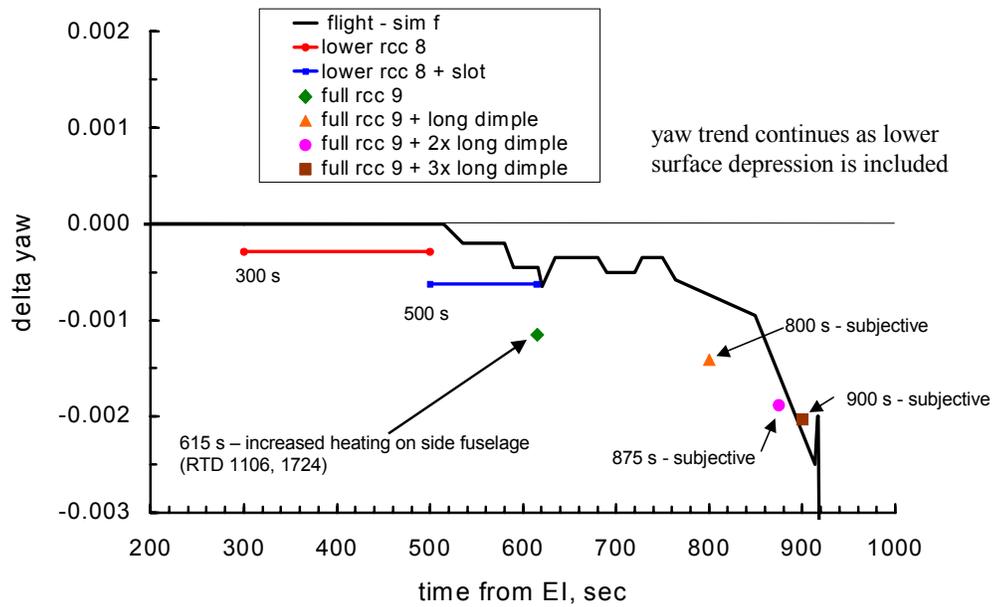
Figure 5-51. Wind tunnel configurations that match delta yaw moment data

Initially, the recessed area would have been relatively small; however, it would gradually grow over time to cause the delta roll moment to increase. By 8:57:29 EST (EI + 800 sec.) wind tunnel testing showed that the depression has to be on the order of 20 feet long, two feet wide, and 5.3 inches deep along with panel 9 missing in order to duplicate the delta roll coefficient shown in Figure 5-50. This configuration provides a delta yaw moment that is slightly larger than was observed, but is consistent with a decreasing negative delta yaw moment observed in this timeframe (Figure 5-51).

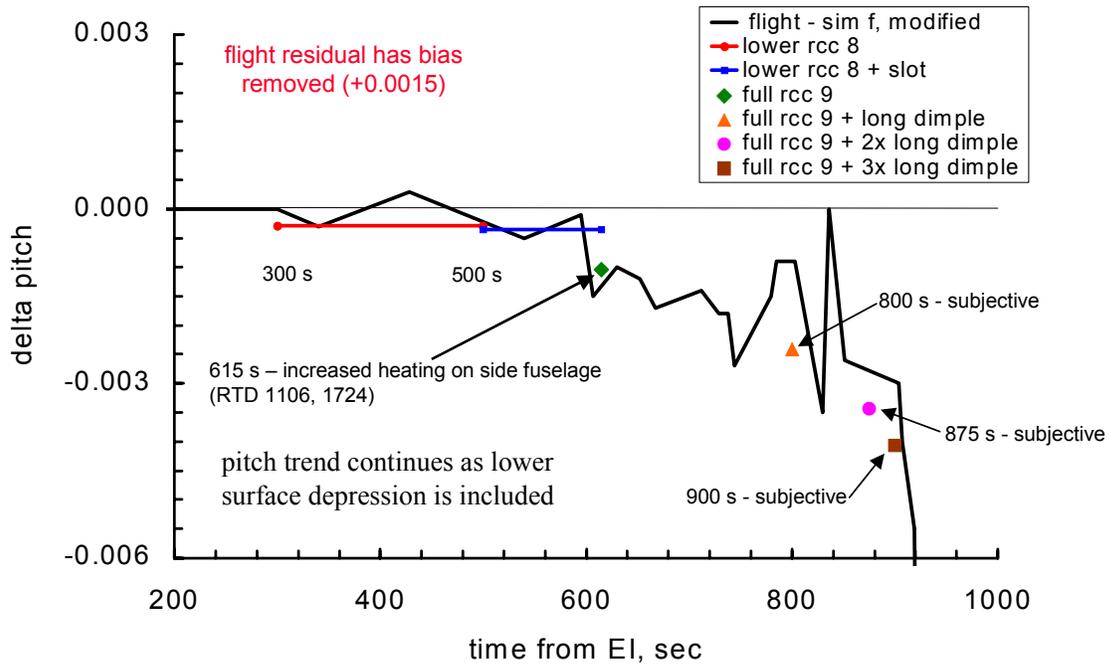
Figure 5-52. Wind tunnel configurations that match delta pitch moment data

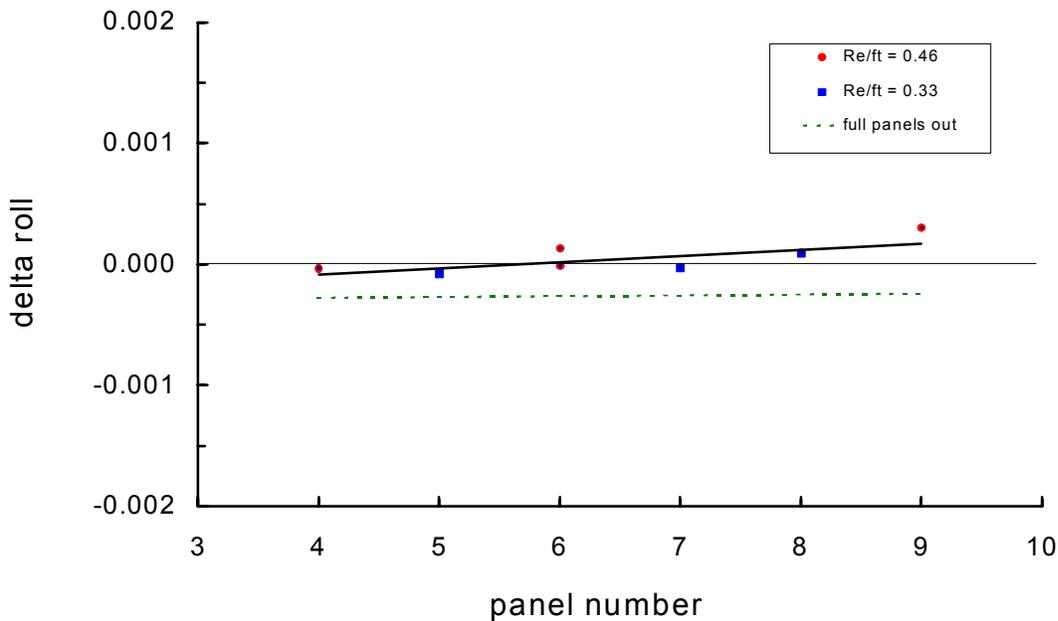
As discussed previously, the reconstructed aerodynamic moments showed little to no change due to damage through 8:52:29 EST (EI + 500 sec.). Based on the forensics data discussed in Section 5.3, the most likely region of initial damage was in the lower part of RCC panel 8. Wind tunnel testing in the Langley Research Center (LaRC) CF4 tunnel indicated that a missing bottom part of RCC panel 8 (from the apex to the lower carrier panel) matches the initial aerodynamic increments, which show a minimal effect on the overall vehicle aerodynamics. In fact, even a full missing panel 8 produces only a small change to the roll and yaw aero moments. Figure 5-53 and Figure 5-54 show the results of this LaRC evaluation.

Figure 5-53. Delta roll for lower half and full panel RCC panel missing

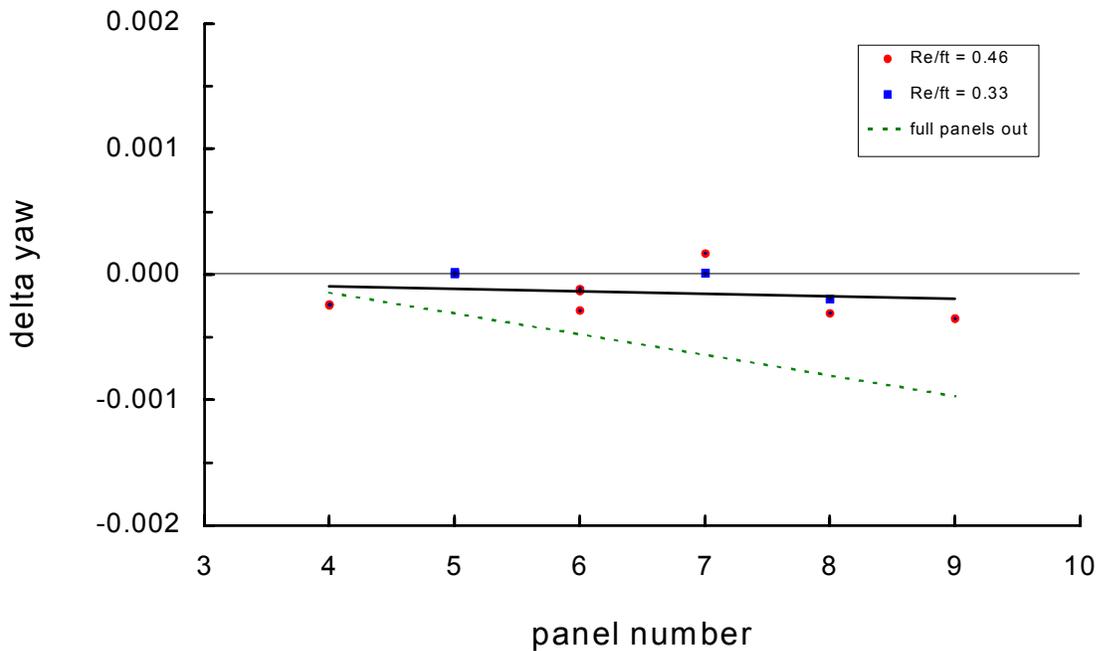
Figure 5-54. Delta yaw for lower half and full panel RCC panel missing

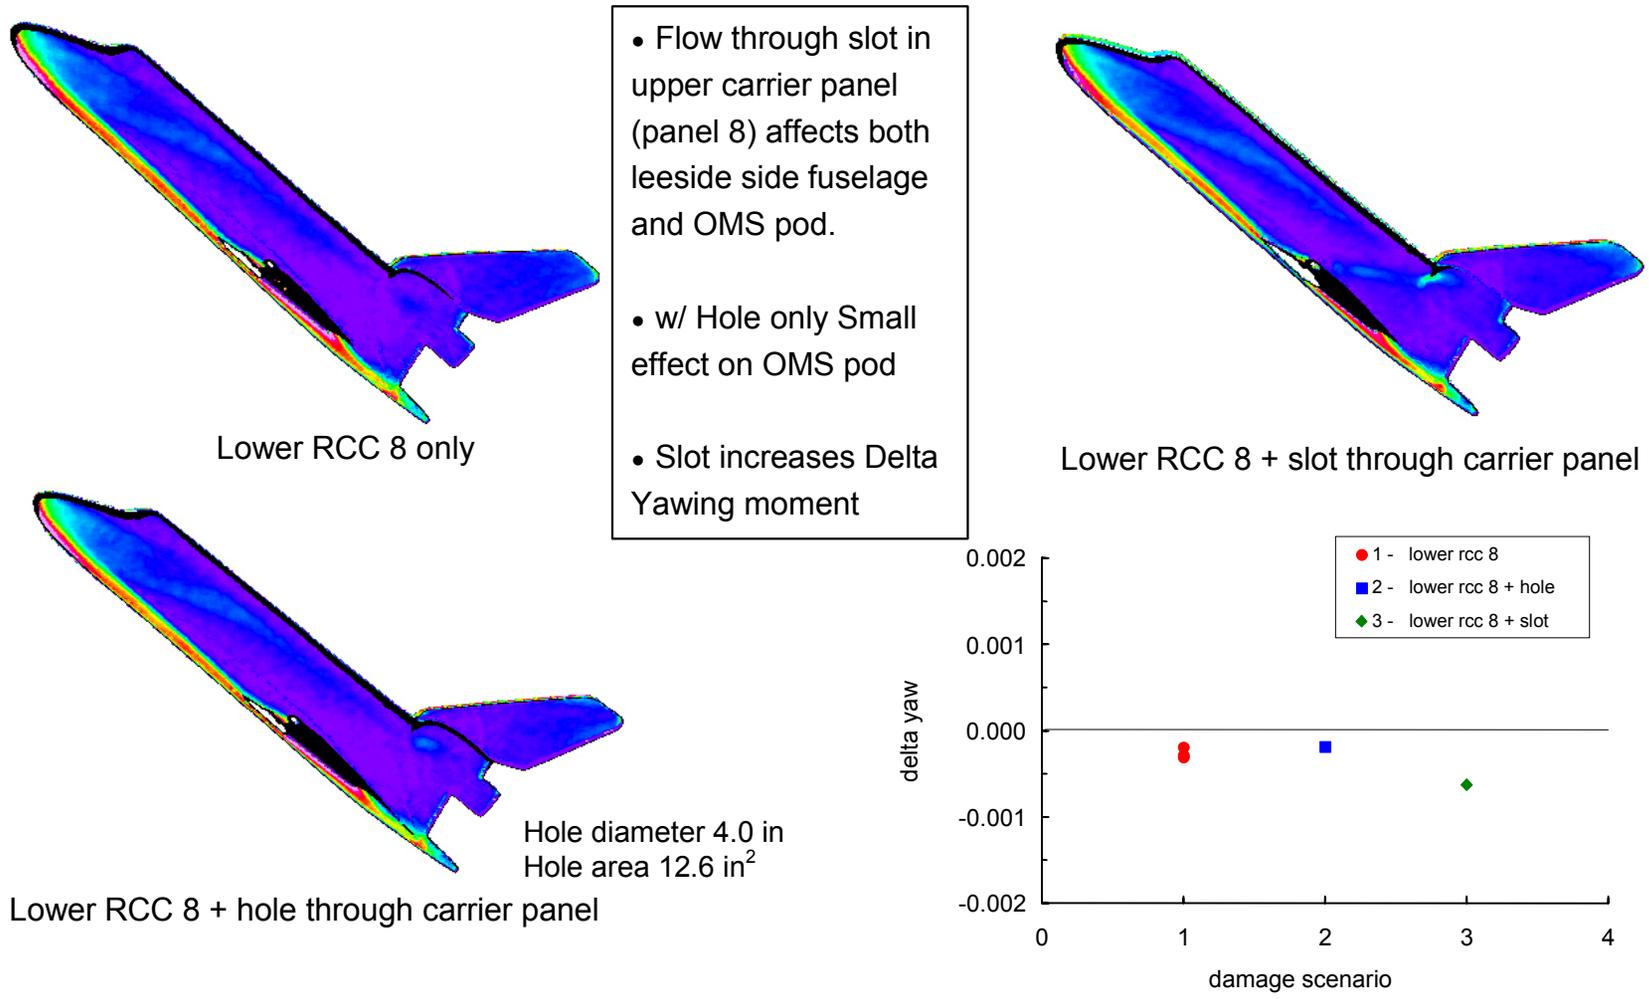
The left wing spar was breached in the 8:51:14 EST (EI + 425 sec.) to 8:52:15 EST (EI + 487 sec.) timeframe. Initially, the spar breach had little to no effect on the derived aero moments. Over time the leading edge damage progressed and a slot or upward deflection of the flow through the upper carrier panel 8 developed. The combination of flow through the wing leading edge and flow through a slot onto the upper carrier panel is consistent with the first observed aerodynamic response, which occurs at 8:52:29 EST (EI + 500 sec.). This can be observed in Figure 5-50 and Figure 5-51 as a slow negative trend in delta roll and yaw. Figure 5-55 shows the wind tunnel test results for three different cases: missing lower RCC panel 8, missing panel 8 combined with a 4 inch diameter hole in the upper carrier panel 8, and missing RCC panel 8 with a slot through the upper carrier panel. The slot was shown to produce the increased delta yaw observed during flight as well as the upper surface flow disturbances on the OMS pod and left side fuselage, which were also observed during flight by abnormal temperature rise rates.

Figure 5-55. Wind tunnel testing results for missing lower carrier panel 8 and a slot and hole through wing

It is possible that a hole through the upper wing developed in the 8:54:11 EST (EI + 600 sec.) to 8:54:31 EST (EI + 630 sec.) timeframe. This is consistent with a lull in the measurement failure rate in the wire bundle along the wheel well that was discussed earlier in Section 5.4.3. Wind tunnel testing and CFD analysis have shown that sizable holes through the wing have little to no effect on the aerodynamics and heating on the left side of the fuselage and OMS pod. A representative sample of this work is shown in Figure 5-55 as damage scenario number 2.

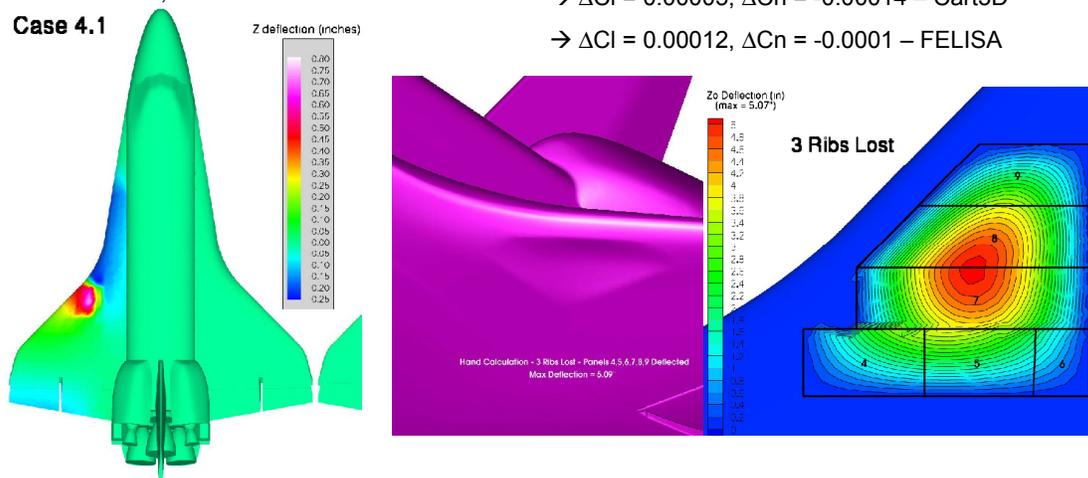
The next significant aerodynamic event occurred at 8:54:11 EST (EI + 602 sec.) when a dramatic reversal of the aero rolling moment trend occurs. By this time hot gas and an internal plume environment had severely degraded the structural integrity of some of the intermediate wing support structure leading to wing deformation. Three different configurations were tested to validate the theory of wing deformation. The first involved global wing deflection of up to 0.79 inches due to damage and is depicted in Figure 5-56. CFD analysis of this configuration showed extremely small aero moment response for yaw and roll that does not match the flight derived data. More substantial local wing skin deformation with a maximum deflection of 5.1 inches due to three ribs missing along with other internal wing damage was examined using CFD tools. Again, these results produced only small aerodynamic moment changes, which did not match the flight-derived data.

- Case 4 Aerodynamic Increments – Global wing deflection due to damage
Max RMS Delta Δ Wing Deflection (Nominal – Damaged structure) is 0.79”
→ Δ Cl = 0.0001, Δ Cn = -0.0001
- Hand Calculation Increments – Local wing deformation due to damage
Max Δ Wing Deflection, $Z_0 = 5.1”$
→ Δ Cl = 0.000, Δ Cn = -0.0001 – Newtonian
→ Δ Cl = 0.00005, Δ Cn = -0.00014 – Cart3D
→ Δ Cl = 0.00012, Δ Cn = -0.0001 – FELISA

Figure 5-56. CFD analysis of wing deformation
