COLUMBIA ACCIDENT INVESTIGATION BOARD (CAIB)/
NATIONAL AERONAUTICS AND SPACE ADMINISTRATION (NASA)
ACCIDENT INVESTIGATION TEAM (NAIT)

WORKING SCENARIO

FINAL VERSION: JULY 8, 2003

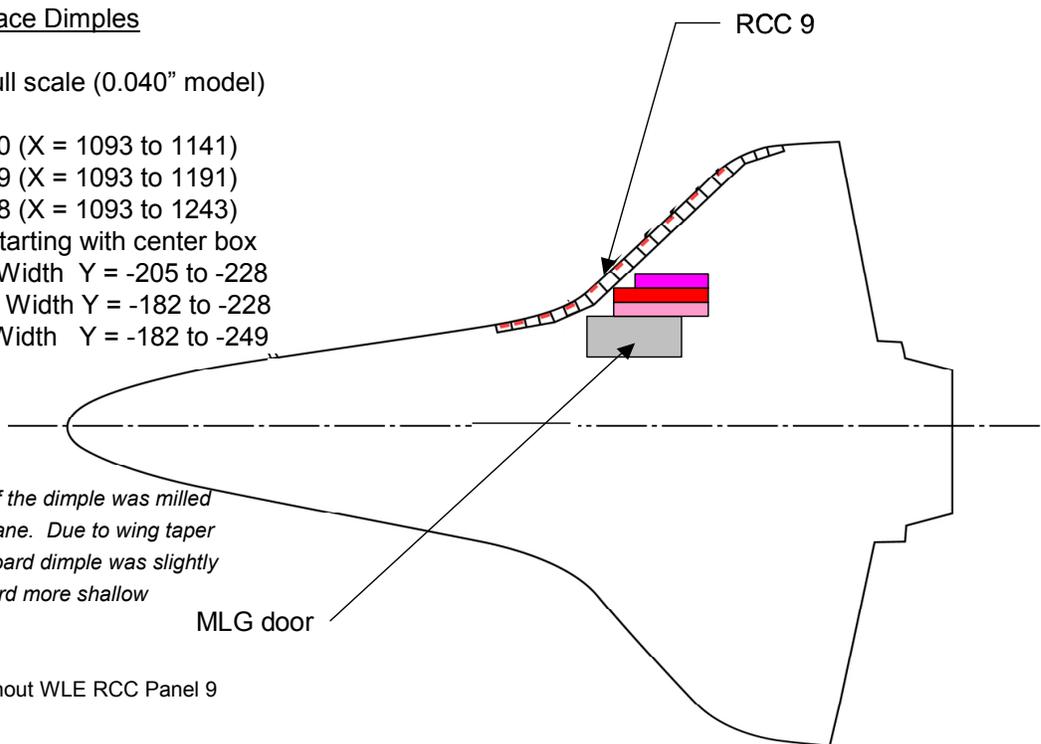
structural damage that was most probable in this timeframe. LaRC wind tunnel testing and CFD analysis were performed for several different configurations of lower surface recessions shown in Figure 5-57. The data shows that it is feasible for a recession to cause the change in the rolling moment sign when combined with some portion of RCC panel 9 missing at 8:54:11 EST (EI + 602 sec.).

Figure 5-57. LaRC wind tunnel testing of lower surface depressions

Initially, the recessed area would have been relatively small; however, it would gradually grow over time to cause the delta roll moment to increase. By 8:57:29 EST (EI + 800 sec.) wind tunnel testing showed that the depression has to be on the order of 20 feet long, two feet wide, and 5.3 inches deep along with panel 9 missing in order to duplicate the delta roll coefficient shown in Figure 5-50. This configuration provides a delta yaw moment that is slightly larger than was observed, but is consistent with a decreasing negative delta yaw moment observed in this timeframe (Figure 5-51).

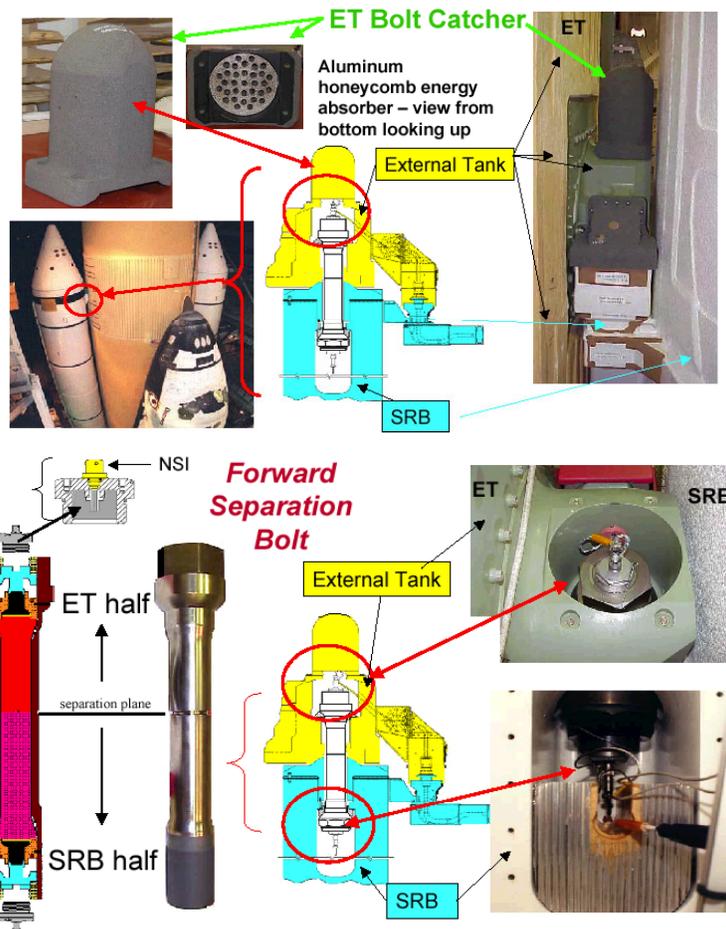
Four blocks on the STS-107 SRB fault tree remain open pending completion of forward bolt catcher testing. The bolt catcher, shown in Figure 7-1, was not qualified as an assembly, and structural qualification testing was not representative of the current flight configuration. The exact magnitude of loads transmitted to the bolt catcher housing cannot be determined based on available data. The SLA-561 thermal protection system (TPS) material on the bolt catcher was qualified by test and analysis for general ET application, but no pyrotechnic shock testing was performed. There is no test data available on the bolt catcher honeycomb dynamic crush strength versus separation bolt velocity, and random pressure loading from the NASA Standard Initiator (NSI) ejection was not included in the original qualification tests. Lastly, the running torque/break-away torque was not measured during STS-107 bolt catcher fastener and ET range safety system (RSS) fairing installation, which is used to verify the insert locking feature is in place. A review has determined that the bolt catchers and RSS fairings were installed and secured for flight with the correct bolts and final torque. Testing is in work to close the four remaining fault tree blocks, but initial static tests results show failure below the required safety factor of 1.4.

Figure 7-1. Details of SRB/ET forward separation bolt catcher assembly

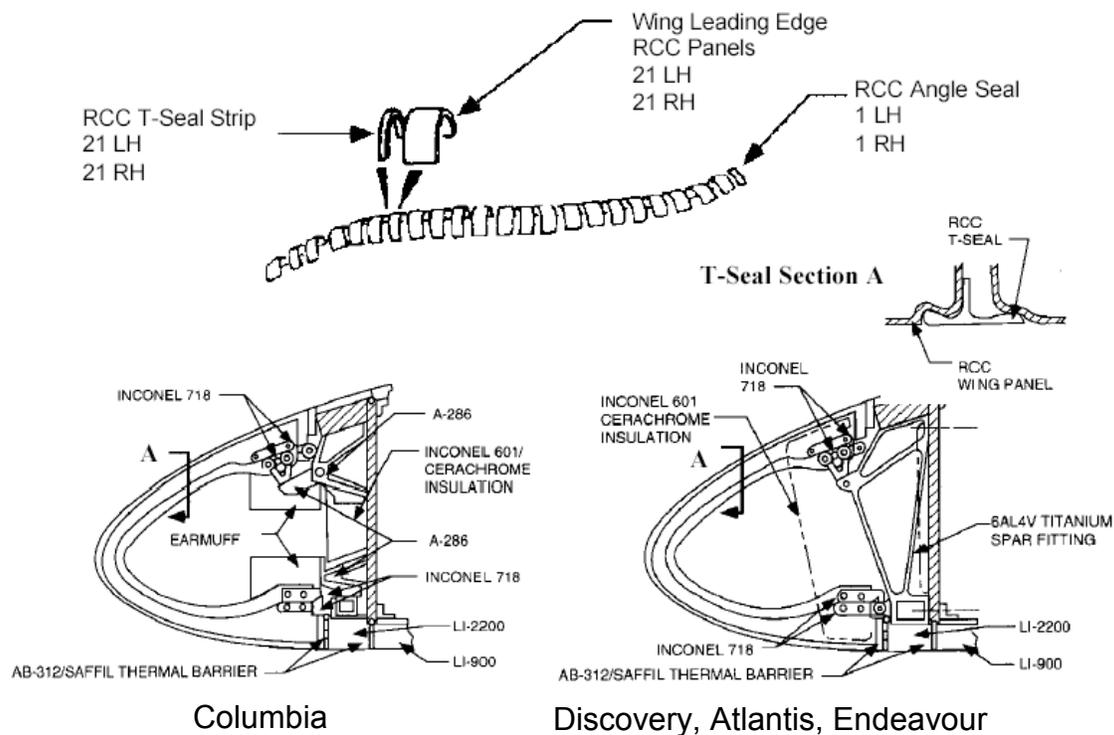
The angle seal at RCC panel 1 on the left wing leading edge (see Figure 10-4) was removed to support the evaluation of the horse collar gap filler between the adjacent tiles. During the removal attempt, the upper bushing remained bound with the shipside clevis. During subsequent attempts, the angle seal was manually manipulated to try and remove the preload. During the KSC paper review, structures engineers realized that the load applied to the angle seal was specified to be kept below 20 pounds, but was never recorded in the paper. The RCC specification requires that RCC panel loads be kept below 30 pounds. Subsequent tests at KSC verified that the angle seal load was below the 30-pound requirement. The LESS prevention and resolution team is addressing the issue of how to measure the load and how to support the seal in future operations. Work continued on the elevon flipper doors. Flipper door 1 blade seal was not making contact with the rub channel, potentially leading to excessive venting from the elevon cove area. This issue surfaced twice during this flow and was Material Review (MR) accepted to fly as is. Modification was made to the Inconel trailing edge seal and bulb seal on the elevon. Additional work was performed on the elevon cove corrosion protection again to reduce the excessiveness of the application.

Figure 10-4. Wing leading edge RCC

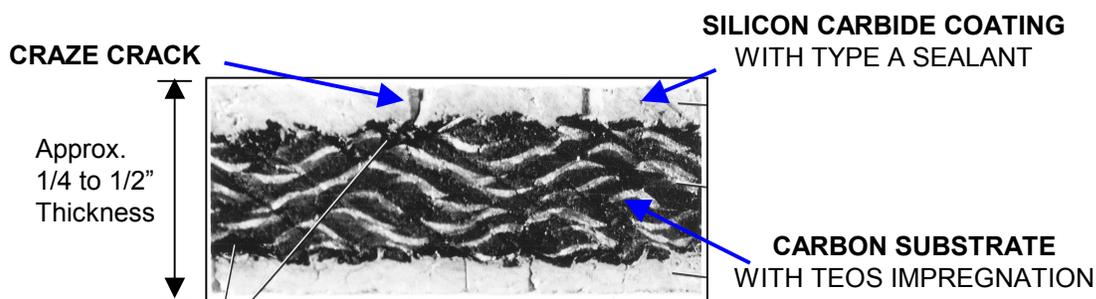
Figure 10-5. RCC cross section

The RCC is composed of a carbon-based substrate (see Figure 10-5) that provides essentially all of the RCC strength. It is composed of graphitized rayon fabric impregnated with a phenolic resin called Tetraethyl Orthosilicate (TEOS) to provide internal protection against porosity within the laminate. The substrate is covered with a silicon carbide coating also enhanced with TEOS and sealed with a sealant to protect it from oxidation within the substrate. The silicon carbide coating provides no thermal protection for the RCC.

During the manufacturing process, the silicon carbide surface acquires surface craze cracks due to differential contraction during the cooling process. The silicon carbide coating cools faster and contracts more than the carbon substrate during the cooling process. The craze cracks sometimes extend completely through the silicon carbide coating to the carbon substrate. A sodium silicate solution called “Type A Sealant” is applied to the silicon carbide coating to decrease porosity in the surface and fill the crazing cracks. Any erosion of the type A sealant and/or the silicon carbide coating could lead to direct exposure of the carbon fibers in the substrate. This provides a path for oxidation and can potentially lead to subsequent burn through of the RCC panel during entry. Development tests for the RCC never identified a susceptibility to oxidation; therefore, Columbia was not treated with the type A sealant until after the first five flights. Beginning in 1992, a double type A (DTA) sealant program was instituted on all vehicles to further enhance the corrosion protection on the wing RCC.

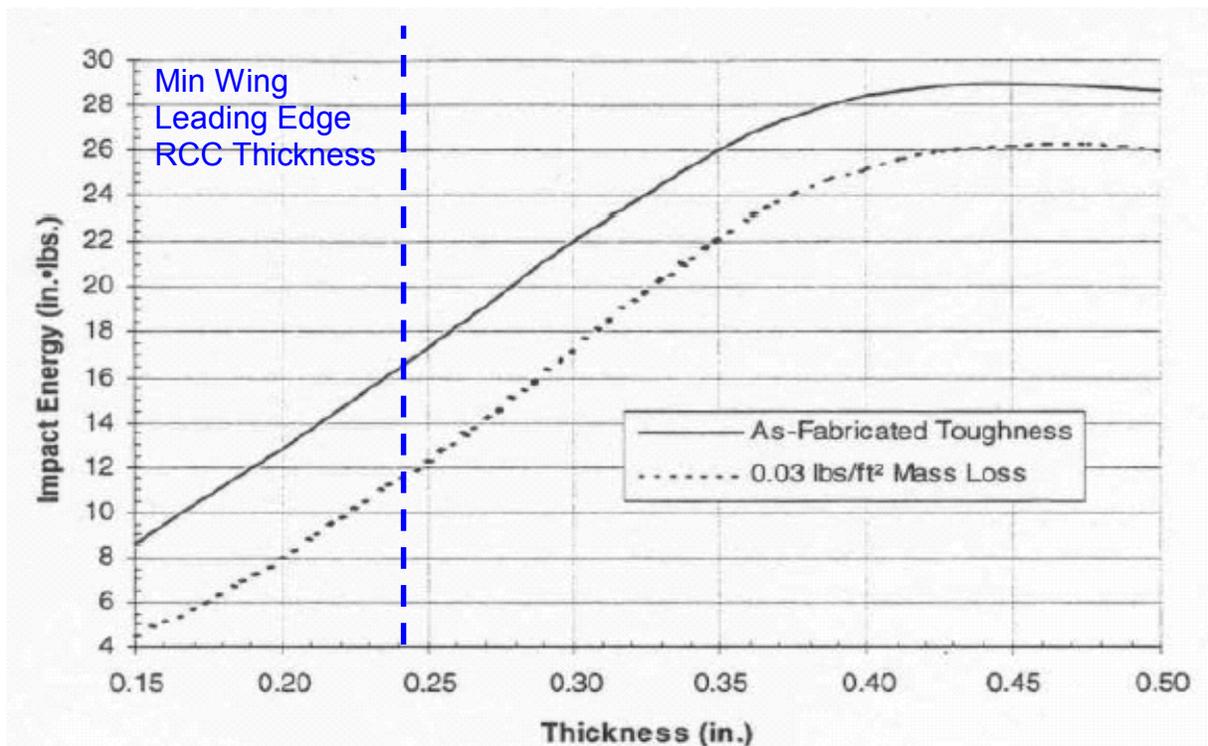
Figure 10-6. RCC impact resistance

The RCC was not considered part of the TPS for the purposes of impact resistance. The TPS was designed to accommodate particle impacts, such as from hail, rain, runway debris, etc., whose impact energy did not exceed 0.006 foot-pounds to the surface. The wing leading edge RCC impact resistance allowed no damage to the RCC with the application of up to 16 inch-pounds of energy. Figure 10-6 shows RCC impact resistance ranging from 4 to 26 inch-pounds depending on the increasing thickness of the RCC element. Different tests including low velocity and hypervelocity tests have been conducted to determine the actual impact resistance of the RCC. Test projectile materials have included nylon, glass, aluminum, steel, lead, and ice and have taken shapes of spheres, bullets, and cylinders. The test results vary widely and appear to be significantly dependent on impact velocity, projectile type, and angle of incidence of impact. Because of the variability of the test results, no actual impact resistance could be defined.

In support of the STS-107 investigation, RCC impact testing was performed at Southwest Research Institute in San Antonio, Texas, by propelling a large piece of foam at high velocity at a previously flown RCC panel. These tests were described earlier in Section 3 and show that RCC material can be damaged by ET foam at impact velocities matching STS-107 debris impact conditions.

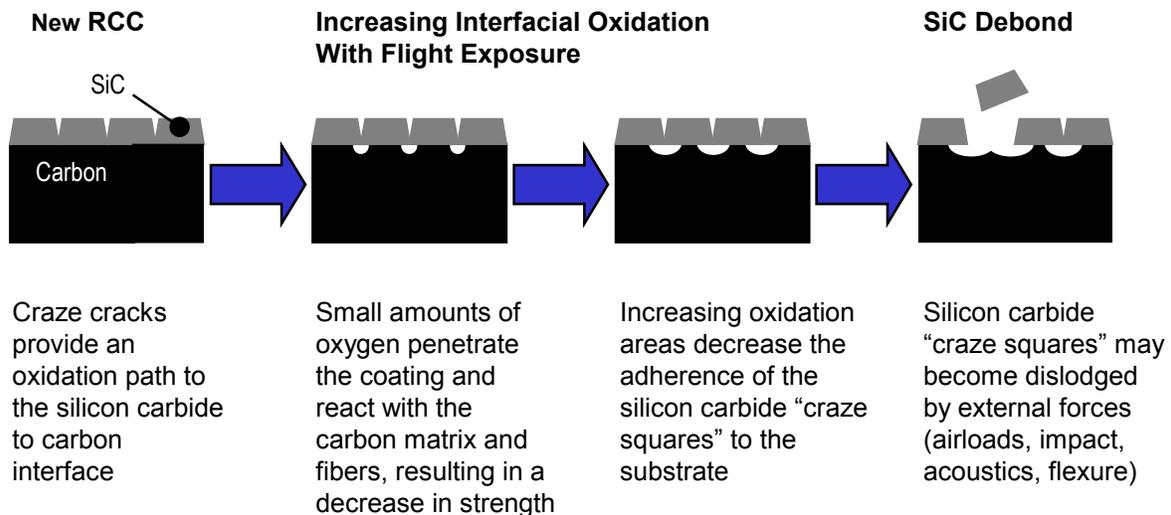
Figure 10-7. RCC corrosion process

Subsurface oxidation has been discovered beneath the silicon carbide surface cracks in the sealant and coating which allow the oxidation process to thrive. This process is considered to be an impact to RCC mission design life, but is not generally considered to be a safety of flight issue. This oxidation process (Figure 10-7) starts with the breakdown of the coating due to entry heating. Surface craze cracks allow oxygen to migrate to the subsurface carbon fibers and react with them. This increase in oxidation develops into larger crazed areas, which eventually allow pieces to become dislodged due to vibration, aerodynamic, or thermal loads. Once the pieces dislodge, they leave a large path for the oxidation process to continue.

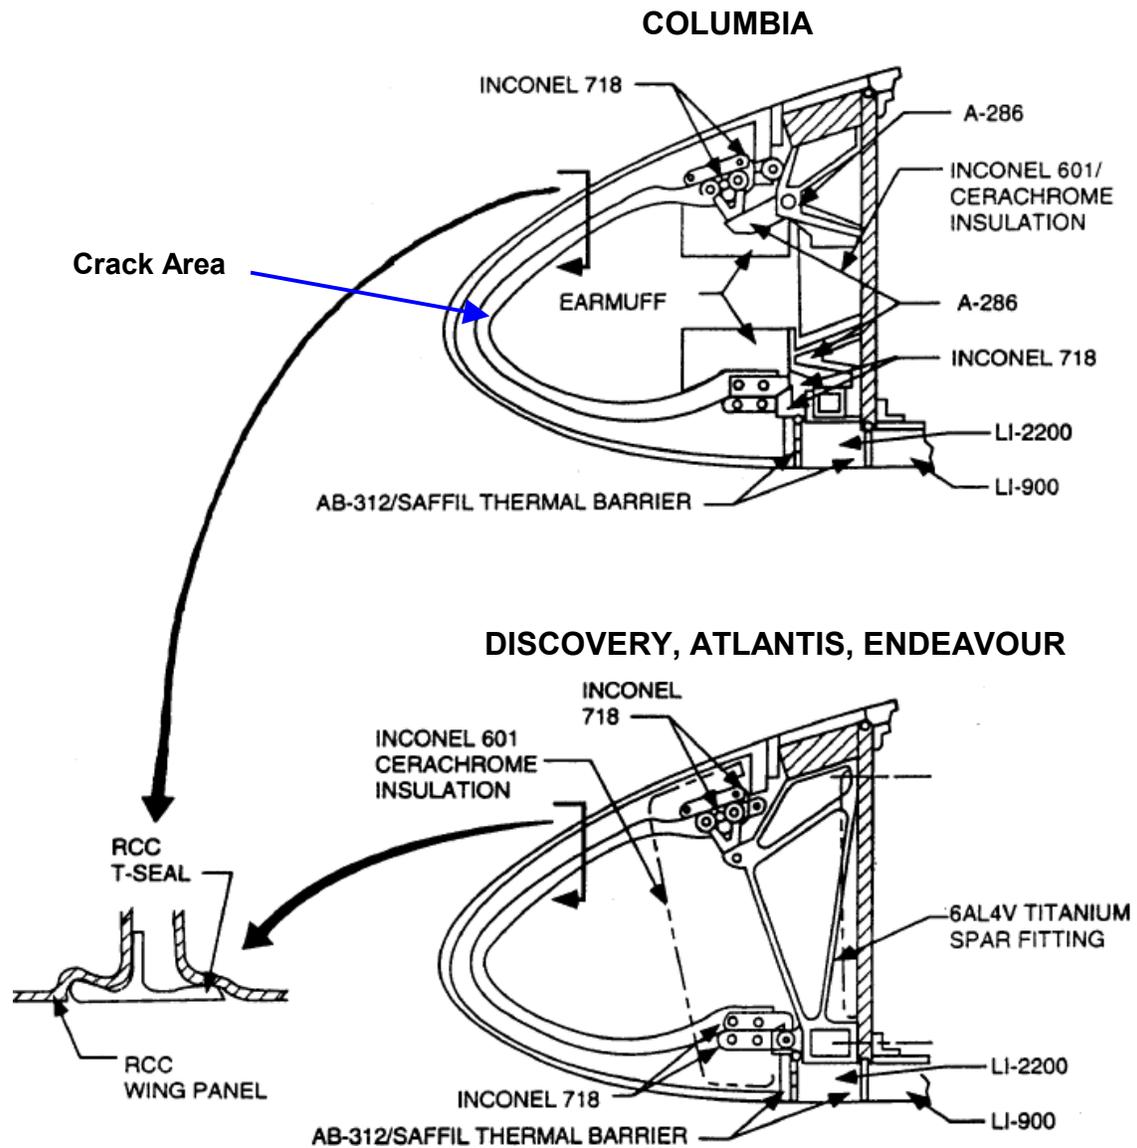
Figure 10-8. Tee seal crack location

Each wing leading edge RCC panel shares a Tee seal that is used to close the gap between adjacent RCC panels. Following STS-43 (Atlantis) in August 1991, routine inspections identified cracks in the web of a Tee seal. The cracks were in the silicon carbide coating and occasionally in the substrate, and were due to normal shrinkage. They were typically less than 1/2 inch long, were not visible to the naked eye, and usually occurred in the web of the seal, on the backside of the seal (Figure 10-8) near the apex rather than on the leading edge. Further examination of the remainder of the shuttle fleet identified 20 (of 132) cracked Tee seals. Columbia had 11 Tee seals identified with possible cracks. Detailed inspections determined that all the cracks were typical of the surface craze cracks in the coating. The Tee seal cracks were determined to be caused by warping of the substrate fabric during lay-up during the original build. The Tee seal cracking (Figure 10-9) leads to a reduction in mission life and loss of oxidation protection. All the seals were refurbished with new coating and sealant and were reinstalled. Failure analysis showed that cracks would form after excessive wishbone loading (bending) caused the brittle coating to crack. Crack testing was performed in 1991 on Tee seal 10 (attached to RCC panel 9) from the left wing of Columbia to try to determine the crack mechanism. The Tee seal was cycled 400 times in bending up to 70% of its ultimate load and no discernable damage was noted. After an engineering evaluation was performed on the health and strength of the Tee seal, it was subsequently reinstalled on Columbia.

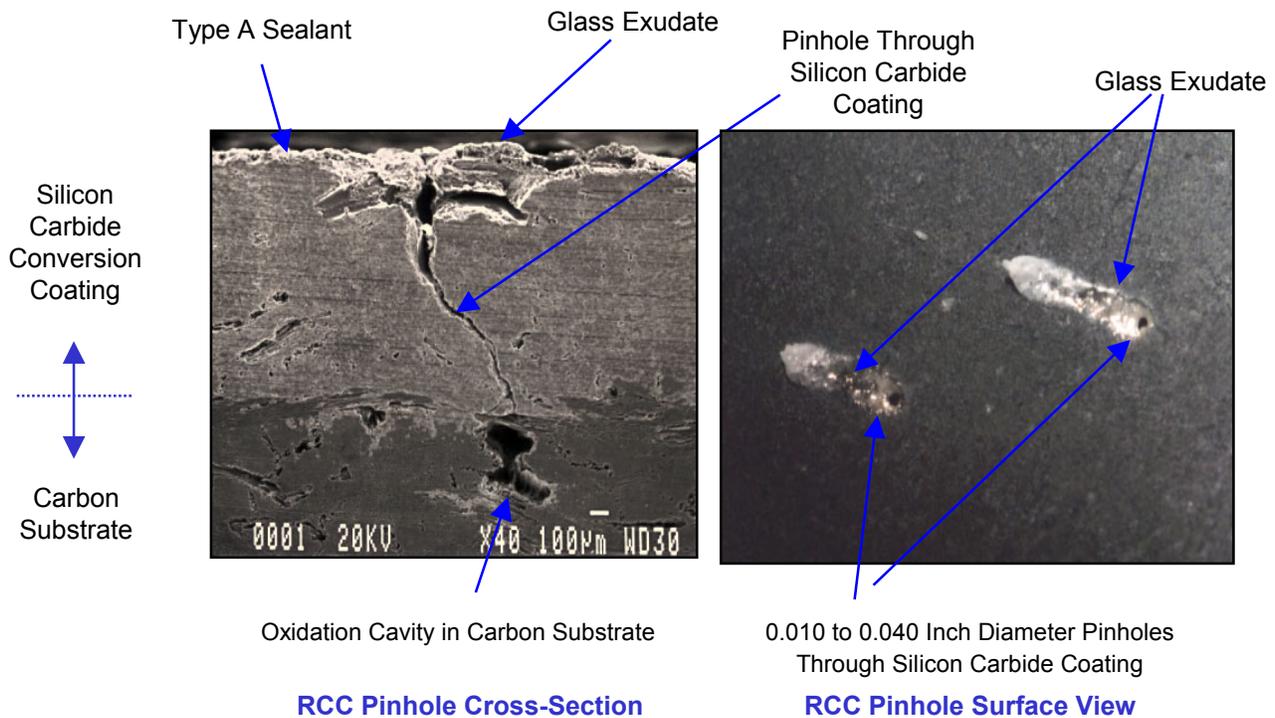
Figure 10-10. RCC pinholes

Another phenomenon, discovered first on Columbia after STS-50 landed, was the existence of pinholes (Figure 10-10) in the RCC panels. The pinholes were found primarily in the wing leading edge RCC and were subsequently identified on all orbiters. Testing has shown that the pinholes are most likely the result of the accelerated oxidation process involving zinc oxide and the silicon carbide coating. The reaction of the zinc oxide and the silicon carbide produces a silica (glass) exudate that flows out of the pinhole area. The presence of zinc oxide is theorized to originate from the paint primer used to recondition the launch pad after each mission and is considered an accelerator to the oxidation process. The zinc-based contamination accumulates on the wing leading edge RCC as rainwater drips off of the launch pad. This contamination rests on the RCC without reacting to the surface material while at ambient conditions at the pad. All of the damaging oxidation occurs once the RCC is exposed to the high temperatures, pressures, and excess oxygen of re-entry. Only a few pinholes have been observed on the nose cap RCC, most likely because the nose

cap remains under a protective cover while at the launch pad. It is also believed that sodium chloride contributes to the oxidation process, but to a much lesser extent than the zinc oxide.

In 1997, pinhole acceptance criteria were established. Pinholes with surface dimensions less than 0.040 inches discovered during routine processing flows are acceptable to fly as is for up to 16 missions unless the carbon substrate is exposed, in which case the panel must be repaired. Pinholes discovered at OMM greater than 0.040 inches are unacceptable. Although the pinholes themselves constitute only a small mass loss, they are not considered to be a safety-of-flight issue by themselves. Analysis has identified that the sustainable thru-hole size in-flight due to orbital debris is 0.25 inches in the lower surfaces of RCC panels 5-13. A hole under 1 inch in diameter anywhere else in the RCC is considered survivable for a single mission.

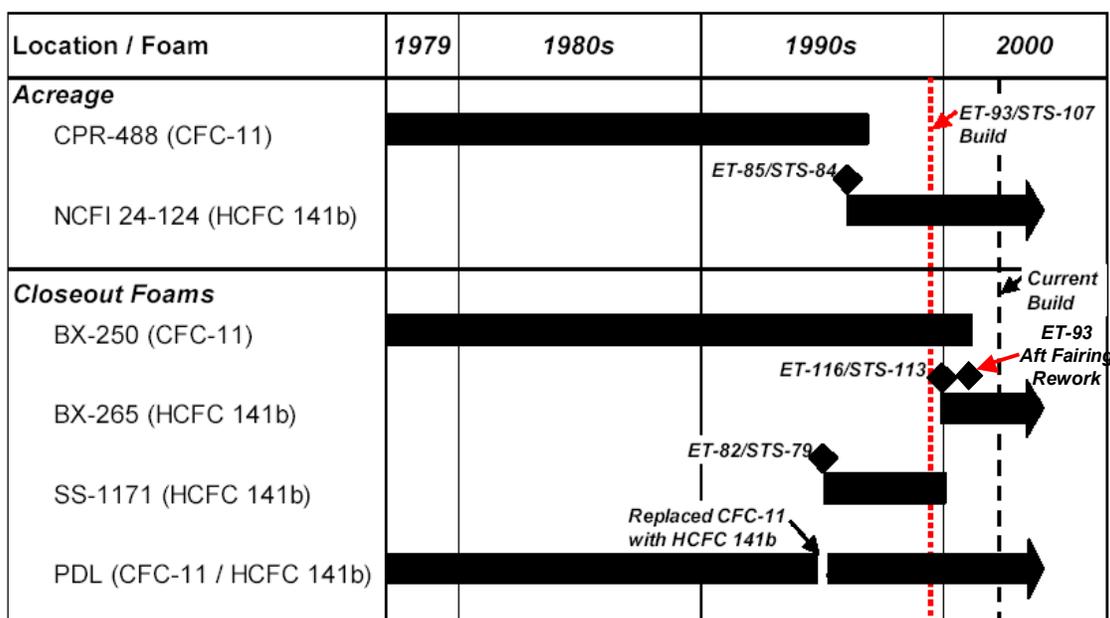
Figure 11-1. History of foam changes. Blowing agent shown in parentheses, no changes to SLA

The ET TPS history is marked by multiple material and configuration changes resulting from ET TPS and ice loss events, design enhancements, environmental regulations (especially blowing agent changes), and supplier changes. The history of foam changes is outlined in Figure 11-1, and Table 11-1 lists the ET flight history, as well as age and exposure data. Thousands of tests have been conducted to develop and qualify the ET TPS. There were no first time ET TPS changes on STS-107/ET-93 except for rework of the TPS on the upper aft ET/Solid Rocket Booster (SRB) fitting fairing (following SRB demate) using BX-265. Basic bipod TPS materials had not changed from the beginning of the program until after ET-93. The bipod TPS configuration has been stable since 1983, when with ET-14 the ramp angle was changed. At ET-76 in 1995, there was one minor change to the ramp intersection with the ET intertank area. At ET-116 in 2002, the bipod material was changed to BX-265, but ET-93 had been constructed with BX-250. No indication has been found that any specific ET TPS foam change or any combination of historical ET TPS foam changes alone caused the bipod foam loss on STS-107/ET-93.

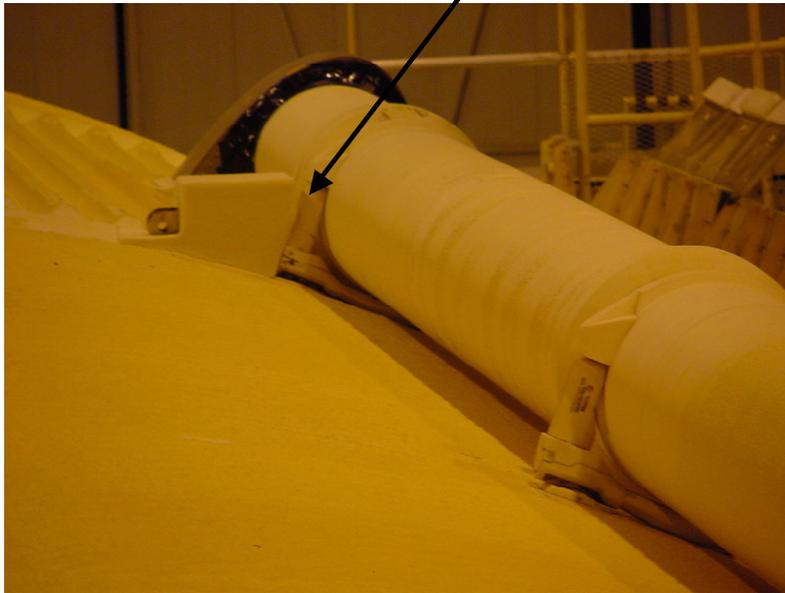
Figure 11-2. Right (+Y) bipod ramp

TPS loss on the right bipod ramp has never been observed. Launch/ascent imagery from ground assets is less favorable for seeing right bipod foam loss as compared to the left bipod, and post-ET separation crew imagery is random between imaging the left or right bipod ramps.

There is no flight or test data to explain why the -Y (left) bipod loses foam and the +Y (right) does not. The Shuttle Program only provides the -Y ramp air loads as a worst case for ET project analysis. There are several bipod configuration differences that may contribute to foam not coming off the +Y ramp. First, the foam ramp is configured slightly differently to accommodate the inboard strut for the LO2 feed line support structure (see Figure 11-2). Second, the proximity of the right bipod to the LO2 feedline could potentially influence local surface pressure causing a lower internal to external pressure differential (see Figure 11-3). Finally, the outboard and aft facing surface of the -Y bipod may experience lower surface pressure due to flow separation and other local effects relative to the +Y side. If the internal ramp pressure was high due to adverse “as-built” features in the ramp, this could lead to a higher differential pressure on the -Y versus the +Y ramp. However, the aerodynamic loads analysis reviewed in Section 3.5 shows that the loads on both ramps are below their design requirements.

+Y Bipod with ramp complete showing feed line and location of foam cut out to accommodate strut

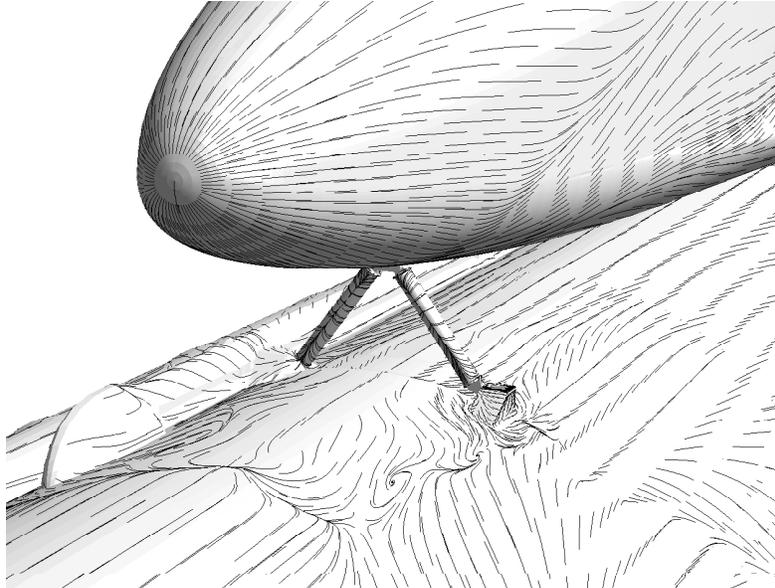
Figure 11-3. Left and right bipod ramp flow differences, CFD results

JSC CFD Results: Mach No. = 2.46, Alpha = 2.08°

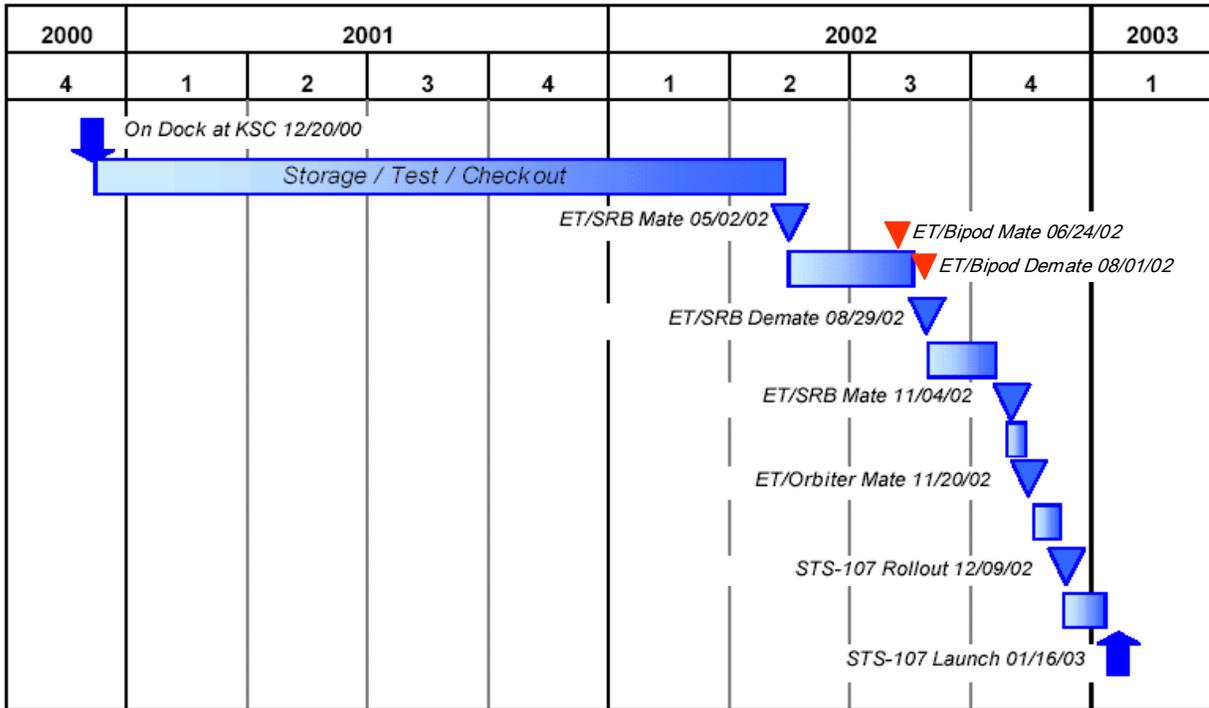
Figure 11-4. ET-93 processing timeline at KSC

The shuttle flight manifest was delayed due to cracks found during inspections of Main Propulsion System feedline flow liners on Atlantis in June 2002. The final manifest moved STS-112 and STS-113 ahead of STS-107. ET-93 was de-mated from SRBs BI-114/RSRM-86 and later mated to SRBs BI-116/RSRM-88, and SRBs BI-114/RSRM-86 were used for STS-113. All mate/de-mate operations were carried out in accordance with standard procedures, and are outlined in Figure 11-4. There are no indications that KSC ET processing (ET shipping, handling, and processing) contributed to the bipod foam loss on STS-107/ET-93.

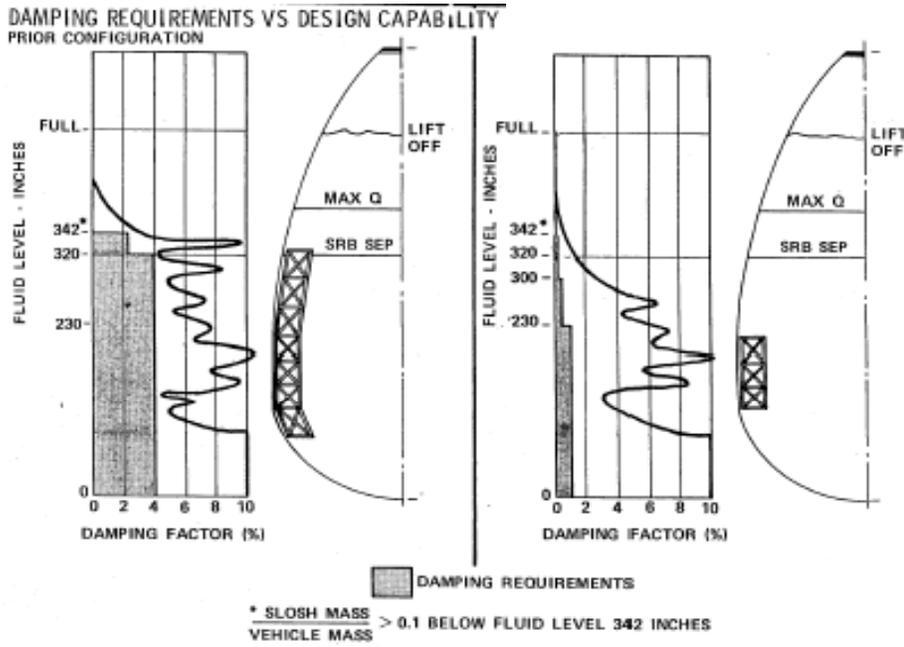
Figure 11-5. ET LO2 slosh baffle changes – ET-14

Eight ET LO2 slosh baffles were used until ET-14 in 1983. Vehicle stability analysis based on development flight instrumentation confirmed minimum LO2 sloshing disturbances and Space Shuttle Program LO2 damping requirements were subsequently reduced. Analysis and sub-scale test showed the baffle count could be reduced from eight to two and still maintain margin, but a reduction to four was selected as a trade off between cost benefit and weight reduction (see Figure 11-5).

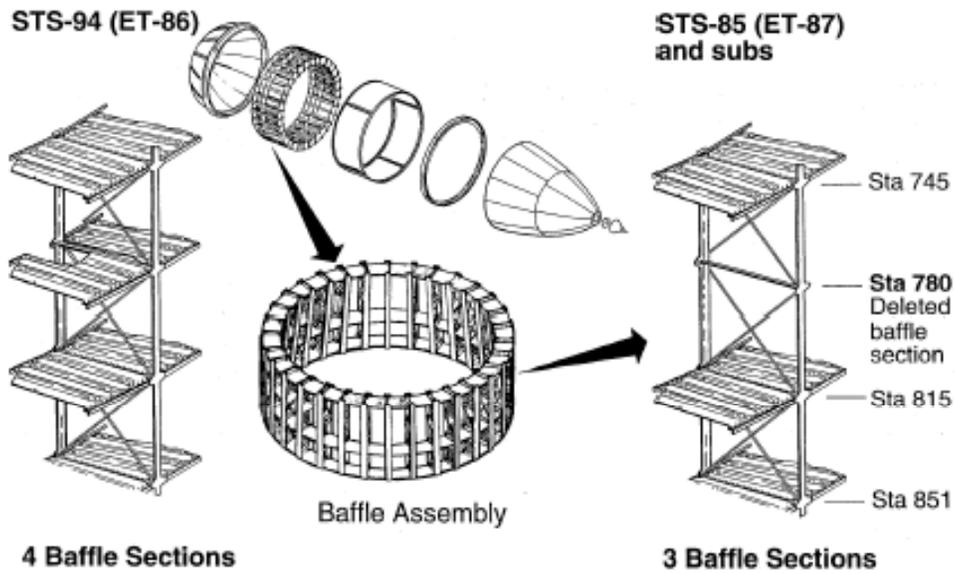
Figure 11-6. ET LO2 slosh baffle changes – ET-87

One weight saving feature of the SLWT is the removal of one more slosh baffles section, as shown in Figure 11-6. This gives a predicted performance gain of 92 pounds. This feature was incorporated into the LWT at ET-87 in 1996 to reduce weight and diminish the number of first time configuration changes for the subsequent first flight of the SLWT. Dynamics analysis showed available damping remained within requirements and propulsion and stress analysis also remained within requirements. Data are inconclusive as to whether the ET LO2 slosh baffle configuration alone caused bipod foam loss on STS-107/ET-93.

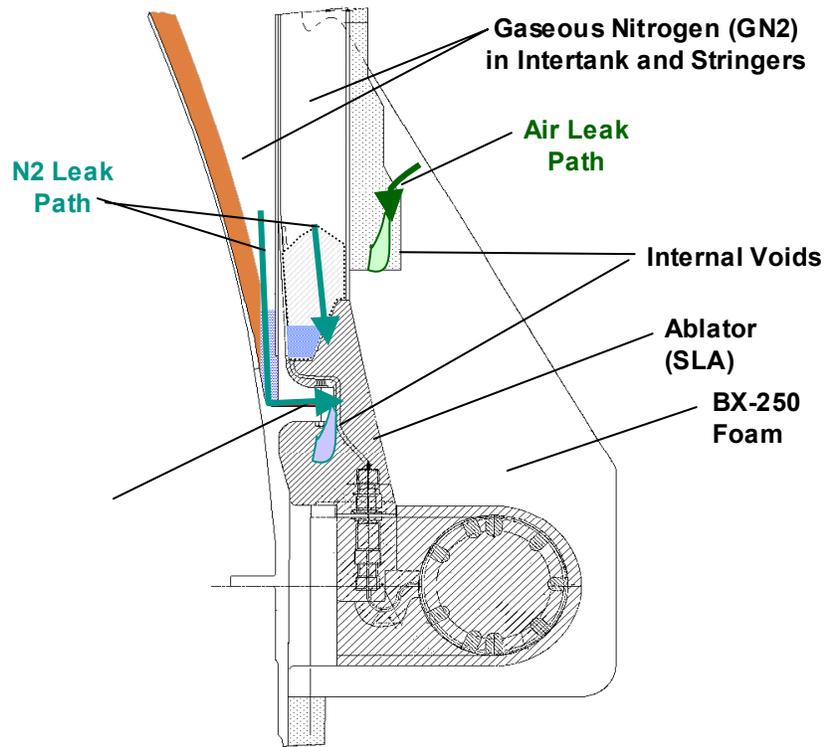
Figure 11-8. Schematic of bipod ramp - potential cryopumping

Cryopumping could contribute to bipod foam loss, shown schematically in Figure 11-8. The mechanism that drives cryopumping is the transformation of a gas to a liquid at cryogenic temperatures. Gases may condense within a void or porous material at low temperatures. Air in cavities or porous material liquefies when in contact with structure below -297°F for oxygen or -320°F for nitrogen. Pressure is reduced locally due to the condensation. If a leak path exists, more air will be “pumped,” providing more gas to condense. When the structure warms, the consequence of cryopumping is that the liquefied air returns to the gaseous state with a local pressure increase. If the leak path is large, gas escapes with no detrimental effect. However, if the leak path is small,

cracks may form in the TPS to relieve pressure, or a rapid increase in pressure may result in a divot. In order for this to occur, the inlet source must be blocked off to avoid venting out the inlet. It should be noted that testing has been unable to demonstrate cryopumping in this application.

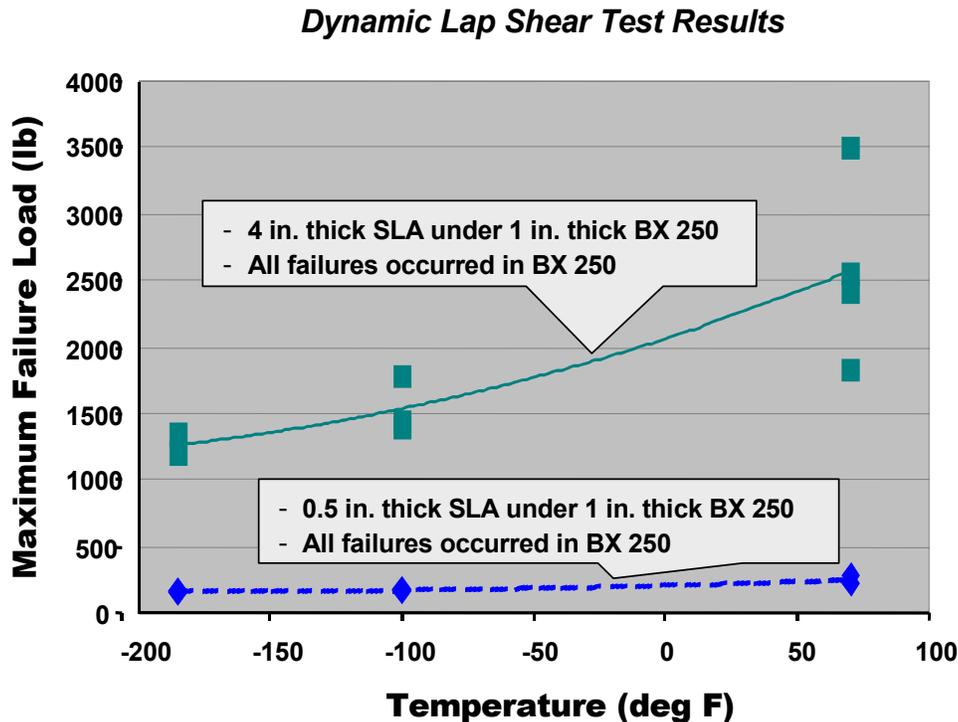
Figure 11-9. Critical test results in debris assessment

Bipod TPS static and dynamic coupon tests were performed (test ET-TR-003). The objectives of these tests were to evaluate the BX-250/SLA hand-pack (HP) bond line laminate mechanical properties and investigate whether liberated BX-250 material could “pull” or “tear” SLA HP material from the bipod region. Analysis shows the critical bipod Spray-On Foam Insulation (SOFI) ramp failure mode due to direct air load is shear failure between SOFI ramp and bipod fitting substrate.

Testing shows that the potential loss of BX-250 does not liberate hand packed SLA due to impulse loading for cryogenic applications; the BX-250 fails before the SLA. For shear, testing shows BX-250 fails before SLA at all test temperatures. For tension, testing shows BX-250 fails before SLA when SLA temperatures are less than or equal to -100 °F (see Figure 11-9).

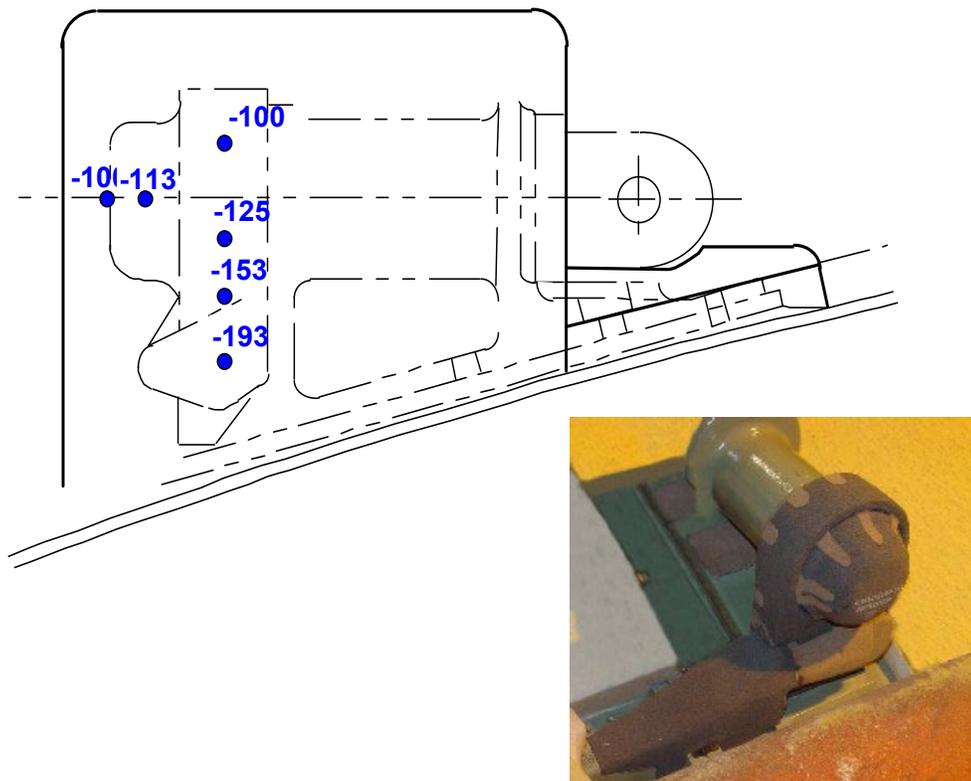
Figure 11-10. Max bipod SLA temperatures (80 seconds MET), °F.

The maximum SLA temperatures possible at 80 seconds were analyzed to determine maximum worst-case multi-event material loss. No cryopumping or cryo ingestion was assumed in order to calculate temperatures as high as possible. STS-107 ambient environments were used. Results showed the maximum SLA temperature possible at 80 seconds MET is less than or equal to -100°F , as shown in Figure 11-10. Tension testing shows BX-250 fails before SLA at temperatures less than or equal to -100°F .

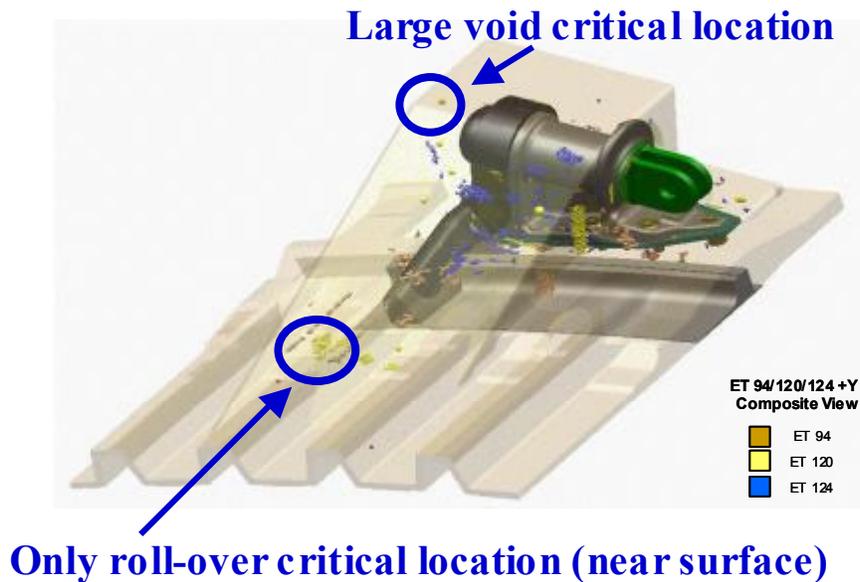
Figure 11-11. Defects found at critical locations

The dissection of six bipod ramps indicated similar patterns for geometry-induced defects in all ramps. Roll-overs were observed at complex substrate elements, and the majority of observations were associated with spraying over complex details at the substrate. Sporadic voids were also observed. One internal delamination and one weak plane at the knit line were observed. Critical locations, or areas at-risk for producing debris, were identified near the edge of the machined foam surface for both voids and roll-overs (see Figure 11-12). Vacuum pressure is the primary driver for divot formation; however, wind shear also contributes to flight loads. A combination of multiple large voids, geometry-induced defects, and critical locations is needed to produce significant foam loss. For example, a large interconnected void at close proximity to the surface plus a “weakened plane” (see Figure 11-13) may produce foam loss.

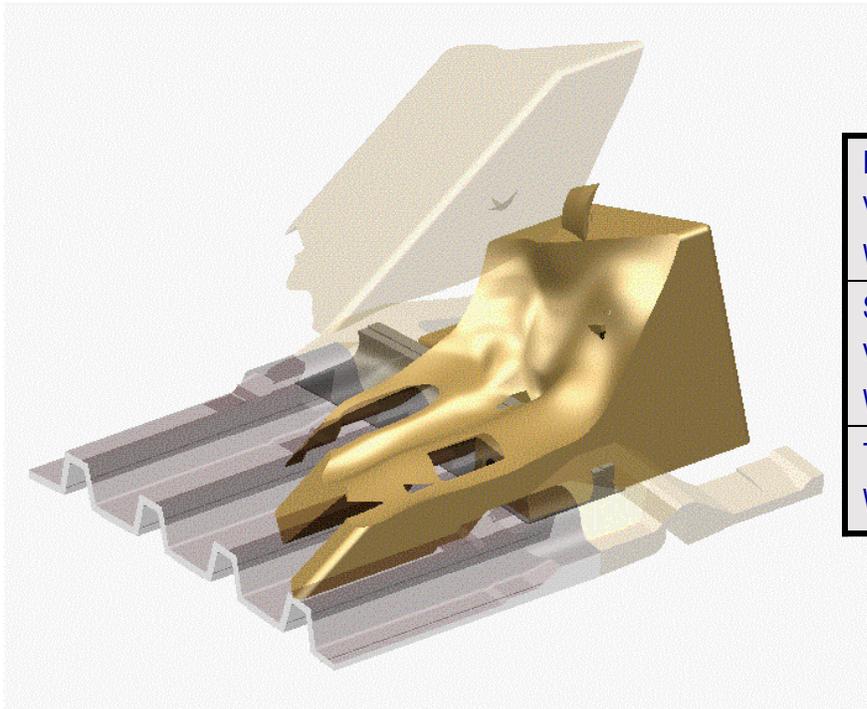
Figure 11-13. Multi-failure mode bipod TPS debris estimated by the ET Working Group. Note that this size and weight were not used in the RCC impact testing as part of the STS-107 investigation.

The ET Working Group conducted an analysis coupled with test data to estimate a multi-failure mode TPS bipod debris size and weight. The ET Working Group scenario includes seven simultaneous and interactive adverse events: A large rollover occurs at the inboard stringer interface immediately below the machined foam surface, side-to-side thermal crack/weak knit line, a large void near the topmost surface one inch below machined foam surface, warm SLA environment, and foam machined to minimum tolerances (not a failure). The specific results are shown in Figure 11-13.

The determination of the STS-107/ET-93 bipod TPS debris is based on evaluation of fault tree findings, possible TPS failure modes and contributors, and results to date from TPS debris test programs including dissection, foam loss secondary effects assessment (SLA/BX-250), and bipod TPS debris size analysis. The TPS bipod debris size was determined by the ET Working Group to be approximately 870 cubic inches and 1.3 pounds.

The transport analysis presented in Section 3 suggests that the debris object may be heavier than average foam, but the ET Working Group analysis indicates there could not be ice or significant SLA in the debris and that the density of the foam is consistent. Also, the imagery analysis showed that not all the debris struck the wing, but it broke up prior to impact, with all debris passing beneath the wing, some without impacting the wing. Recall that the transport analysis presented in Section 3 states the bipod TPS debris would be 1026 cubic inches and 1.4 pounds for a 820 ft/sec velocity or 1239 cubic inches and 1.7 pounds for a 775 ft/sec velocity. The RCC foam impact test conducted at Southwest Research Institute was performed at 775 ft/sec with a 1.67-pound foam article.

Foam	
Vol.	~867.2 cu in
Weight	~1.23 lbs
SLA	
Vol.	~1.9 cu in
Weight	~0.02 lbs
TOT	
Weight	~1.3 lbs
