## HYPERGOLIC PROPELLANTS: THE HANDLING HAZARDS AND LESSONS LEARNED FROM USE

B. Nufer

NASA Kennedy Space Center, Engineering Directorate, Fluids Division, Hypergolic and Hydraulic  
Systems Branch

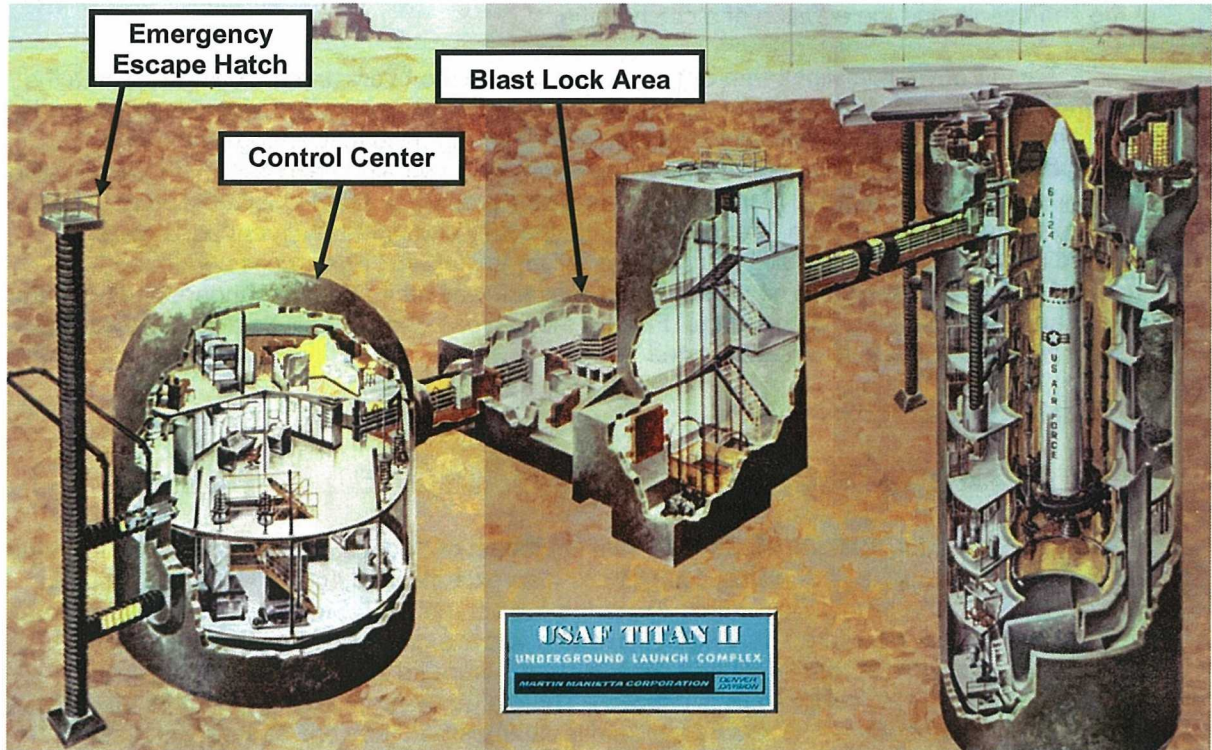
Figure 7: Underground Titan II Missile Complex

Very high concentrations of NO<sub>2</sub> vapors traveled from the silo into the connecting cableway to the blast lock area, which was located just outside of the control center where several personnel were located (see Figure 7). All the personnel located in the blast lock area managed to escape the vapors by exiting through the access portal at ground level. The personnel in the control center would normally be isolated from the silo; however, two technicians involved in the spill opened the airlock door to try and obtain assistance for their supervisor who was in need of immediate medical attention. The two technicians and four other control center personnel then evacuated through the emergency escape hatch, once they realized the immediate danger of the situation. The nearby town of Rock, Kansas had to evacuate about 100 people as a result of the vapors that were escaping from the silo (see Figure 8).

It was later discovered that the suit of the supervisor had failed, introducing him to dangerous levels of N<sub>2</sub>O<sub>4</sub> (NO<sub>2</sub>) vapors, which was ultimately fatal to him within minutes of being

- Proper configuration control of GSE components, in this case the filter, is highly important in the handling of toxic chemicals, especially hypergols (root cause of the incident)
- Emergency procedures and safing must always be reviewed, practiced, and ingrained in the minds of personnel working with toxic chemicals
- Procedural oversight may have been beneficial
- Proper isolation of bulk propellant should be inherently designed into any rocket propulsion system and used accordingly during loading operations
- Personal protective equipment (PPE) should be inspected prior to every use

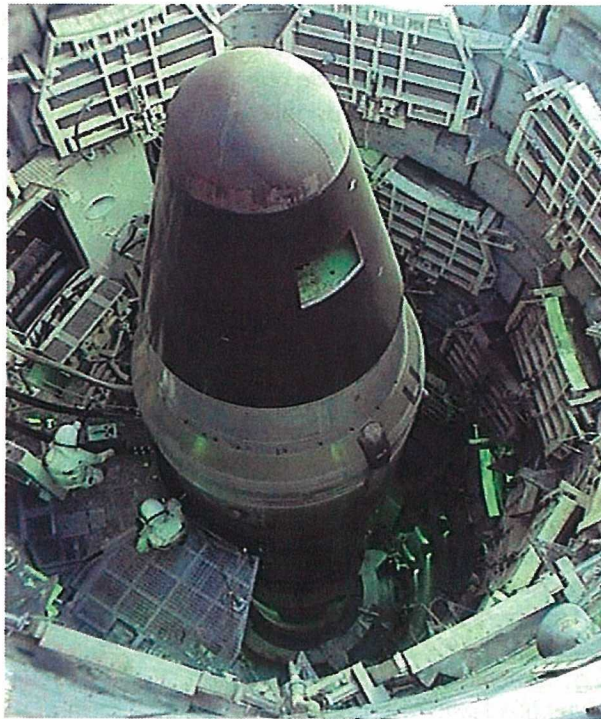
**Figure 9: Technicians Working on Fold-Down Platform in Titan Silo Level 2**

At about 6:30 PM on September 18, 1980, an airman was conducting a maintenance operation on level two (see Figure 9) of the underground silo when he accidentally dropped a large wrench socket. The standing platforms were hydraulically-controlled, flip-down structures with a rubber boot mounted between the platform and the rocket. The socket fell hitting the standing level two platform and bounced in the direction of the rocket where it slipped through the small gap between the rubber boot (which had become pliable over the years) and the Titan II rocket. It fell about 70 feet before hitting the thrust mount near the base of the rocket. The socket then bounced into and ruptured the stage one fuel tank (proximate cause). Approximately 11,140 gallons of A-50 drained into the bottom of the silo. Fuel vapors heated up the silo and caused the pressures in the non-ruptured propellant tanks to rise substantially.

- All workers should wear a belt with lanyards to attach tools
  - Operational human error is, therefore, the root cause
- Cloths should be placed on the platforms to prevent tools from bouncing off the metal

- The Titan II missile silo platforms should be renovated to increase safety
- The training and qualification program was insufficient prior to the incident (a root cause)

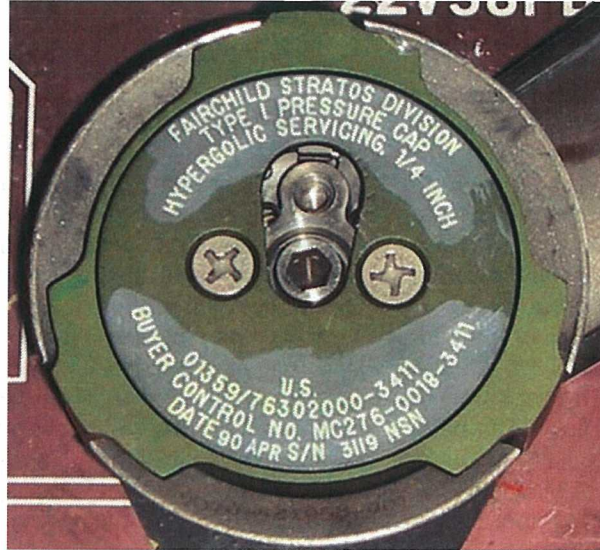
**Figure 11: Fairchild ½-inch Flight Cap**

On roughly July 14, 1981 in OPF1, there was an inadvertent release of N<sub>2</sub>O<sub>4</sub> (NO<sub>2</sub>) vapors during the MD338 flight cap installation procedure. The cap was removed from MD338 on June 15, 1981 and routed to another facility with a fume hood for refurbishment. During the refurbishment procedure the incorrect part number (MC276-0018-2411, a ¼-inch flight cap, see Table 1 for a description of the numbering nomenclature) was recorded for the cap and a parts tag with the incorrect number was attached. The correct part number was MC276-0018-2811 (a ½-inch oxidizer flight cap, shown in Figure 11). There had been issues with oxidizer flight caps becoming corroded; therefore, a problem report (PR) was generated to clean the caps. During the cleaning procedure the part number that was etched onto the cap was sanded off and all that was left to identify the cap was the attached parts tag (which was incorrect).

During the MD338 flight cap installation procedure, on roughly July 14, 1981, the work step correctly called for the installation of a ½-inch cap (part number MC276-0018-2811) onto the AHC. The cap that was staged for installation was the misidentified ¼-inch cap. When a ¼-inch cap is placed onto a ½-inch AHC, the dimensions of the stem allow for the actuation of the ½-inch AHC poppet (reference Figure 30 for an illustration of this) if the proper force is applied to the cap and poppet. This is exactly what happened. An oxidizer vapor release was reported when the technician tried to install the ¼-inch cap (proximate cause). The root causes are human error, improper configuration management, and improper vehicle design. The original flight cap design should not have enabled this type of incident to occur. The technician received minor injuries from exposure to NO<sub>2</sub> vapors. Close attention needs to be paid to the identification of flight caps and other hardware to prevent an event like this from occurring again (which it does on November 4, 1992 at WSTF).

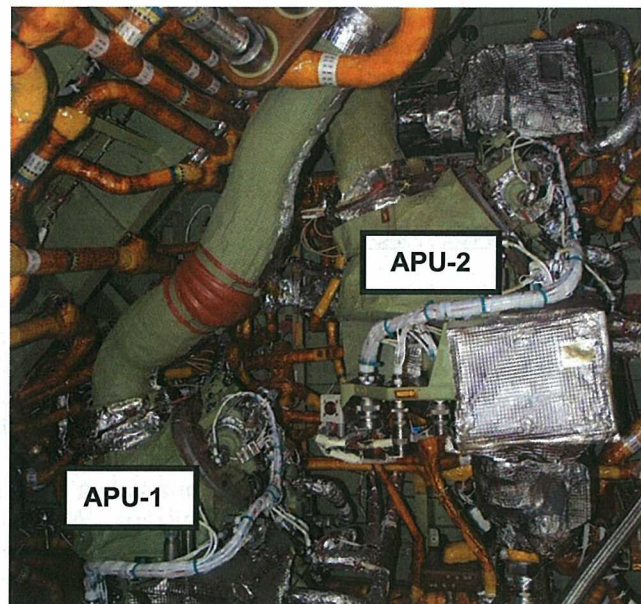
**Figure 19: APU-1 and -2 in a Nominal Configuration**

On December 8, 1983, Space Shuttle Columbia landed at EAFB at 3:48 PM pacific local time, concluding the STS-9 mission. About seven minutes after landing, an unusual series of events occurred. First, APU-1 shut down prematurely in response to a sensed turbine "underspeed" condition. About four and a half minutes later an explosion occurred in the APU. Figure 18 shows what remained of the APU-1 fuel pump following the explosion along with the resulting collateral damage. At the instant of the APU-1 explosion, APU-2 spontaneously shut down. Fifteen minutes later it exploded. Figure 19 is a photograph of APU-1 and APU-2 in the aft of OV-105 (similar to the OV-102 configuration). APU-3 ran nominally.

Following the STS-9 flight, several changes were made to the APU subsystem, including soaking of the carbon seals in hydrazine prior to installation, chromizing the injector stems to prevent corrosion, and minimizing stresses on the injector stems during manufacturing and installation. These design flaws are believed to be the root causes of the incident.

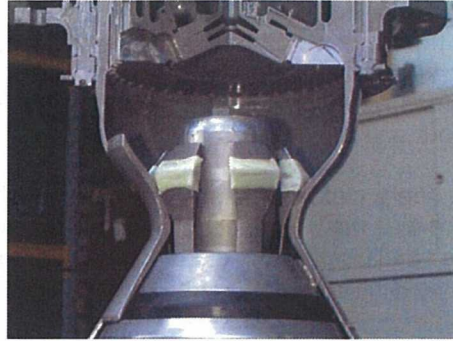
**Figure 20: Space Shuttle Thruster Chamber Cutaway with Purge Adapter Installed**

On May 24, 1985, while preparing for the removal of R4D (down-firing thruster on the Space Shuttle right pod) from OV-099, there was an MMH spill in OPF1 on the 10-foot level west side. R4D was being removed as a result of an in-flight anomaly related to a heater failure on the thruster. The manifold had been drained of its propellant and it was thought that a purge through the MD348 line (which connects to the manifold) and out the thruster nozzle purge adapter was sufficient to remove the liquid and most of the fuel vapors. Figure 20 shows a purge adapter in a cutaway of a primary thruster nozzle. During the part of the procedure where the purge adapter was being removed, approximately one cup of liquid MMH spilled from the thruster and down onto the body flap (which is illustrated relative to thruster R4D in Figure 21). The body flap was partially covered with spill protection sheets. The OPF1 hypergol exhaust fans were activated and the facility was immediately evacuated. It was recorded that some of the liquid MMH had saturated the body flap tile filler bar. It is unknown if the tile had to be removed. Unlike N<sub>2</sub>O<sub>4</sub>, which was known to breakdown Koropon primer (from the STS-2 N<sub>2</sub>O<sub>4</sub> spill mentioned previously), the effect of MMH on Koropon was not well known in 1985.

There are three possible proximate causes to this spill. A combination of two or more of the following causes is also possible. The first involves an improper configuration in which the flexhose that was being used for the procedure had previously been utilized for a similar operation on the left pod thruster L1U's manifold. This flexhose was several feet longer than the flexhose that was normally used for the right pod manifold evacuations. It was routed from the R4D thruster purge adapter to the 19-foot level above, then down to the eductor on the 10-foot level. This excessive length in hose may have allowed for a "u-shaped" low point trap to be formed in which liquid MMH could have collected. The second possible proximate cause involved a procedural error made by the engineers on console. The evacuation could have created a pressure differential across the liquid MMH. When the eductor was deactivated and removed, this pressure differential may have pushed the liquid into the thruster chamber. The third possible proximate cause was the liquid had collected in the thruster chamber (see Figure 20) and the purge was of insufficient duration to remove all the liquid MMH or the liquid trap may have

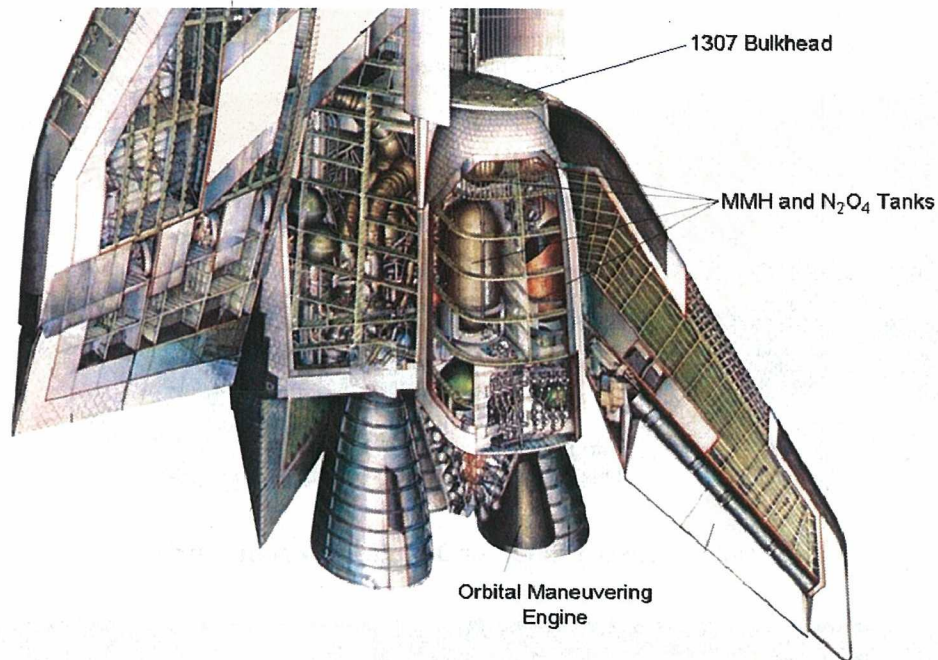
**Figure 25: Cutaway View of Space Shuttle Orbiter Aft**

On July 14, 1988, about three days after the loading of  $N_2O_4$  onto Discovery at Pad 39B for the STS-26R Return to Flight mission, a small  $N_2O_4$  ( $NO_2$ ) vapor leak was detected in the left OMS pod (LP04) of Discovery. STS-26R was the first flight following the Challenger disaster on January 28, 1986. The leak did not result in any injuries or hardware damage, but it did impact the launch date of Discovery. Along with several other Return to Flight actions, the launch team at KSC was required to test fire the three main engines on Discovery while it was at the launch pad. This was known as the Flight Readiness Firing (FRF) and was scheduled to occur on July 26, 1988. The Space Shuttle Program decided to complete the FRF regardless of the known oxidizer vapor leak; therefore, the engineering team assigned to assess the leak had a couple weeks to study possible solutions, while other groups were preparing for the FRF.

First, the exact location of the leak within the pod had to be found (a cutaway view of the Space Shuttle OMS pod can be seen in Figure 25). This was difficult because the internals of the aft pods and forward module are not meant to be accessed while the vehicle is at the launch pad. The location of the leak had been isolated to the LRCS  $N_2O_4$  system or the associated tubing through monitoring of the instrumentation in the LCC. The leak was measured to be 0.26 psi per hour (about 800 standard cubic centimeters per hour) and a TVC found the concentration of  $NO_2$  vapor to be 15 ppm at the vehicle vent door. This later decreased to 3 ppm. An access door was removed on the pod's outer skin and several internal thermal blankets were removed. A long section of PVC pipe was then inserted into the pod to function as a guide for a borescope. Using a borescope, the leak was finally isolated (after a six hour search) to a ½-inch dynatube fitting on the MD224 leg (the  $N_2O_4$  propellant tank ullage vent). A cross-section view of a dynatube is shown in Figure 26 and a photograph of the leak location can be seen in Figure 27.

The engineering team came up with the following solutions to resolve the leaking dynatube:

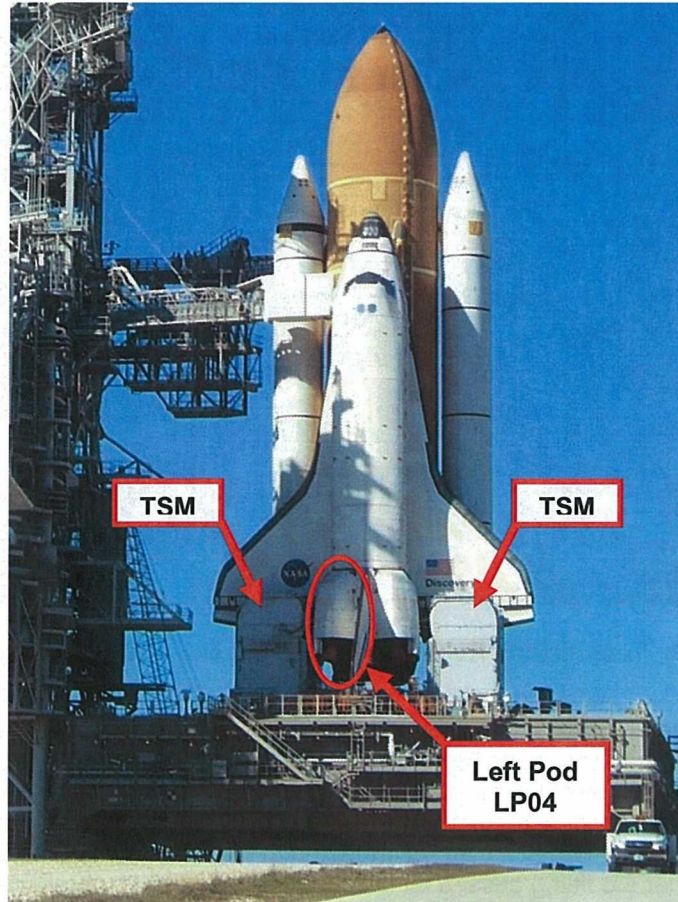
**Figure 28: Location of Left Pod on Space Shuttle**

- The orbiter aft pods are not able to be removed and replaced at the launch pad since the removal and handling equipment does not exist for this type of operation and the pods are obstructed by the MLP tail service mass (TSM), shown in Figure 28

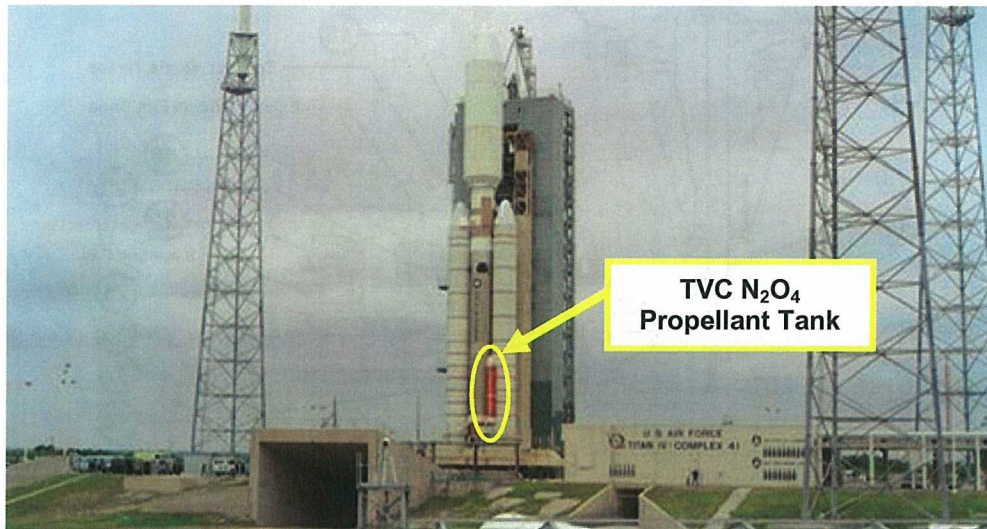
**Figure 31: SLC-41 with Titan IV A (Servicing Structure Retracted)**

On August 20, 1994, at Space Launch Complex 41 (SLC-41) on CCAFS there was a large release of liquid N<sub>2</sub>O<sub>4</sub>. Oxidizer was being loaded into the Titan IV A's solid rocket motor (SRM) thrust vector control (TVC) system in preparation for the launch of the National Reconnaissance Office's Mercury Electronic Intelligence or ELINT satellite on August 27, 1994. The N<sub>2</sub>O<sub>4</sub> was used to alter the combustion in the Titan IV A SRM nozzle and, therefore, provide TVC. A photograph of the SLC-41 launch pad with a Titan IV A is shown in Figure 31. A diagram of the Titan IV A's TVC system is shown in Figure 32 with the numbered callouts listed in Table 2. The incident occurred about three and a half hours after sunrise when the solar heat caused the pressure to increase in the N<sub>2</sub>O<sub>4</sub> tubing while the system was in a static configuration.

The pressure increase went unnoticed by the engineers and technicians. Remote data monitoring was available on the launch vehicle, but not on the propellant transfer systems (GSE). Local dial gauges likely showed the increase in pressure; however, there were no technicians monitoring these particular gauges. The pressure rise eventually caused a weld seam to fail at the base of the transfer system (proximate cause). This portion of the N<sub>2</sub>O<sub>4</sub> servicing GSE lacked a relief valve, thus allowing the propellant in the tubing to become "liquid locked" since a drain-back and purge had not been completed (improper design; a root cause). There was no damage to the GSE (excluding the ruptured tubing) or vehicle hardware and there were no reported injuries.

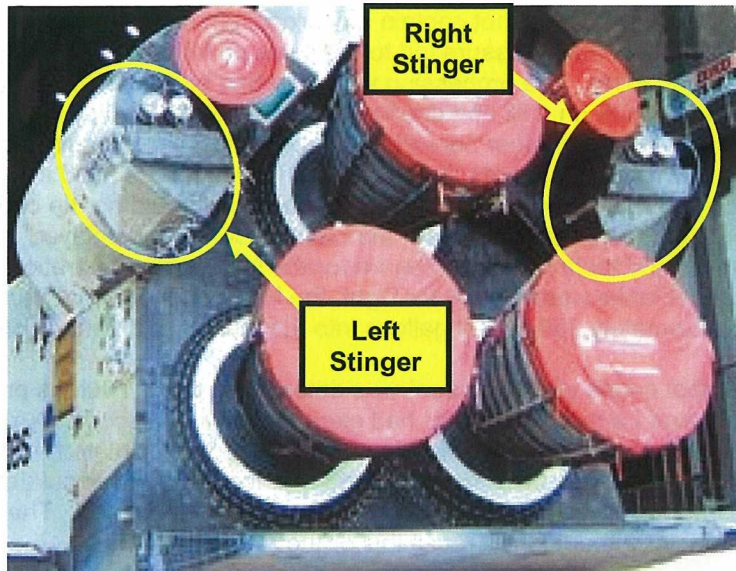
**Figure 33: Stinger Locations on Orbiter**

During the STS-69 OV-105 flow, while performing a thruster L3D removal and replacement, an MMH flame was reported in the Space Shuttle left OMS pod stinger area (see Figure 33 for the relative location of the stingers). The technician in SCAPE was preparing to inspect the dynatube (approximately an hour after the thruster was removed) with a mirror when he reported a small flame on the MMH thruster feedline dynatube. Another technician was unable to find any water to put out the fire and mistakenly picked up an alcohol bottle and sprayed the flame which produced a small flash near the feedline, igniting the residual MMH inside it. It is believed that the technician thought the spray bottle was Freon. It was reported that the flame was extinguished by the technician placing his SCAPE glove over the dynatube end. This was probably not the best idea since MMH can react exothermically in a rigid volume and burn in an atmosphere 2.5% to 98% by volume in air.

Prior to the reported fire, the technician removed the Aclar (plastic film) bag from the open end of the thruster feedline dynatube fitting. This fitting connects the manifold to the thruster. When he did this, he noted that there was an exceptionally large amount of fuel vapor present and some liquid MMH was dripping from the open line. The technician proceeded to place the aspirator directly on the feedline dynatube (the procedure and known practice was to place the aspirator perpendicular to the dynatube exit). This was likely the proximate cause of the fire. The engineer on console then noted that the manifold pressure dropped from 16 psia indicated to 6 psia indicated in about five seconds (the transducer had a 2 psi offset). The manifold pressure stabilized to 16 psia indicated after a couple minutes. At this point, the technician was instructed by the engineer to remove the aspirator from the dynatube. He did this and then left the area to find a mirror to aid in the dynatube inspection. When he approached the dynatube with the mirror he noted a "cream/yellowish color" flame and "heat waves." As previously mentioned, he proceeded to put out the flame with his glove after the other technician doused the area with alcohol.

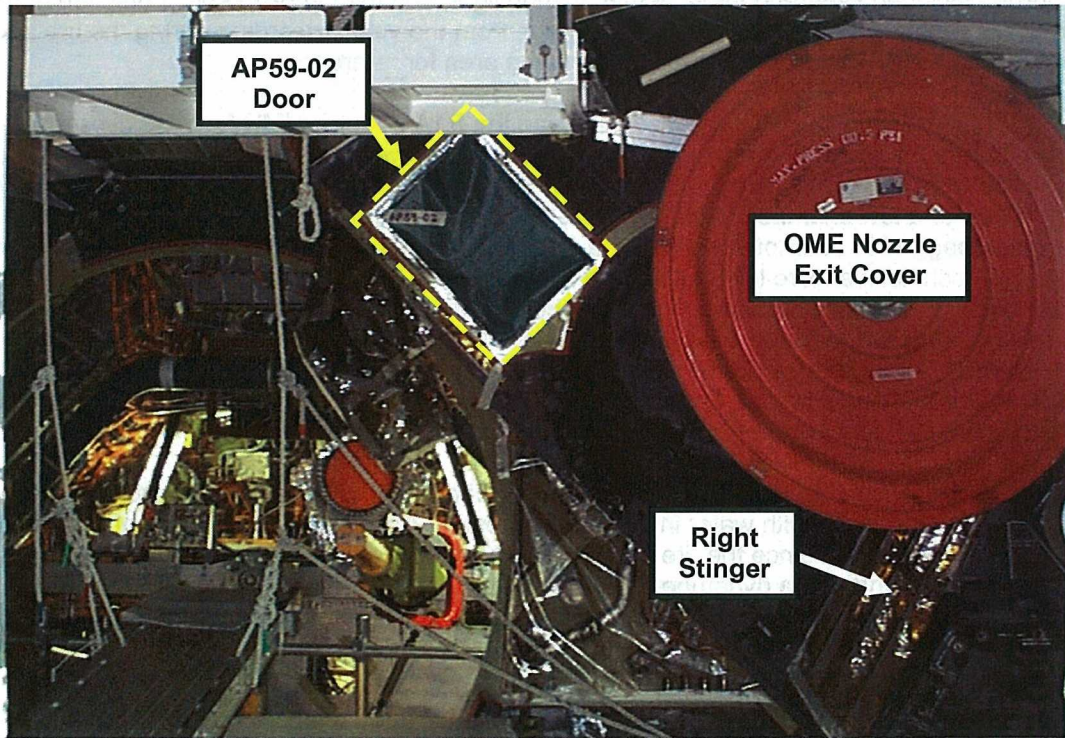
Figure 35: Color Photograph of Right Pod and Orbiter Aft

During the STS-69 OV-105 flow, while performing a thruster R1A removal and replacement, a fire broke out in the Space Shuttle right OMS pod stinger area. The fire burned strongly for about 30 seconds and a smaller flame burned for about one minute and 45 seconds. The size of the flame was estimated to be approximately 15 inches x 11 inches x 11 inches with a damage region of approximately 22 inches x 14 inches x 14 inches in the stinger. The materials that burned included several ounces of fuel, a shop light, and the Orcofilm spill protection (flame retardant covering films). Figure 34 is a still image from the video recording during the fire and Figure 35 is a clearer color photograph of the same area for reference.

The engineers on console in the LCC believed that they had purged the manifolds enough to reduce the residual MMH to manageable levels. Immediately preceding the feedline dynatube disconnect, the engineer on console incorrectly read the fuel feedline pressure transducer on the vehicle. The subject transducer indicated 16 psia (approximately atmospheric pressure). In actuality, the transducer was biased low (as determined from a previous test completed during the OMDP of RP01 about 18 months prior); therefore, the actual pressure in the manifold had increased to about eight psi above atmospheric pressure. There had also been a shift change between the venting and disconnection operations which may have led to the transducer bias going unnoticed. The increase in pressure may have been a result of a leaking manifold one isolation valve (LV317, the valve holding back the bulk propellant from the feedline).

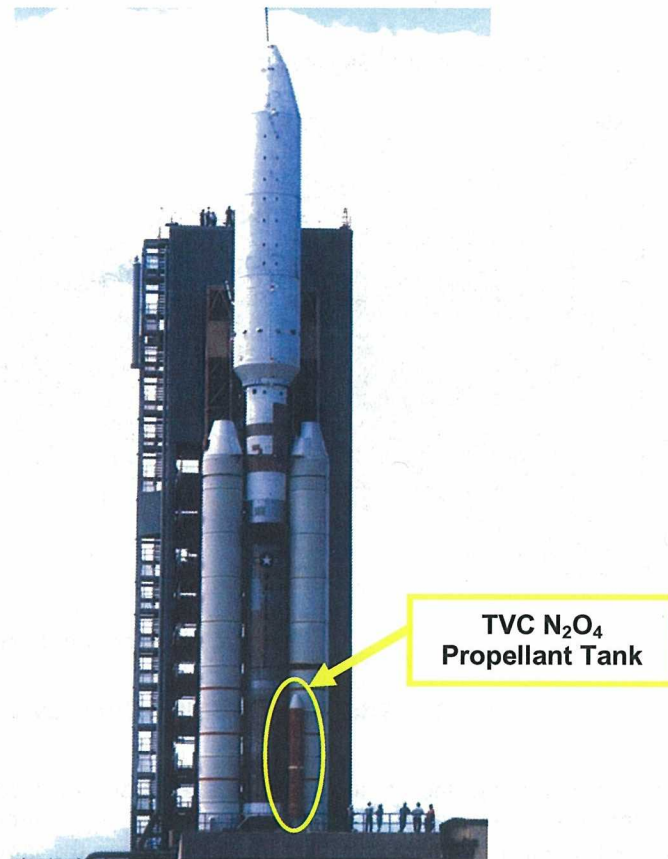
**Figure 38: Titan IV A on Launch Pad**

On July 16, 1997 engineers at VAFB SLC-4E were remotely pressurizing the two N<sub>2</sub>O<sub>4</sub> propellant tanks, one each on the two Titan IV A's SRM TVC systems. Reference **Error! Reference source not found.** for a diagram of the TVC system. The propellant tank servicing was completed without incident about nine days prior to the pressurization. Each tank contained about 8,400 lbs (702 gallons) of liquid N<sub>2</sub>O<sub>4</sub>. The rocket was being prepared for a planned mid-July 1997 launch on a Department of Defense mission to replace an aging reconnaissance

satellite. Figure 38 shows a Titan IV A configuration at its launch pad and points out the location of the  $N_2O_4$  tank.

About 20 minutes after initiating the propellant tank pressurization, liquid  $N_2O_4$  was observed to be streaming out of the aft skirt heat shield region on *both* SRMs. There were no reported injuries and the flight hardware had minimal collateral damage (mainly on the SRM nozzles). At the time of the observed  $N_2O_4$  release (likely initially noticed by the signature brownish-orange  $NO_2$  vapors characteristic of an  $N_2O_4$  spill) the propellant tanks were at a pressure of about 830 psi. The target pressure was about 1,040 psi. The engineers quickly began to depressurize the propellant tanks, which had the immediate affect of decreasing the rate of propellant release. The tanks were vented from their initial pressure of about 830 psi to a final pressure of 38 psi, at which time the  $N_2O_4$  release ceased. At that time, all systems were secured and the operation terminated. It was decided to offload all of the propellant from the subject tanks, so about eight hours later, the engineers and technicians began the offloading procedure. This operation was completed without incident. Following the offload and evacuation of the TVC  $N_2O_4$  system and tubing, the total amount of propellant transferred was estimated. About 1,160 gallons of  $N_2O_4$  was re-captured as a result of the drain-back. This logically implies that about 244 gallons of  $N_2O_4$  was released to the atmosphere.

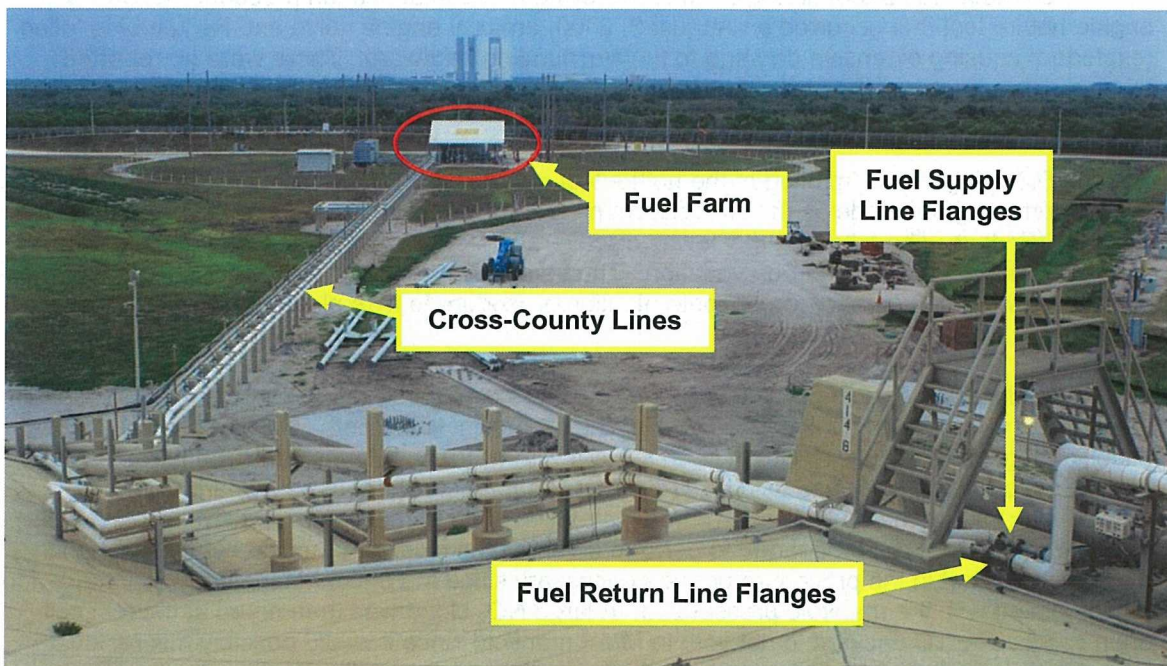
**Figure 44: Former Site of Fuel Cross-Over Valve Complex at Pad 39A**

Following this incident, the Pad 39B drawings were updated to require the installation of the proper flange seals. All the cross-over valves were removed and replaced with flanged pipe as they were no longer needed for hypergolic propellant loading. This reduced processing time on the valves and greatly reduced the risk of a leak at the valve flanges. Figure 43 is a photograph of the location where the cross-over valve complex was previously located at Pad 39B and Figure 44 is a photograph of the location of the Pad 39B fuel cross-over valve complex with the fuel farm and Vehicle Assembly Building in the background.

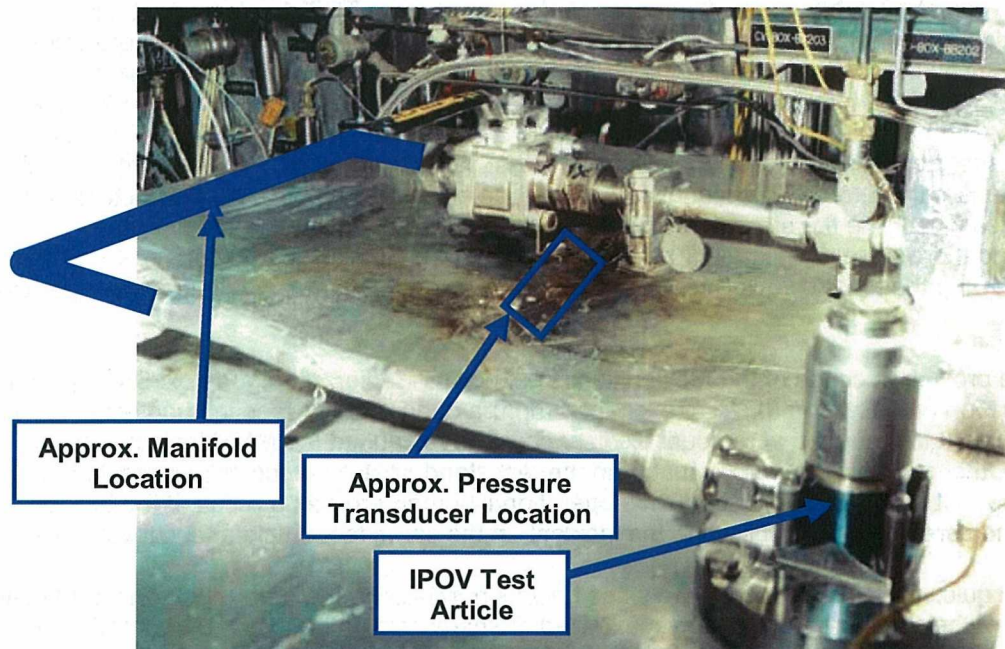
**Figure 45: IPOV Test Setup**

On March 25, 2003, in Test Cell 831 at WSTF, during the life cycle testing of an N<sub>2</sub>O<sub>4</sub> Improved Pilot Operating Valve (IPOV), there was an explosion. Following the explosion, there was an N<sub>2</sub>O<sub>4</sub> vapor release (approximately three quarts) into the test cell. There were no reported injuries since the cell was vacated prior to starting the test. It was found that a pressure transducer had catastrophically failed as a result of a material incompatibility within the pressure transducer (proximate cause). Figure 45 is a photograph of the test setup following the explosion with the relative location of the pressure transducer prior to the explosion.

Initial inspections of the pressure transducer indicated that the transducer failed as a result of one of the following: over-pressurization, inadequate design, or cyclic fatigue at a highly stressed location. Since the pressure transducer failed, data from it at around the time of the failure may be suspect; therefore, the investigation included a detailed inspection of the nearby system tubing to determine if there was an over-pressurization event. Close inspection of the pressure transducer itself would indicate if the transducer failed from cyclic fatigue or was subject to a ductile failure from a single overload event.

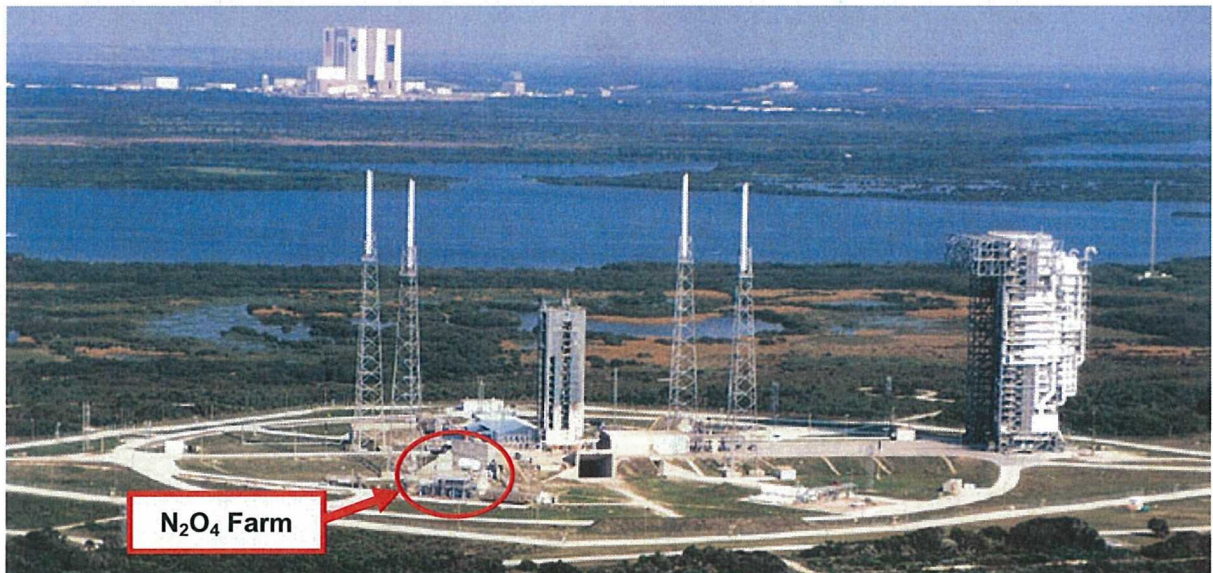
**Figure 47: LC-40 at CCAFS**

On August 12, 2003, at CCAFS launch Pad LC-40 (shown in Figure 47) during the bleed-in operation for the B36 Stage II (Titan IV) propellant load, the oxidizer centrifugal pump exploded (proximate cause of the N<sub>2</sub>O<sub>4</sub> spill). The Titan IV launch vehicle was being loaded in preparation for the September 9, 2003 launch of the National Reconnaissance Office's payload. Along with the liquid N<sub>2</sub>O<sub>4</sub> release of approximately 40 gallons, the explosion created a large amount of shrapnel which caused significant damage to the surrounding GSE. The pump was completely destroyed as shown in Figure 48. Fourteen people reported to an on site health facility. They were all later released without injury. The storage tank holding several thousand gallons of liquid N<sub>2</sub>O<sub>4</sub> remained intact with minimal damage. An extensive investigation was initiated as a result of the Space Shuttle Program using these same pumps at Pads 39A and 39B (eight pumps in four locations) along with the Titan program which used them at LC-40.

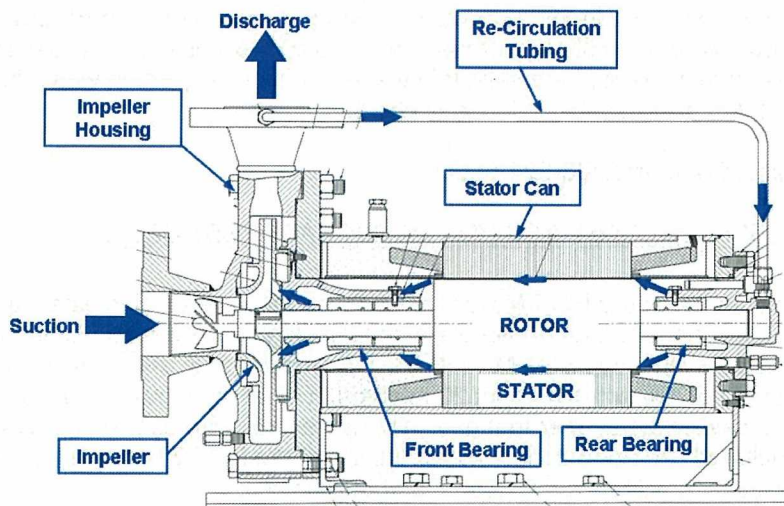
**Figure 49: Pump Schematic**

The incident failure analysis concluded, according to Crass, that there was a “cooling anomaly at the [carbon graphite journal] bearings...leading to [an explosion] in the stator can winding area.” It was found that the most likely contributor to this was a clogged filter in the pump recirculation loop that circulates liquid through the rotor cavity to cool the front and rear bearings as illustrated in Figure 49. Data analysis showed that the upstream and downstream temperature transducers indicated an increase in temperature of 8 °F across the pump. The low flow rate of 40 gpm and high ambient temperatures (high of 86 °F for 8/12/2003) accelerated the failure of the pump. At these flow conditions, the pump was not able to be properly lubricated as a result of the high vapor pressure of liquid  $N_2O_4$  (these particular pumps are designed to be lubricated with the liquid that they are pumping). The excessive bearing wear led to damage to the stator liner can, allowing oxidizer to leak onto the hot copper windings. The  $N_2O_4$  reacted with the copper winding insulation and caused the coil wire to short, which was the proximate cause of the explosion.

Following the explosion, there were some design changes made to the pumps since an improper pump design was a root cause, these changes include the following:

- Machining of the pump from a single billet of stainless steel rather than casting them
- Serrations were added on the impellor housing and rear bearing housing for improved sealing capability
- The addition of a thermowell for thermocouple monitoring rather than the old thermostwitch which proved to be unreliable

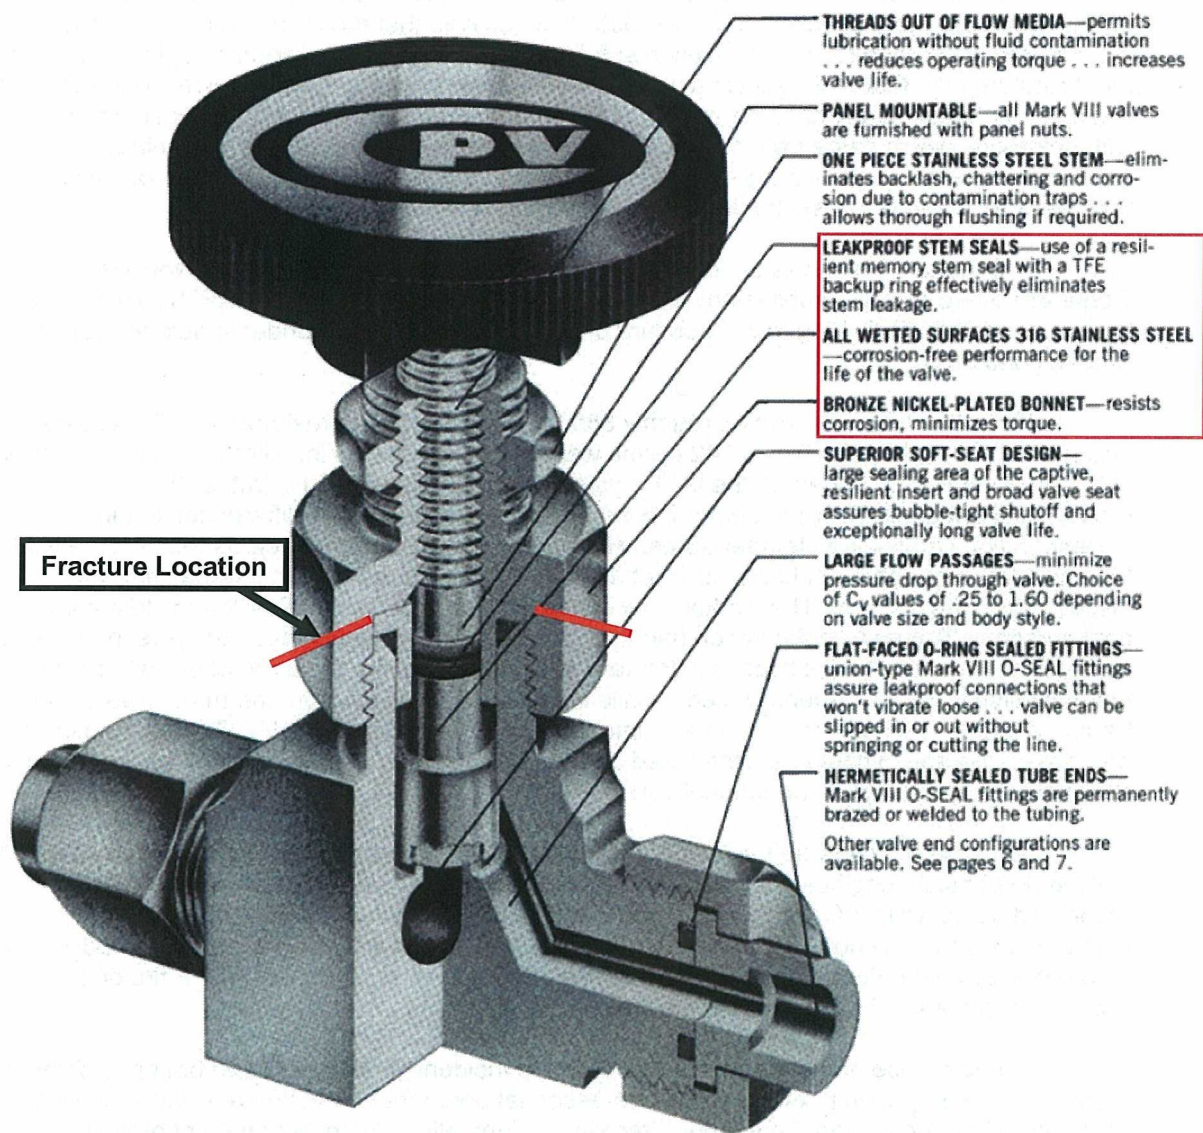
**Figure 51: Schematic of Failed Manual Valve**

The failure began as an intergranular crack in the nickel-plated, aluminum bronze bonnet threads (fracture surface shown in Figure 50). It is believed that the crack began as a result of the ethylene propylene rubber and Teflon soft seals allowing corrosive agents to slowly leak into the thread region. Figure 51 shows a cross-section cutaway of the manual valve. The Teflon soft seals can be seen clearly near the middle of the threaded shaft. The corrosive agents reacted with ammonia, which came from the decomposition of  $N_2H_4$  ( $N_2H_4 \rightarrow 1/3 N_2 + 4/3 NH_3$ ). This accelerated the local corrosion and cracking. This was the first failure for this type of valve since they were procured and installed in several hypergolic systems at WSTF in 1994.

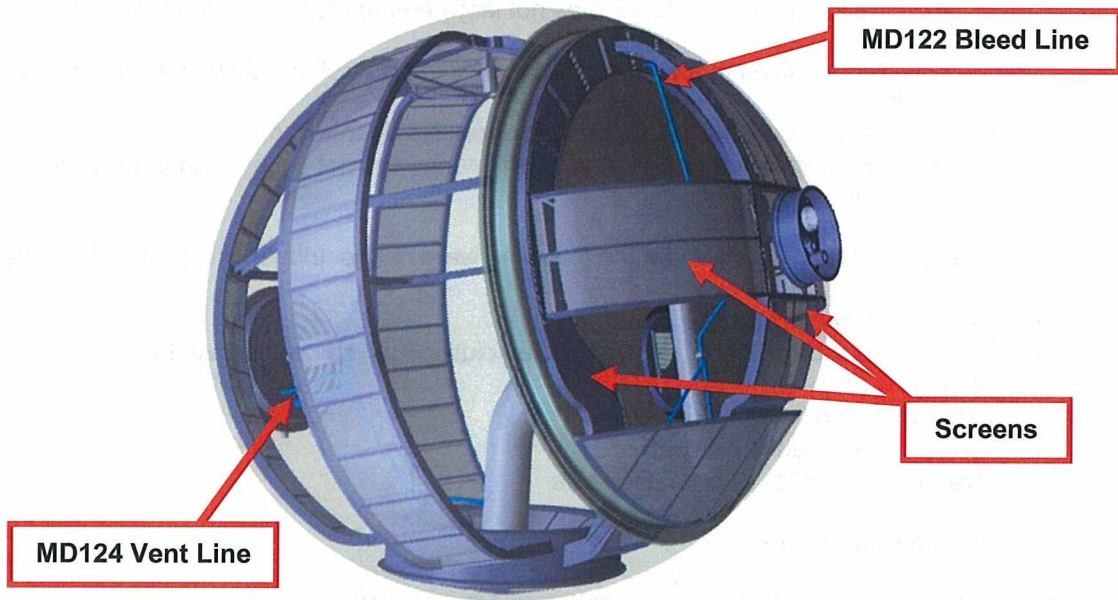
**Figure 52: Solid Model of RCS Propellant Tank in (Roughly) the Horizontal Orientation**

With the vehicle in a horizontal orientation, the MD122 line runs from the high point of the oxidizer tank lower compartment channel, through an interface at the tank outlet flange, and out to an AHC located in an externally accessible door on the FRCS outer mold line (AP28-00 door). It is known through pressure measurements that the MD122 and MD120 connected GSE lines were clear of any liquid immediately following the two, five-minute purges; however, it is not known if the propellant acquisition system channel in the lower compartment was broken down (i.e. it did not contain any liquid). If the screen was not completely broken down, it is possible that liquid oxidizer “wicked” up the screen following the purges to the point where MD122 connects to the acquisition screens. See Figure 52 for visual aid of the propellant acquisition system screens

and the MD122 line. The absence of liquid in the lines can be confirmed by noting that there was not any significant pressure increase in the lines. The tank was *not* in thermal equilibrium. The tank shell (skin) temperature rose from 49 °F, when tank venting was complete, to 58 °F, when MD124 GSE vent valve was opened for the emergency vent through MD124 in the upper compartment of the tank. When the two purges were complete the tank shell temperature was 54 °F. From the time of the spill to the emergency MD124 vent, the tank shell temperature rose from 57 °F to 58 °F. The fluid and gas temperatures likely rose by a degree or two during this time.

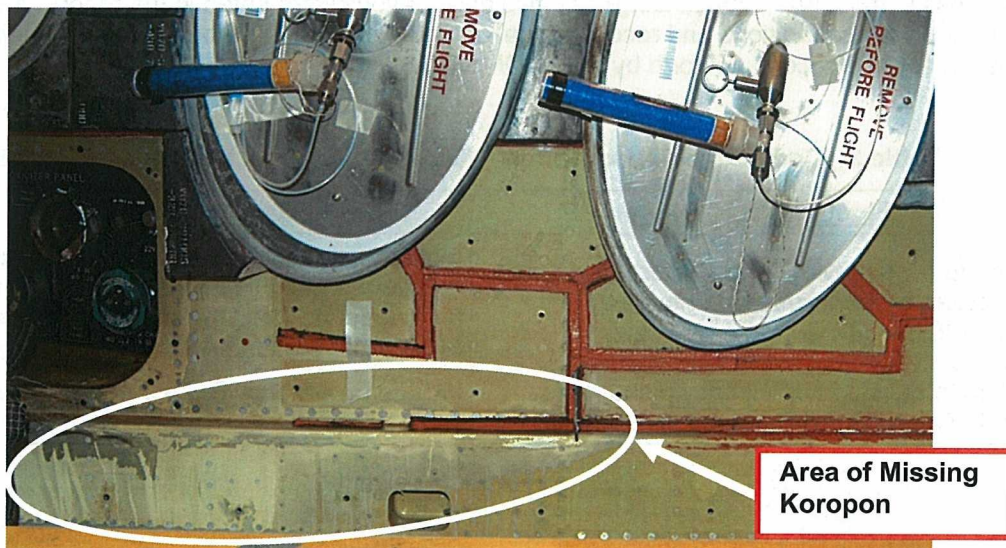
**Figure 54: View Looking at R/H Side Down-Firing Thrusters (F2D & F4D)**

The spilled oxidizer appears to have reacted with Koropon, RTV, and silver plating (nutplates and barrel nut elements). The oxidizer vapors reacted with the Koropon and removed a large area, as shown in Figure 54, and passed through the nutplate holes and around the perimeter of the phenolic QD service panel into the interior of the FRCS module, as shown in Figure 55, causing damage to the Koropon on the interior side of the FRCS module.

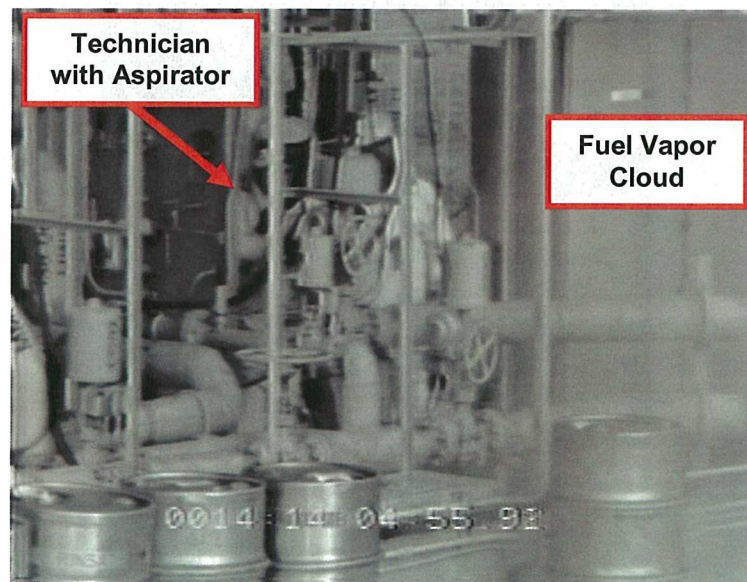
**Figure 56: Screen Capture of Video during Spill**

In preparation for the component removal, the tubing was purged to clear out residual liquid MMH and fuel vapors. All the necessary valves were closed to isolate the particular section of the servicing system tubing. Once a spare component was obtained, the pressure transducer was removed from its ¼-inch lines that connect to the three-inch fuel supply pipe that runs to the launch tower at launch pad 39A. A few drops of fuel were noted when the pressure transducer was removed. During an inspection by the SCAPE technicians, it was found that they had the incorrect connection fittings. The technicians relocated to their work bench several dozen feet away to swap the connection fittings from the old pressure transducer to the new one. Console operators in the LCC began to notice “smokiness” on their closed circuit, black and white video monitors. This was not reported to the technicians who relocating back to the removal site. When they arrived, the SCAPE technicians reported a steady stream of liquid MMH coming from the ¼-inch tube from which the pressure transducer was removed. One technician immediately placed an aspirator below the line to collect the liquid (shown in Figure 56) while the other began to douse the area with water from a nearby fire hose. Direction was given by the console engineers to use a manual overdrive wheel on an upstream valve in attempt to isolate the liquid source. The leak was stopped by this action.

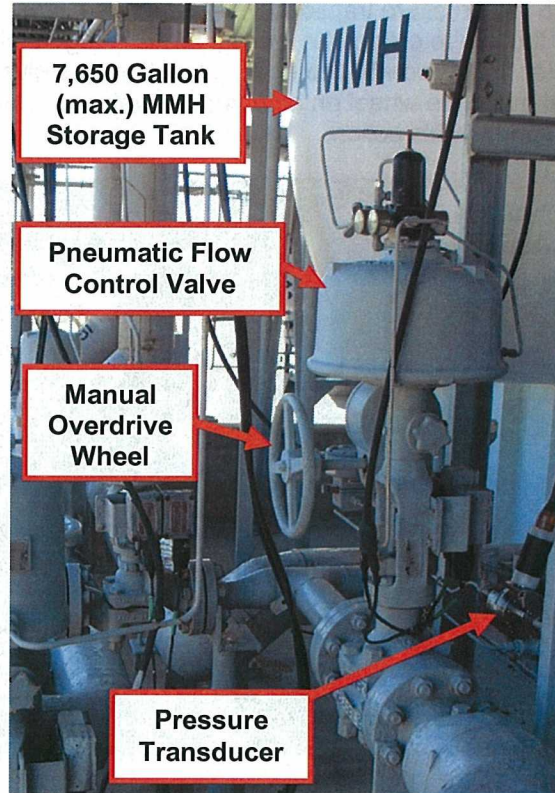
**Figure 57: Pad 39A Fuel Farm Pressure Transducer Location**

Normally, when this component is replaced the system is dry as a result of weeks without use. However, in this case, the system had just been wetted and then purged. It is well known that it takes a few days for the propellant to completely drain back into the storage tank from the servicing distribution system tubing. The liquid accumulated in the tubing (and subsequently spilled out the ¼-inch line) as a result of a leaking upstream pneumatically operated flow control valve, which is shown in Figure 57.
