Selected Lessons Learned in Space Shuttle Orbiter Propulsion and Power Subsystems

Francisco J. Hernandez¹, Hugo Martinez², Abigail Ryan³, Shayne Westover⁴, and Frank Davies⁵

NASA/Johnson Space Center, Houston, TX 77058

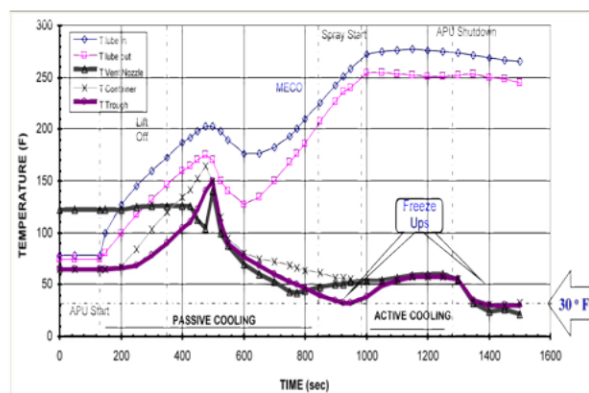
Figure 12: WSB temperatures during ascent

Throughout the shuttle history, the WSB has exhibited over 36 cases of freeze-ups flown with water pre-load (>33% of all the Orbiter WSBs) that prevented cooling, resulting in impacts to safety, mission success and mission operations. These freeze-ups typically occurred during ascent, prior to APU shutdown, as well as post-APU shutdown, as a result of the ice formation that forms in the container under space vacuum conditions. The high altitude environment promotes water-to-ice formation via flash-freezing conditions above an altitude of 126,000 feet, where the ambient pressure drops below the water triple-point of 4 torr (Fig. 12). STS-3 had likely the most significant event where a WSB freeze-up resulted in the early (pre-MECCO) ascent shutdown of an APU. Numerous unsuccessful design and operational attempts were taken to address the freeze-up problem. Implementation of an azeotropic mixture of Propylene Glycol Monomethyl Ether (PGME) and water successfully solved the problem. The lesson learned from this are: to avoid open to space vacuum cooling system where the cooling fluid pressure drops below its triple point, causing freeze-ups and blocking flow passages and orifices.

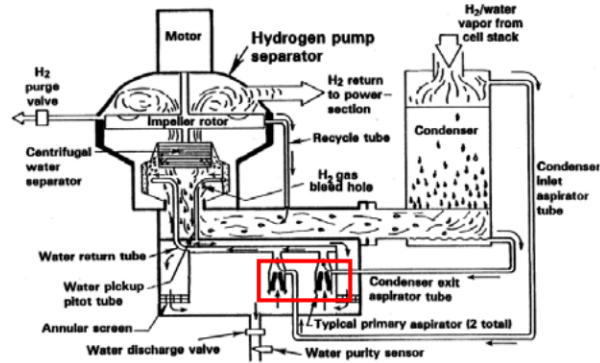
Fig 26: H₂ Pump Separator schematic; aspirator tubes highlighted in red square

Post-flight, it was determined that an H₂ pump aspirator orifice (Fig. 26) was plugged with some contamination particle and that, without a properly working water separation system, the fuel cell had flooded. The aspirator was replaced with a recycle line, and filter screens were added to keep out contamination. Further, realizing that there was not enough insight into how the water separation system was functioning, the team added an H₂ pump motor sensor that would indicate motor failure. Further, the team added a bus-tying procedure to the flight rules that would

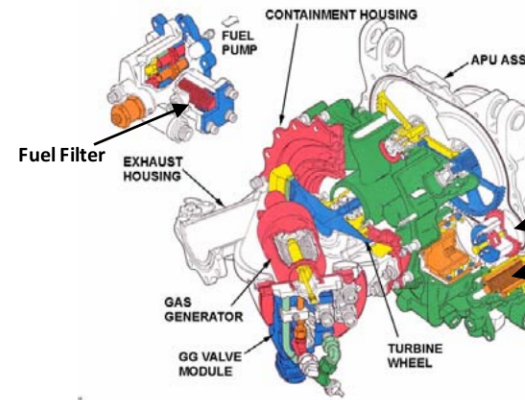
Orbiter APU Unit

- STS-9 APU 1 and 2 fires during entry and APU detonations post landing caused by stress corrosion cracking in GG injector stems.
 - ☼ Reduce installation and removal stresses on critical materials; monitor if necessary.
 - ☼ Reduce residual carbon and stresses from manufacturing process.
 - ☼ Implement periodic inspections (e.g., borescope) and maintenance plan based on critical parameters and expand as data/experience is gathered.
 - ☼ Conduct qualification or fleet lead program to uncover time-related problems.
 - ☼ Change to a chromized-layer injector also brought up the unintended consequence of nitriding/flaking of chromium layer.
- See following pages for additional lessons

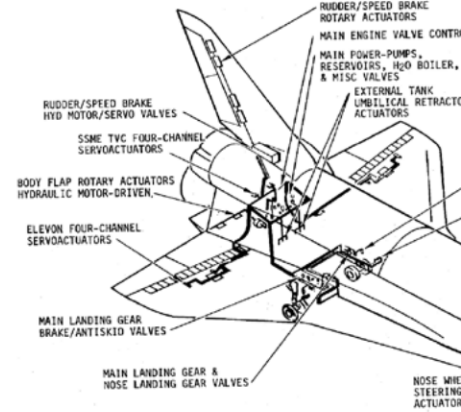
Orbiter Hydraulic Subsystem

- On STS-76 ascent, a hydraulic system #3 leak developed, with the leak rate increasing to 1%/min.
 - ☀ Always verify the system integrity after any intrusive work is performed on the hardware.
 - ☀ Subjecting the component (e.g., flexhose) to vibrations could reveal a leak that could go undetected on the ground.
 - ☀ Design the system for ease of leak checking and integrity verification.
- Main Pump port cap to housing pulled out inserts due to incorrect use of bolts prior to STS-109.
 - ☀ Need adequate mandatory inspection points (MIP).
 - ☀ Careful assessment of helical coil inserts, and torque requirements.
 - ☀ Design critical joints to be: low maintenance, easy to inspect, prevent moisture intrusion/corrosion, high pullout strength, and preload consistency (nut factor).

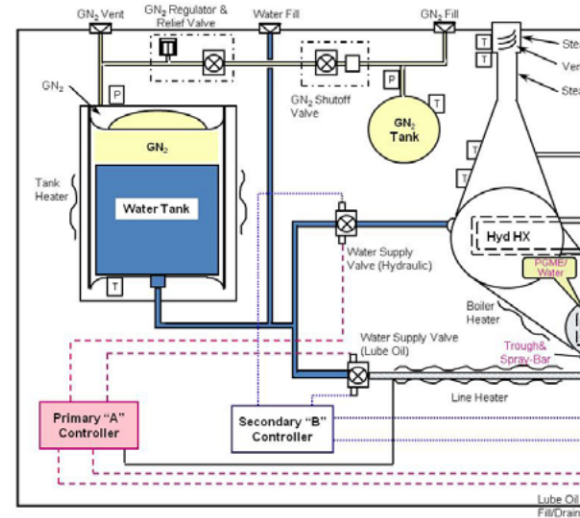
- WSB regulator leaks.
 - ☼ Select soft-good materials with higher strength and elasticity.
 - ☼ Impose a tighter and cleaner ATP requirement at the vendors.
 - ☼ Reduce gas supply filter size (e.g., 10 microns).
 - ☼ Avoid designs that require relief valve actuation as part of nominal system operation, particularly during the dynamic ascent phase.
 - ☼ Continuously trend hardware data to uncover early any degraded performance.
- Water Spray Boiler freeze-ups on more than 30 flights and >33% of units.
 - ☼ Avoid open to space vacuum cooling system where the cooling fluid pressure drops below its triple point; causing freeze-ups and blocking critical flow passages and orifices. Utilize a low vapor pressure cooling fluid.

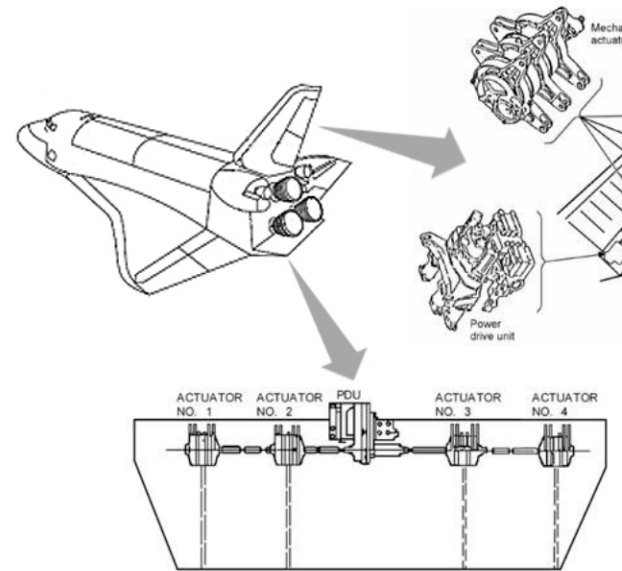
Rudder/Speedbrake and Body Flap actuation system

- External corrosion, internal wear, and corrosion fretting of RSB and BF actuators.
 - ☼ Perform periodic external and internal maintenance inspections on all critical hardware for corrosion damage.
 - ☼ Establish a fleet leader inspection plan to assess the condition of the hardware over time and uncover any unexpected issues.
 - ☼ Apply corrosion-preventive primer (e.g., Super Koropon) to all external hardware surfaces.

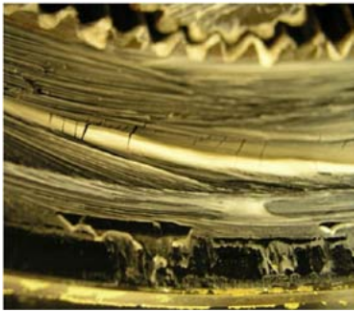
RSB actuator planetary gear corrosion damage

Problem Description	Lesson
<p>RSB PDU gearbox discrepancies: gear scuffing, dark/contaminated/low oil level.</p>	<ul style="list-style-type: none"> ☀ Perform periodic inspections on isolated fluid cavities that normally are not checked/sampled and are not continuously filtered, e.g., gearboxes.
<p>RSB and BF actuators internal grease degradation (Braycote 601)</p>

<ul style="list-style-type: none"> ☀ Utilize grease with extreme pressure (EP) additives necessary for efficient boundary lubrication, better oxidation/gassing qualities, more stable base oil, corrosion-inhibitors, and improved properties against physical separation and chemical breakdown.
<p>Body Flap PDU internal leakage.</p>

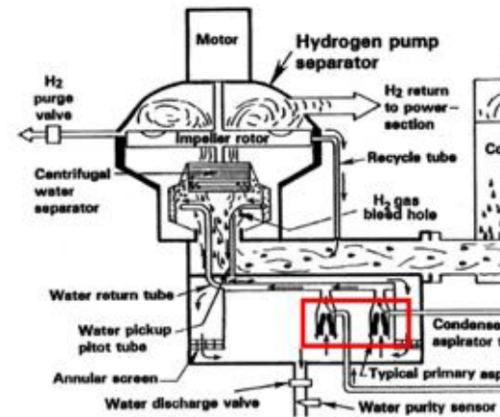
- STS-2 FC1 shutdown following H₂ pump/water separator failure and FC flooding.
 - ☼ Bus-tying the suspicious fuel cell with a healthy fuel cell is the method for monitoring performance of the suspect fuel cell when one fuel cell picks up the load from another.
 - ☼ For vital systems, redundancy in monitoring the system's health is as important as it is in the system itself.

Fuel Cell Hydrogen Pump Separator
aspirator tubes highlighted in red

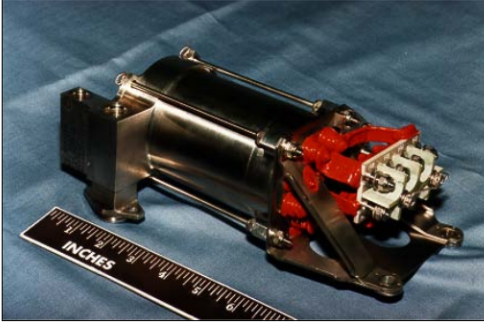
Problem Description	Lesson
<p>Water relief line freeze possibility.</p>	<ul style="list-style-type: none"> ☼ Operating environments need to be identified, implemented performed and evaluated. ☼ When new mission configurations arise (e.g., docking to a s problems may also arise which might require re-evaluation o
<p>H2 pump current sensor sensitivity.</p>	<ul style="list-style-type: none"> ☼ Unusual sensor activity can indicate a trend toward failure o pump motor, and thus a subsequent loss of the fuel cell. ☼ When using an instrumentation measurement as a failure ind make sure that all causes for output variations are understood procedures are in place for filtering out actual failure indica
<p>STS-127 long sustaining heater cycle.</p>

<ul style="list-style-type: none"> ☼ Effects of thermal environments must be included in design demonstrated by testing. ☼ Due to lower power requirements on SSPTS flights, the fuel sometimes require heating to return to operating temperatur ☼ When the fuel cells are performing on the low end of their c (2kW), sustaining heater cycles become a necessary compon operation: if they fail ON, the fuel cell needs to be safed im the coolant system malfunctions in any way; if they fail OF cell load needs to be increased to maintain temperature, resu cryogenic margin impact.

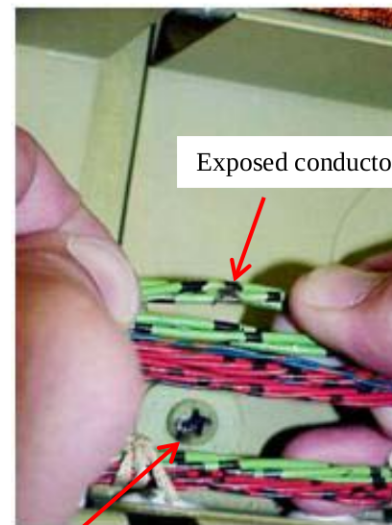
- STS-93 wire short description:
 - Short circuit in the AC system during ascent caused the loss of 2 main engine controllers.
 - Post flight investigation found the cause to be a damaged wire with an exposed conductor that contacted a nearby burred screw head.
 - As a result of the inspections, many other incidents were found of damaged wires and improperly protected wire harness.

Burred screw

- STS-93 wire short (Lessons):
 - ☼ Ground maintenance and vehicle modifications can cause damage like burrs on screw heads that lead to later wire damage.
 - ☼ Closeout inspections did not focus on inspecting the wiring.
 - ☼ Use auxiliary lighting and mirrors to inspect all accessible wiring.
 - ☼ Formalized and more clearly defined wire inspection criteria and processes. Perform periodic wiring inspections; particularly inspect for previously undetected wiring discrepancies.
 - ☼ Any primary wire insulation damage is unacceptable regardless of whether conductor is exposed or not.
 - ☼ Separate critical redundant wire runs and/or install barrier materials to protect against the effects of arc tracking.
 - ☼ Widespread use of chafe protection greatly reduced wire damage.
 - ☼ Enhanced workforce awareness and training is paramount in ensuring the health of electrical wiring.
